**Tree Risk Assessment, &  
Cultural Modified Trees  
Identification, Initial Data  
Collection and Reporting  
Gulf Islands National Park  
Reserve of Canada  
Canal Road  
Pender Island, B.C.**

2022-04-11 | Revision #0

Submitted to: Ministry of Transportation and  
Infrastructure Contract: 851 CS 1013A  
Prepared by: McElhanney

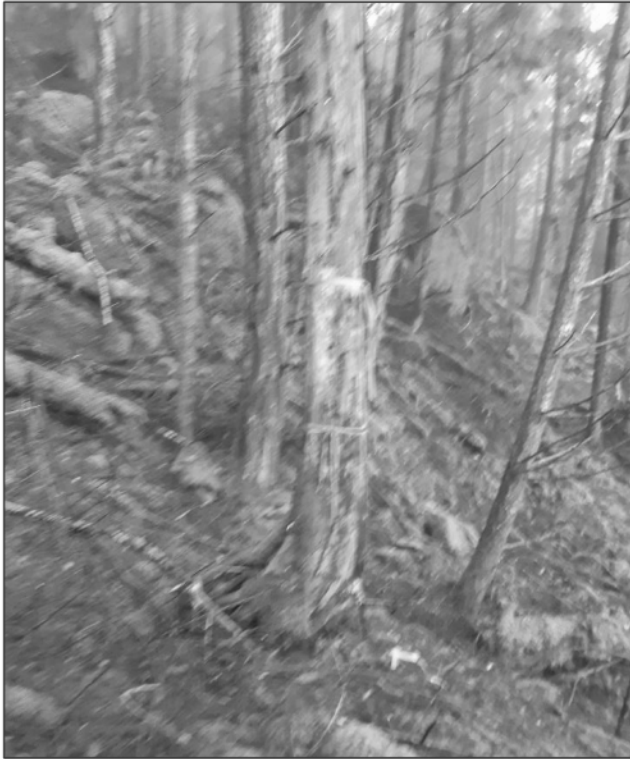
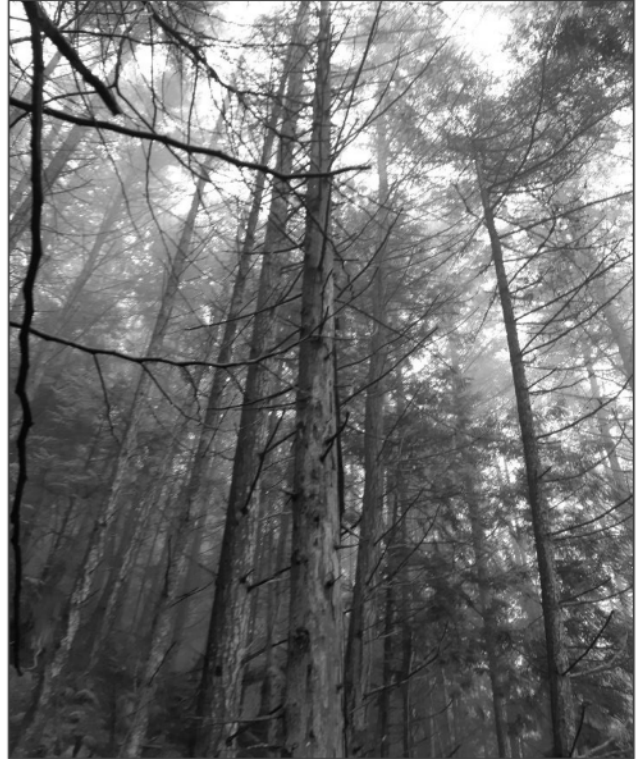
*Photos 1 & 2. Tree #1 images of the lower trunk and top.*

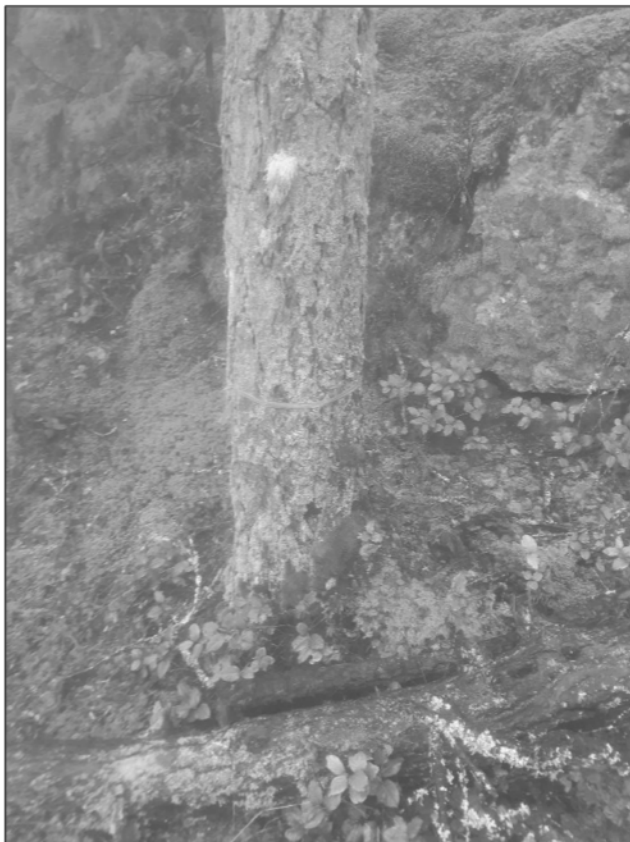
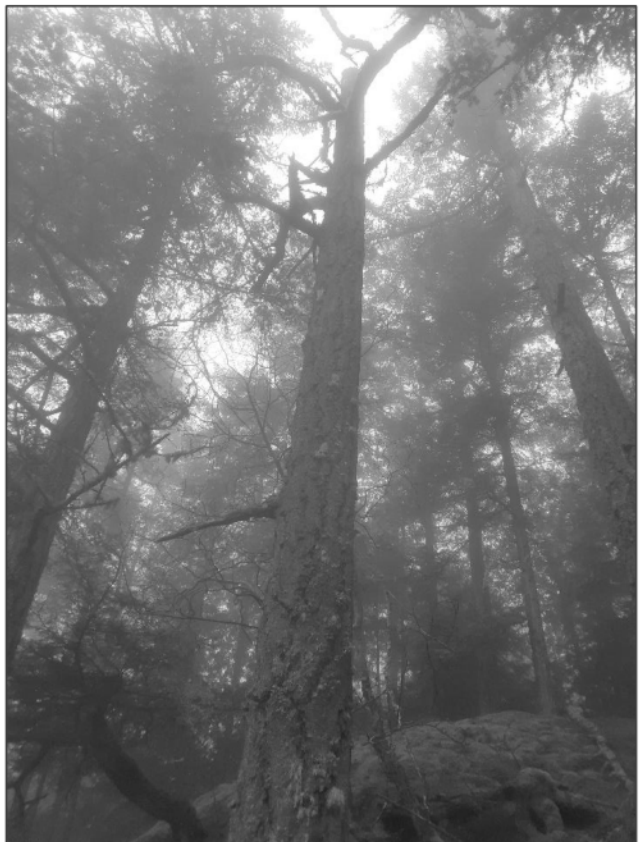
*Photo 3 & 4. Tree #4 lower trunk and top images. High value wildlife tree.*

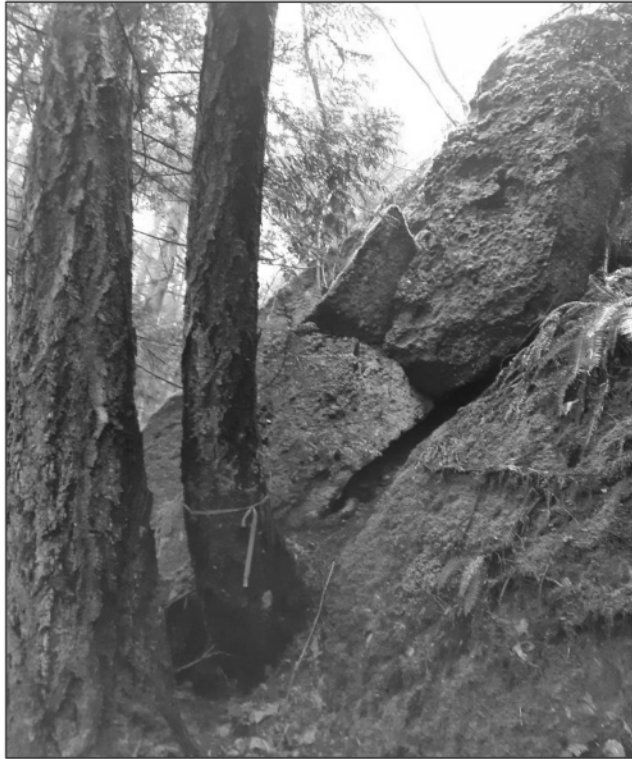
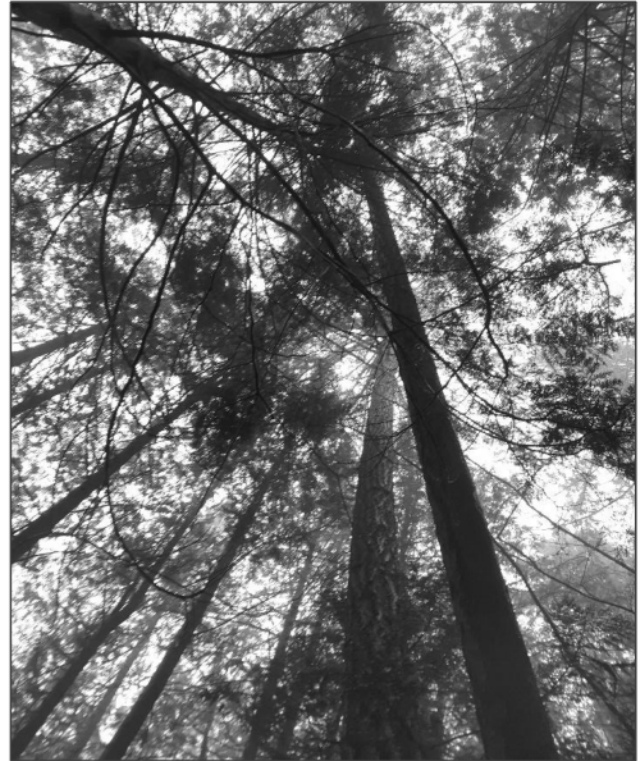
*Photo 5 & 6. Tree #5 images of the base of trunk anchored in the rock and leaning trunk (corrected).*

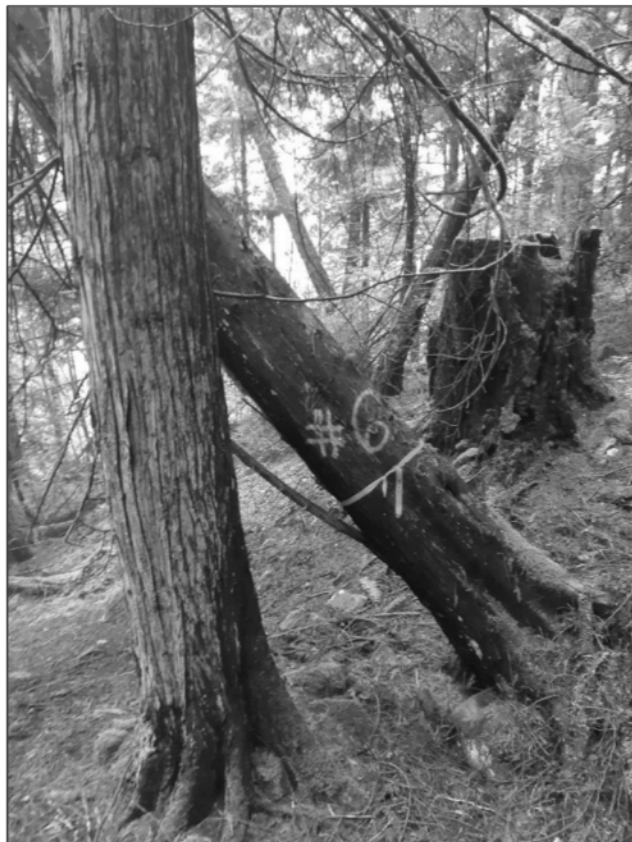
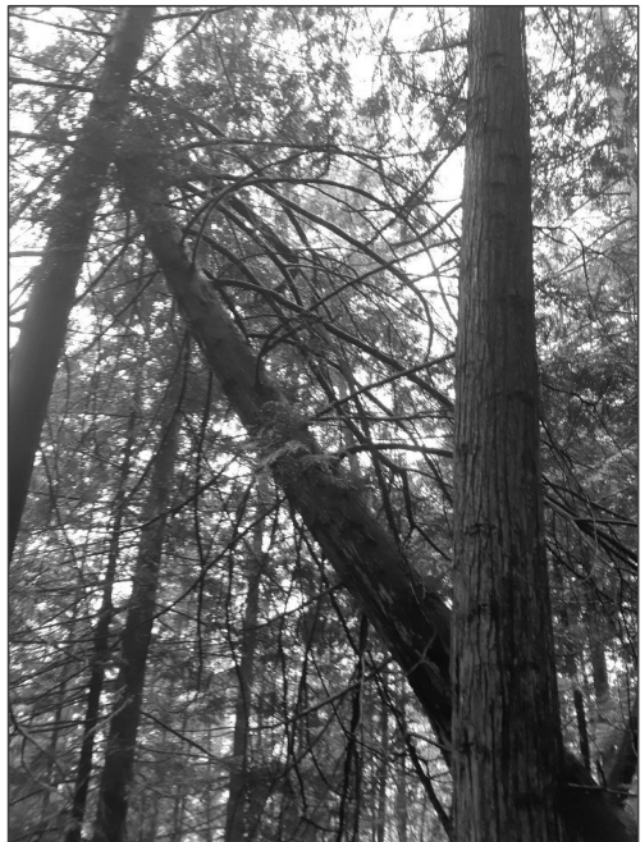
*Photo 7 & 8. Tree #6 images of the lower and upper trunk leaning but corrected.*

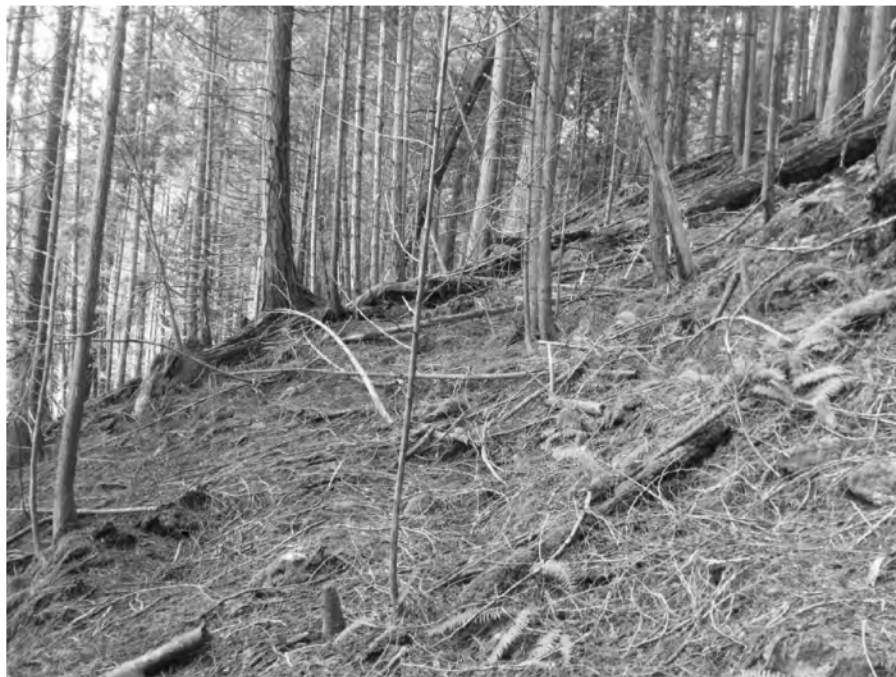
During the field visit, vegetation at the project site was observed to be predominantly young coniferous forest (trees ranging approximately 0.10 to 0.30 m diameter at breast height (DBH)), with some mature trees present (approximately 0.5 m to 0.8 m DBH) (**Photo 2** and **Photo 3**). Vegetation observed at the site included Douglas fir, western red cedar, salal, moss, western sword fern, and ocean spray.

**Photo 2** Representative photo of young coniferous forest upslope of Canal Road. Photo taken looking east on February 17, 2022.

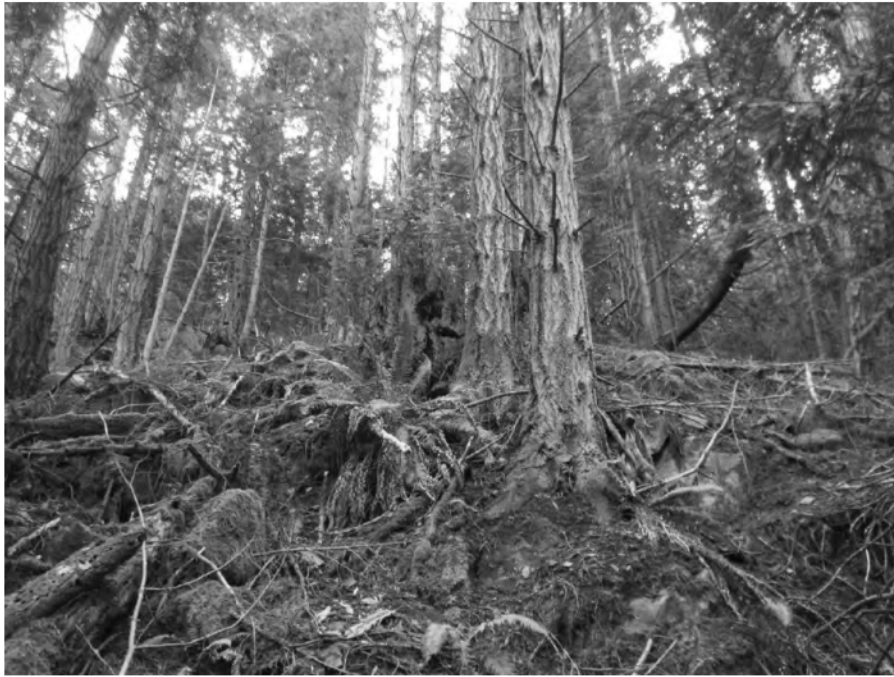
**Photo 3** Representative photo of coniferous forest observed upslope of Canal Road. Photo taken looking south on February 17, 2022.

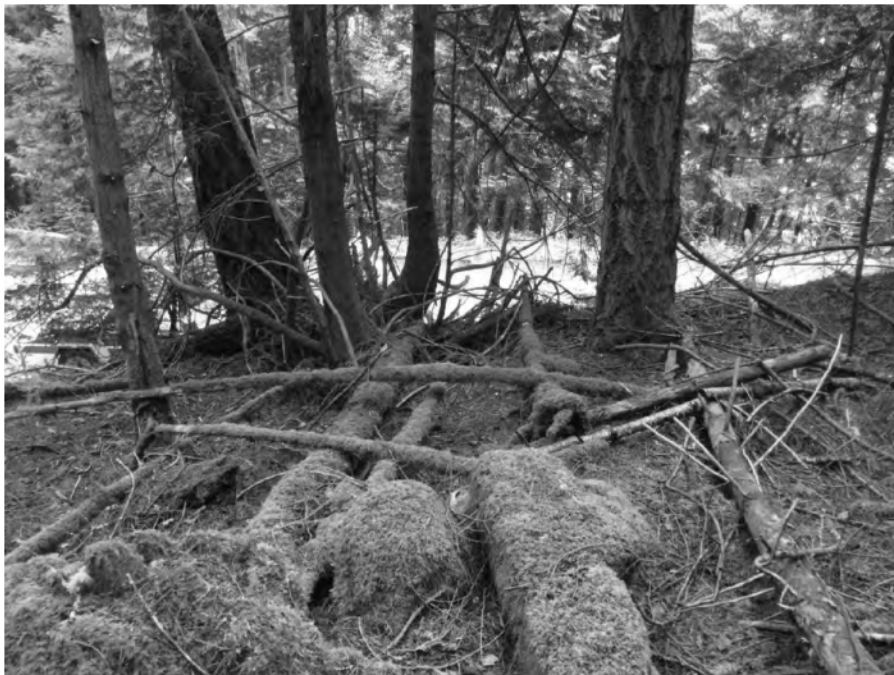
Mature western red cedar, Douglas fir, and big leaf maple trees were observed within the slide zone, with very limited understory vegetation comprised mainly of sword fern and patches of moss (**Photo 4**). The project site was well shaded with high canopy closure at the slide location. Groundcover was predominantly moss, sword fern, salal, and decaying red alder. Some evidence of forest fire burns was observed.

**Photo 4** Mature trees observed upslope of Canal Road. Photo taken looking north on February 17, 2022.

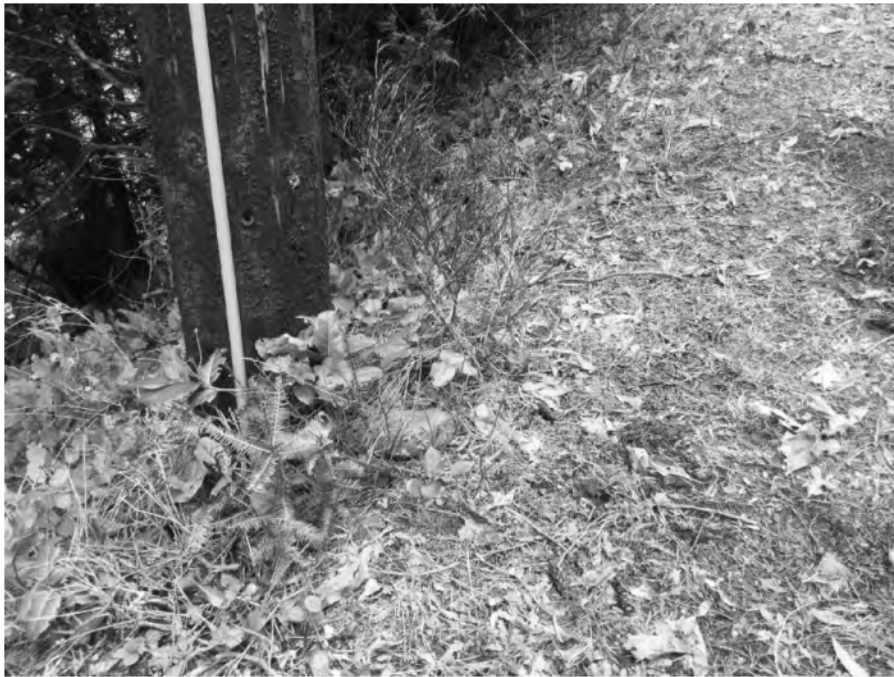
Invasive plant species observed along the roadside, mostly on the north side, included common foxglove (*Digitalis purpurea*), common cat's-ear (*Hypochaeris radicata*), and scotch broom (*Cytisus scoparius*) (**Photo 5**). No evidence of invasive plant species was observed west of the roadway.

**Photo 5** Scotch broom observed just east of existing culvert on north side of Canal Road. Photo taken looking northeast on February 17, 2022.

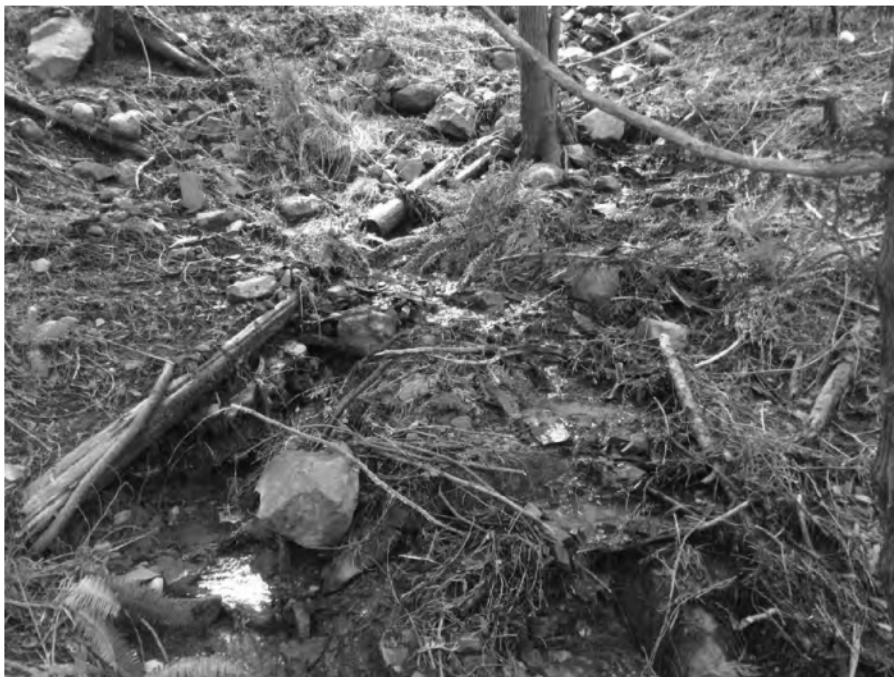
An unnamed watercourse (**Photo 6**) is located at the western extent of the project site, approximately 155 m east of the Mount Norman Trail Access. Provincial mapping of this watercourse indicates that it is a first-order watercourse with its headwaters originating in GINPR approximately 650 m from its marine confluence. The Fish Inventory Data Queries database and BC Habitat Wizard online mapping tool did contain any information regarding fish and fish habitat associated with the watercourse.

**Photo 6** Unnamed watercourse that crosses Canal Road; looking upstream from the south side of Canal Road. Photo taken looking south on February 17, 2022.

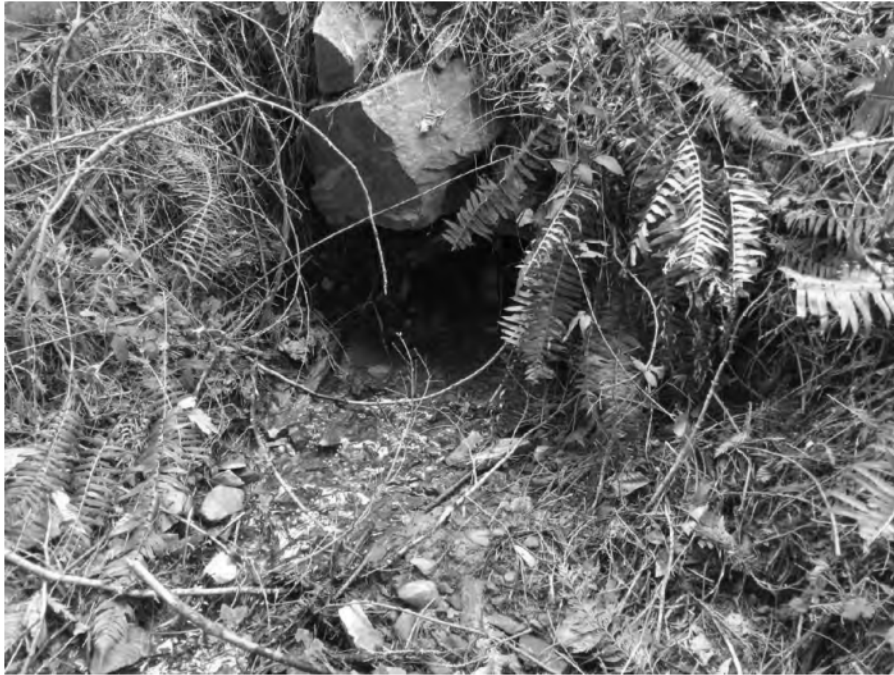
Based on observations during the field visit, the channel flows through a culvert (approximately 0.6 m) beneath the existing road, and flows northeast, eventually discharging into the ocean (**Photo 7** and **Photo 8**). The watercourse is approximately 1.5 m wide with a gradient of approximately 50%. At the time of the field visit, the depth of the water was observed to be shallow (<0.1 m) with step-pool morphology. Banks were poorly defined, and substrates were dominated by gravels and cobbles.

**Photo 7** Unnamed watercourse at culvert outlet on north side of Canal Road.  
Photo taken looking south on February 17, 2022.

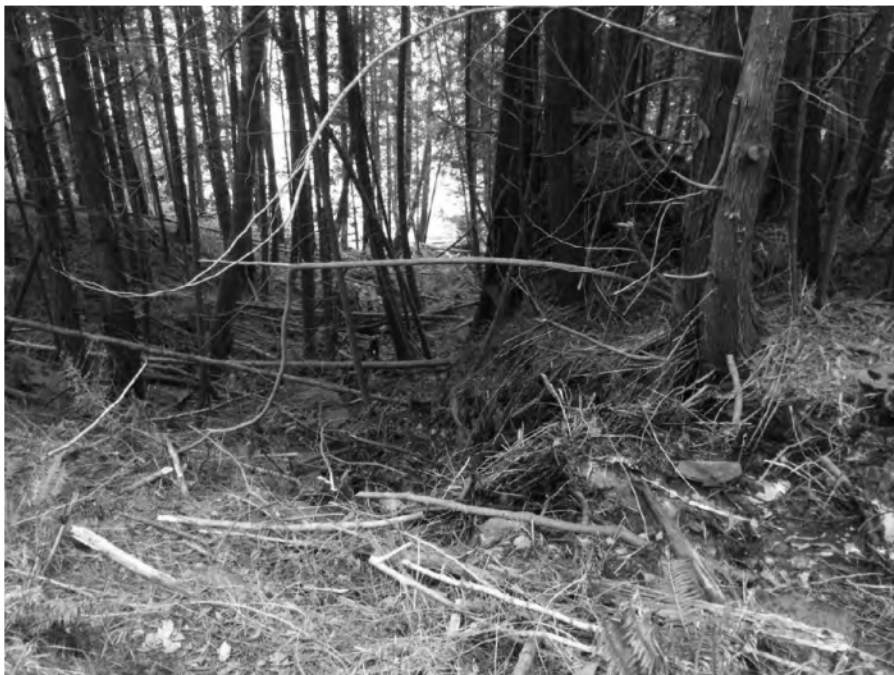
**Photo 8** Unnamed watercourse looking downstream from the north side of Canal Road; looking towards the confluence with the ocean. Photo taken looking north on February 17, 2022.

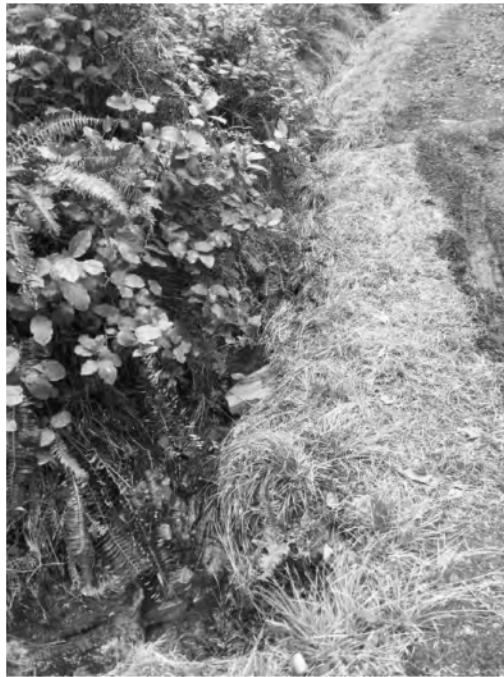
A roadside ditch was observed on the south side of Canal Road (**Photo 9**). The ditch was less than 0.3 m wide, appeared to be ephemeral, and flowed through an existing culvert that was approximately 0.3-0.4 m diameter.

**Photo 9** Roadside ditch observed on the south side of Canal Road. Photo taken on February 17, 2022.

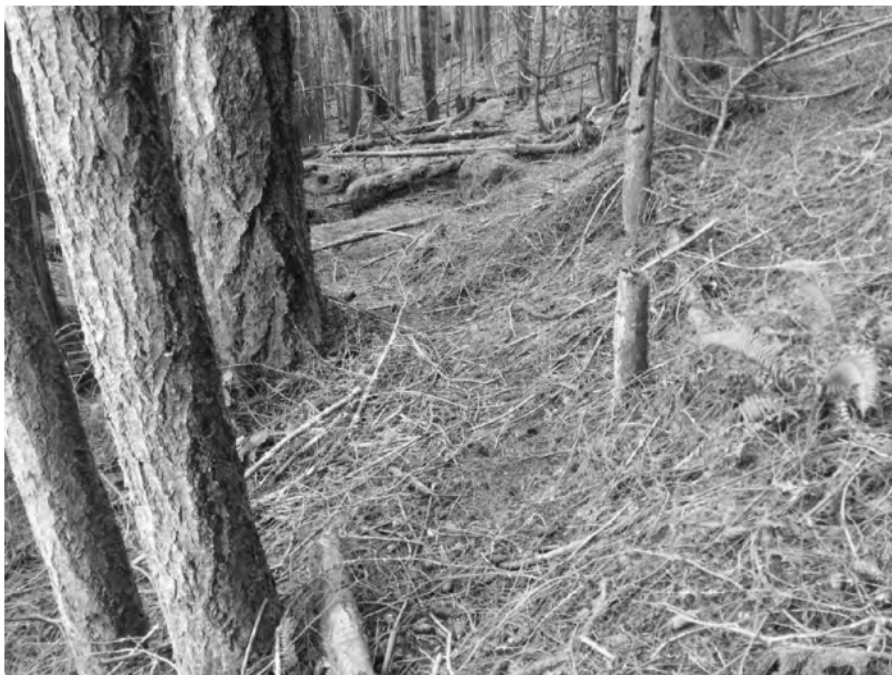
**Photo 10** Potential wildlife trail; parallels road, approximately 30 m south. Photo taken looking east on February 17, 2022.

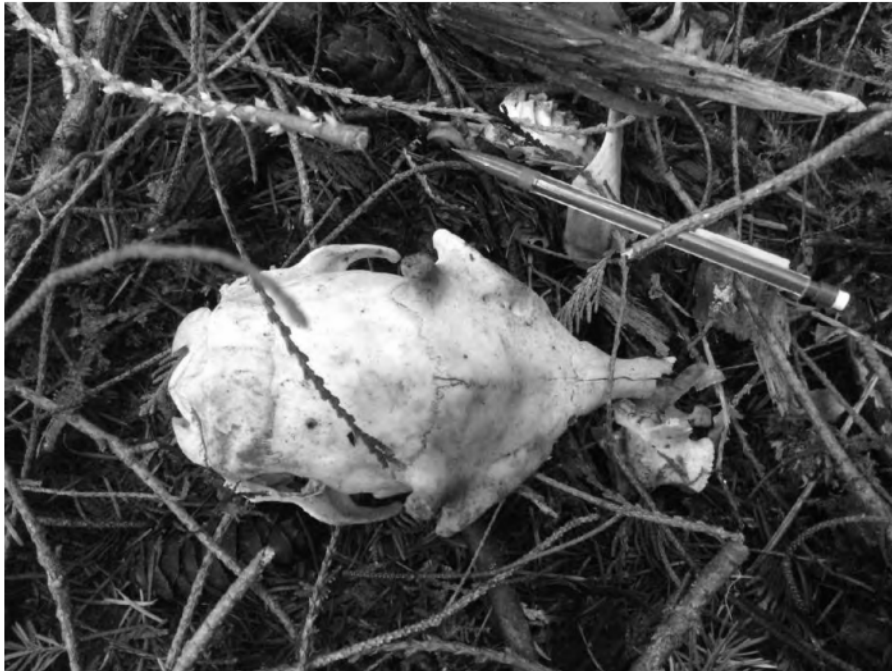
**Photo 12** Wildlife bones, potentially a young deer deer, observed on the south side of Canal Road, near the east extent of the site. Photo taken February 17, 2022.

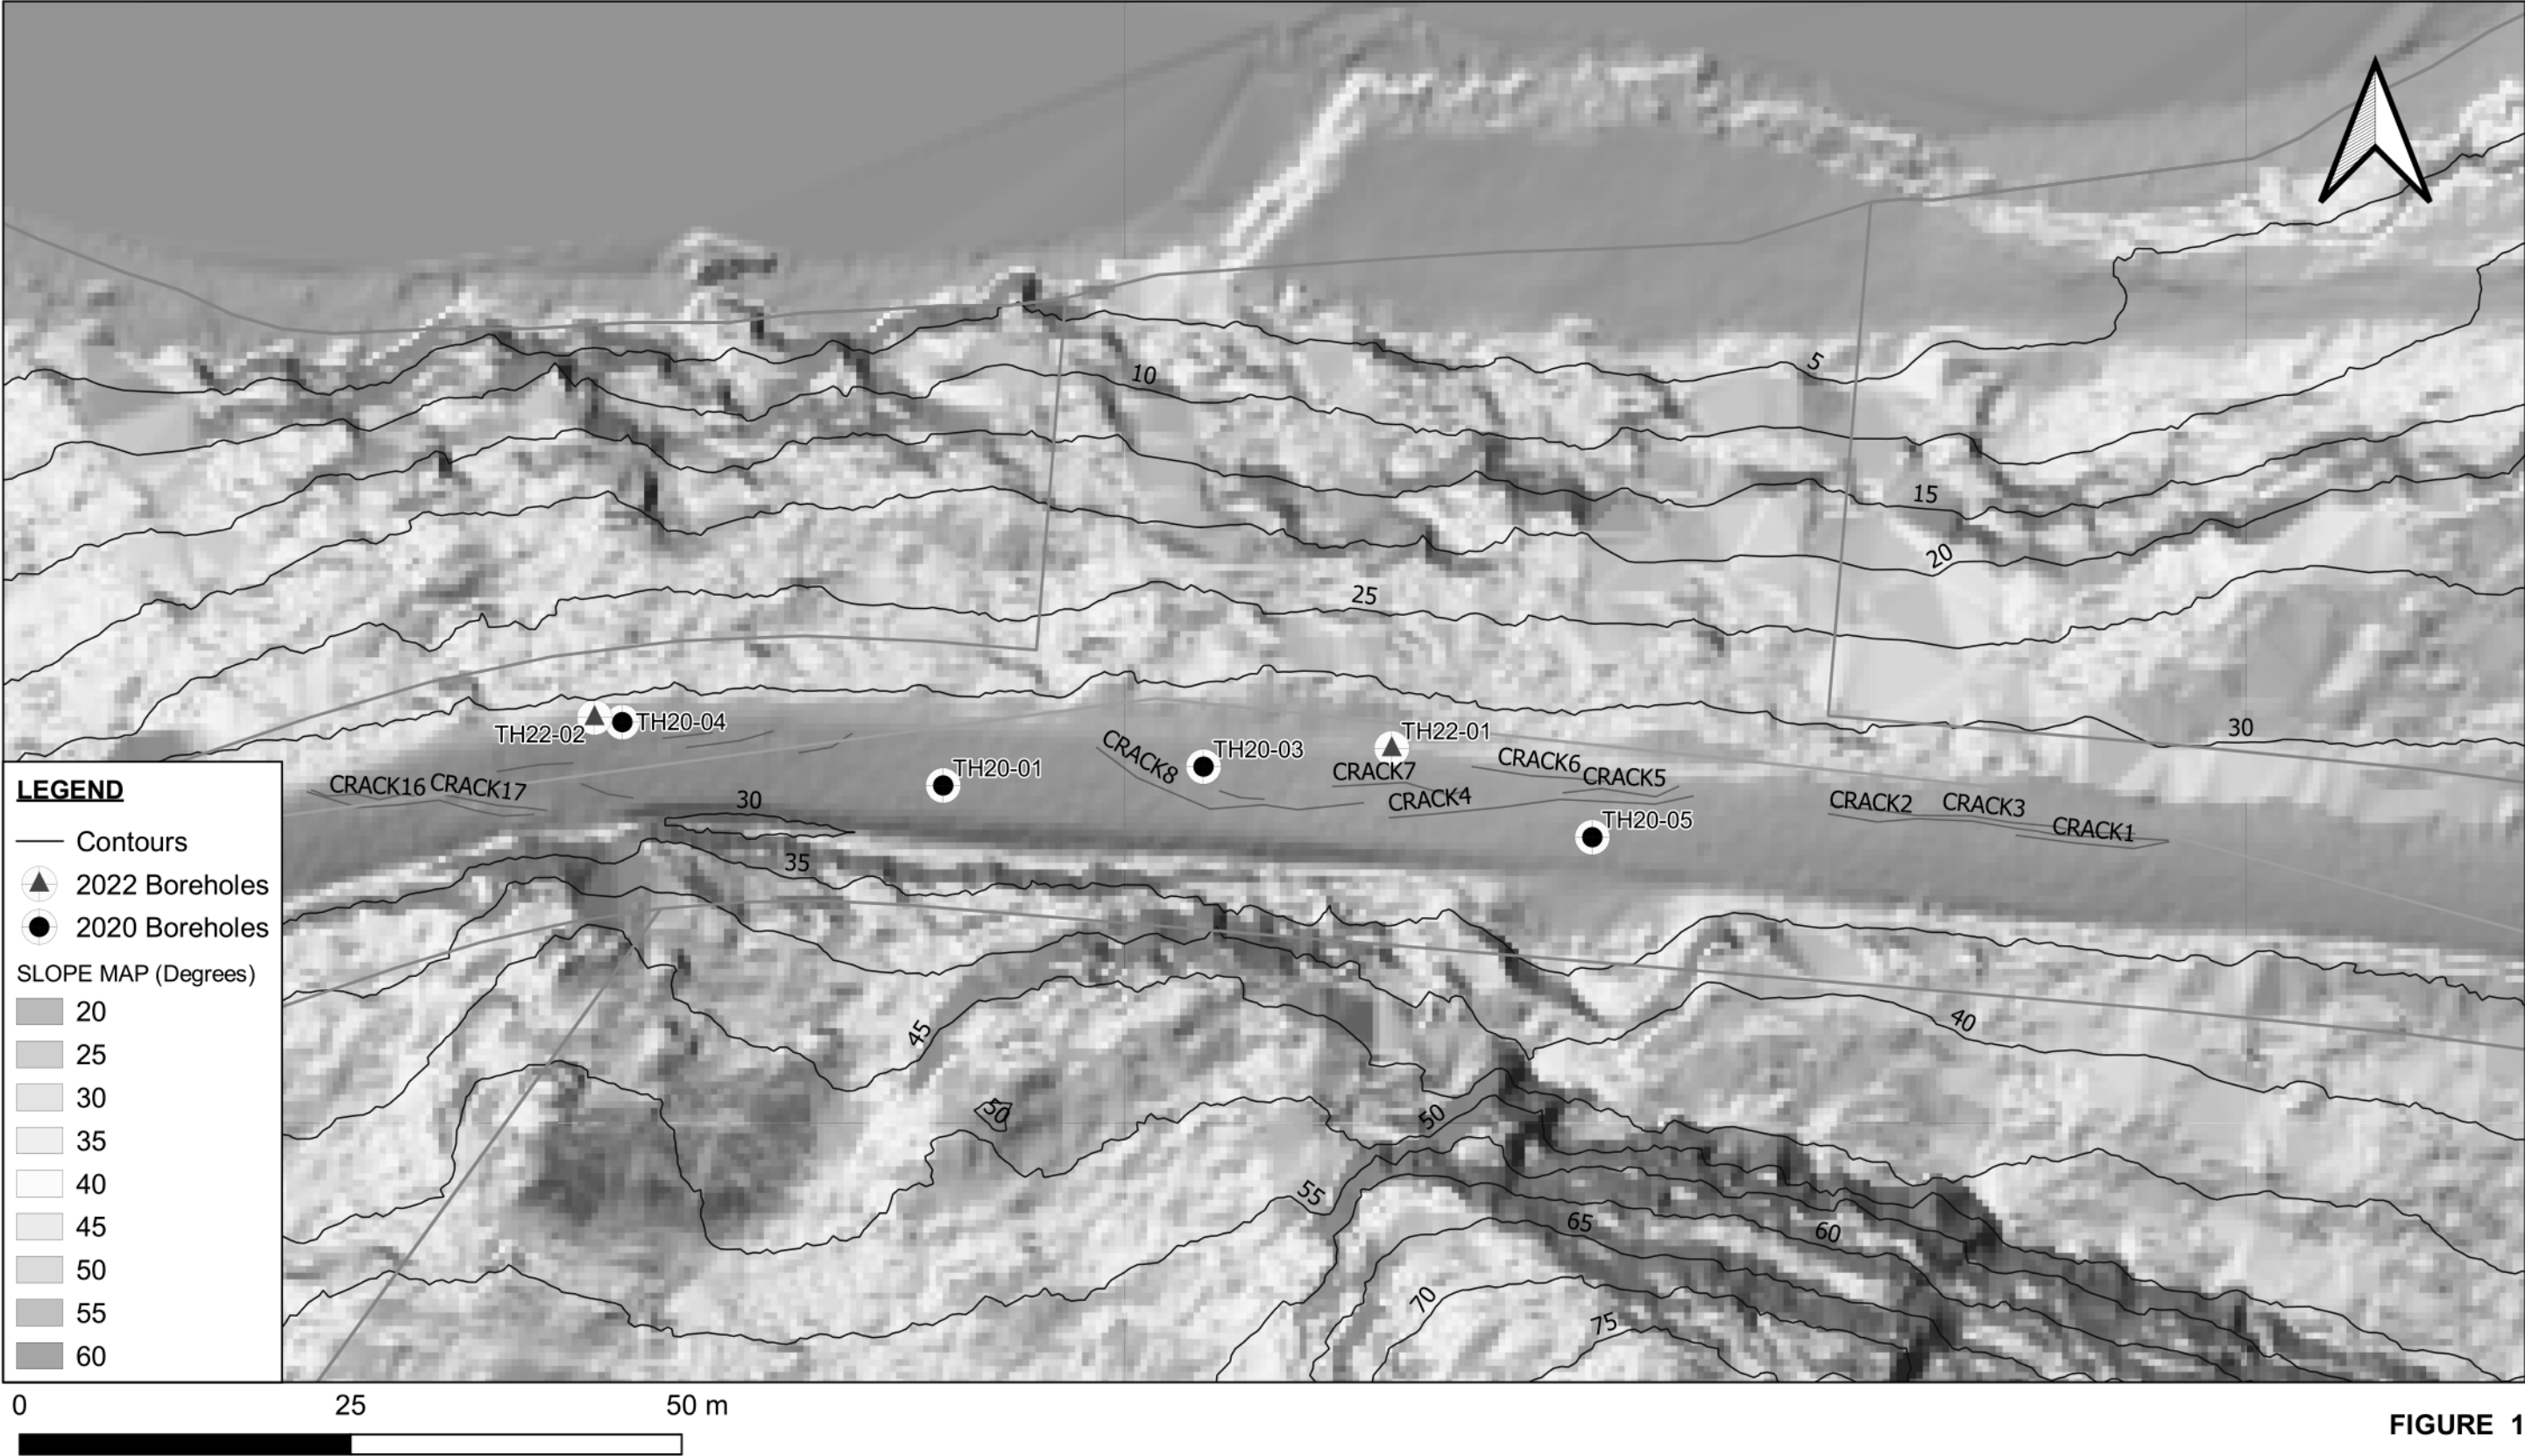
FIGURE 1

MoTI conducted a geotechnical investigation of the site in 2020 to investigate the slide location and soil conditions. Five geotechnical test holes were drilled to depths up to 13.4 m within the roadway. One monitoring well was installed at TH20-03. Draft MoTI test hole logs were provided by MoTI and have not yet been finalized. The test hole location plan can be found following the text of this letter in Figure 1.
