To
Alfred Ho, P.Eng., MBA - Asset Management Engineer
**Ministry of Transportation and Infrastructure
(MOTI)**

Re
06880 Canal Road Bridge:
Substructure Renewal Recommendations

Date
November 16, 2020

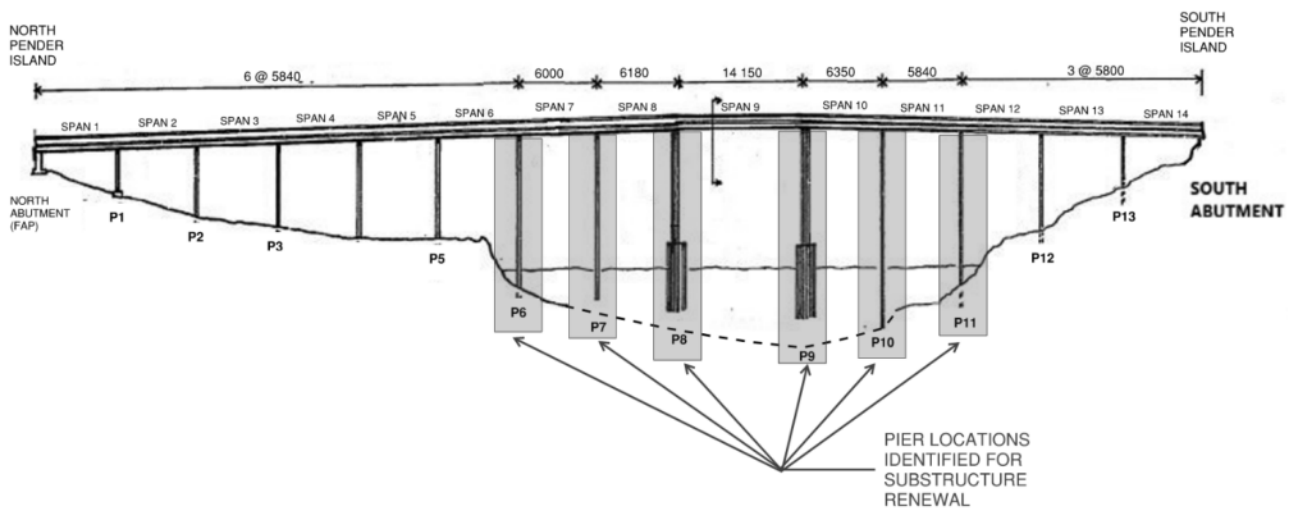
Figure 3 - Substructure Renewal Locations

Based on discussions with MOTI, McElhanney understands that the scope of the substructure renewal work will consist of extensive rehabilitation to the piles, cross-bracing, and lower pile cap locations at Piers 6 to 11, see **Figure 3**. Based on the extent of identified deterioration, localized replacements of deteriorated members are no longer considered feasible. The retrofit strategy will target complete replacement of the substructure elements for an anticipated repair design life of 20 years.

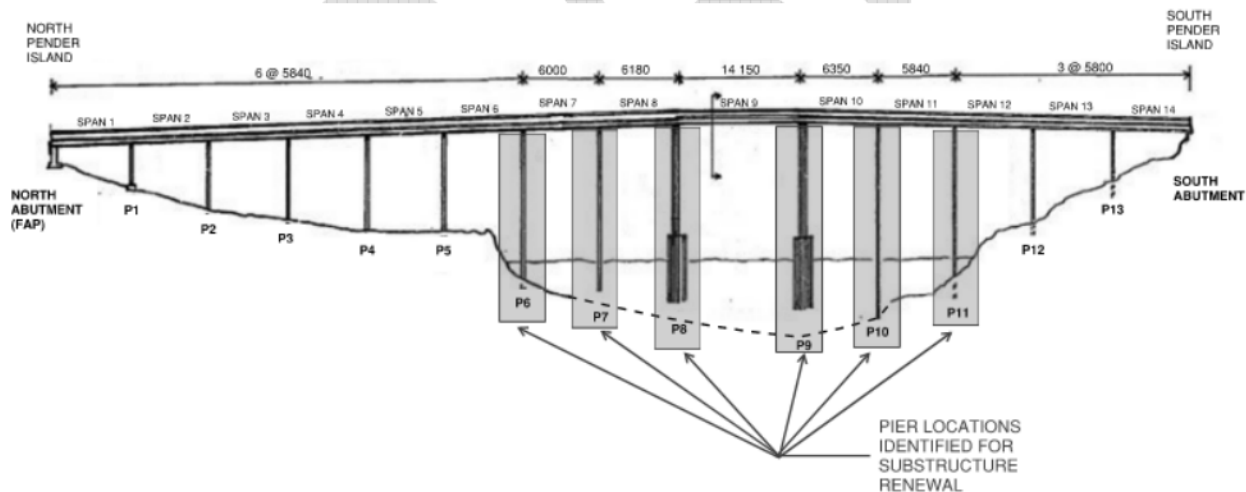
Figure 2 - Substructure Renewal Locations

The site review confirmed that the scope of substructure renewal works should include Piers 6 to 11 as shown in **Figure 2**. While there are several small repairs at the remaining pier and abutment locations, the extent of deterioration at the remaining substructure locations do not necessitate immediate substructure renewal.

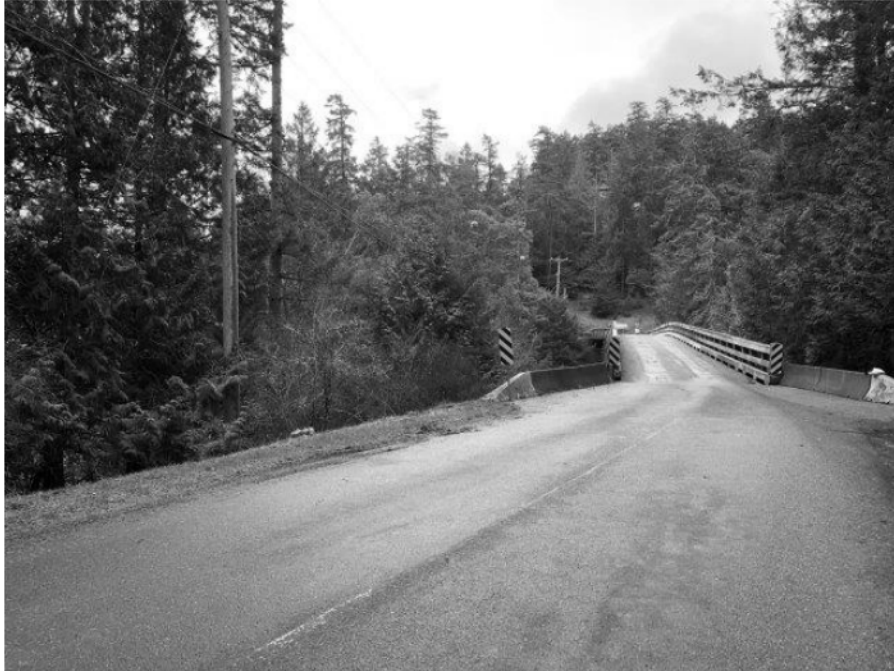
Photo 1 – North Bridge Approach Area

Location	General Description of Condition	Recommended Action Items
Bridge Topsides	<ul style="list-style-type: none"> Minor localized erosion/settlement of north and south approaches (<i>Photos 1 and 2</i>). Asphalt wearing surface has widespread cracking and deterioration (<i>Photo 3 and 4</i>). Handrails and curbs have moderate weathering and splitting (<i>Photo 5</i>). 	Monitor
North Abutment	<ul style="list-style-type: none"> Typical water ingress and staining of timber deck and stringers (<i>Photo 6</i>). Minor gaps in timber bulkhead wall. Minor slope failures of adjacent slope area. 	Monitor
Pier 1	<ul style="list-style-type: none"> Typical water ingress and minor surface fungal decay of timber elements (<i>Photo 7</i>). Cross bracing appears well secured to the support posts. Support posts are supported on cast-in-place spread footings. 	Monitor
Pier 2	<ul style="list-style-type: none"> Typical water ingress and minor localized surface fungal decay of timber elements (<i>Photo 8</i>). Pile B (2nd from east side) has a timber sub-cap block installed. Cross bracing appears well secured to the timber piles. 	Monitor

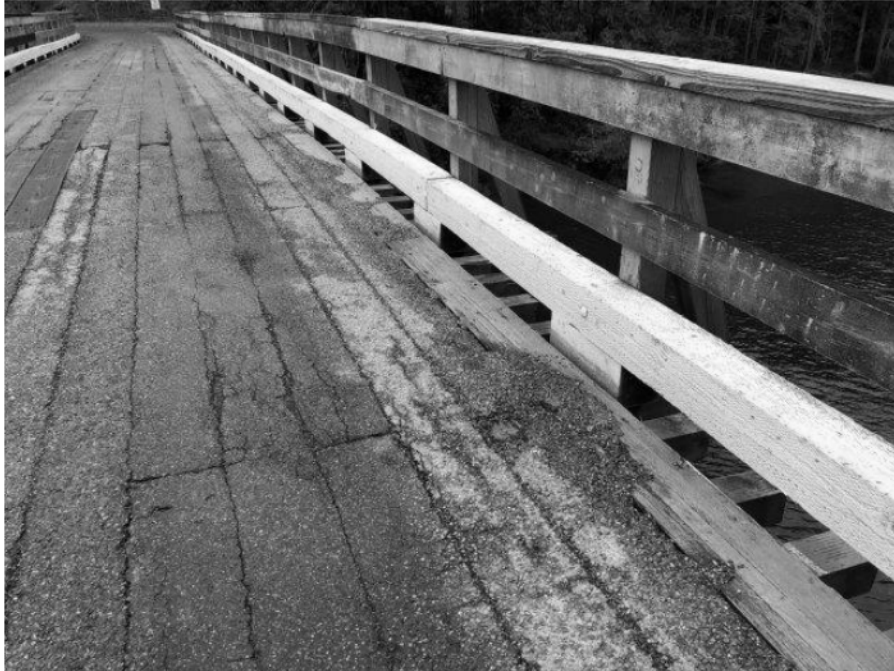
Photo 5 – Typical Condition of Timber Curb and Handrail

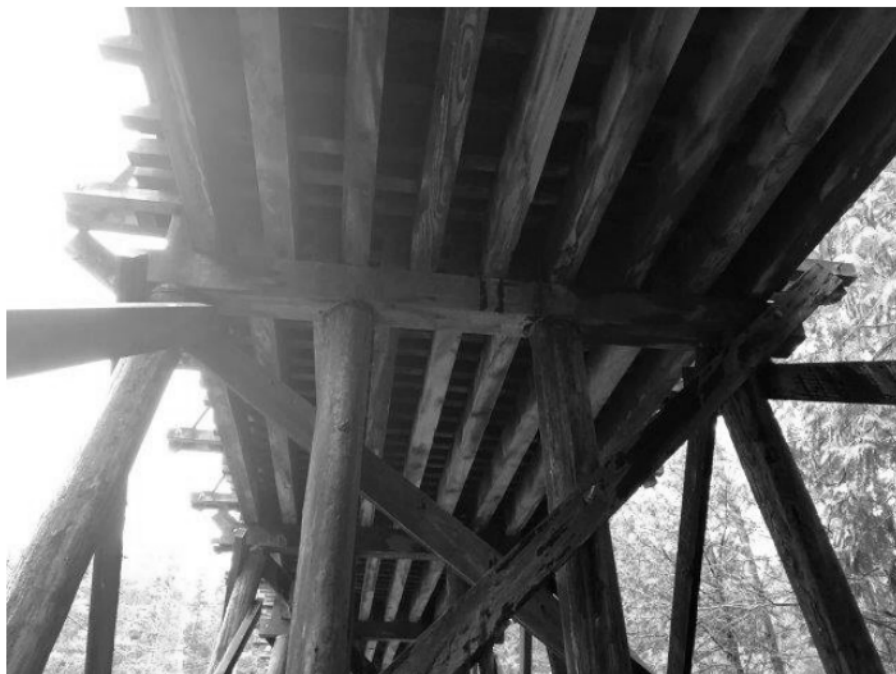
Photo 9 – Pier 3 Typical View

Pier 3	<ul style="list-style-type: none"> Typical water ingress and minor localized surface fungal decay of timber elements (<i>Photos 9 and 10</i>). Cross bracing appears well secured to the timber piles. 	Monitor
Pier 4	<ul style="list-style-type: none"> Typical water ingress and minor localized surface fungal decay of timber elements (<i>Photo 11</i>). Cross bracing appears well secured to the timber piles. The middle east and west piles have evidence of previous clamps installed at the groundline. Clamps appear to have failed (<i>Photos 12 and 13</i>). 	Monitor
Pier 5	<ul style="list-style-type: none"> Typical water ingress and minor localized surface fungal decay of timber elements (<i>Photo 14</i>). Cross bracing appears well secured to the timber piles. Minor erosion of the ground at the base of the piles due to water current at high tide (<i>Photo 15</i>). Erosion and undermining of the concrete foreshore wall between Piers 5 and 6 (<i>Photo 16</i>). 	Monitor

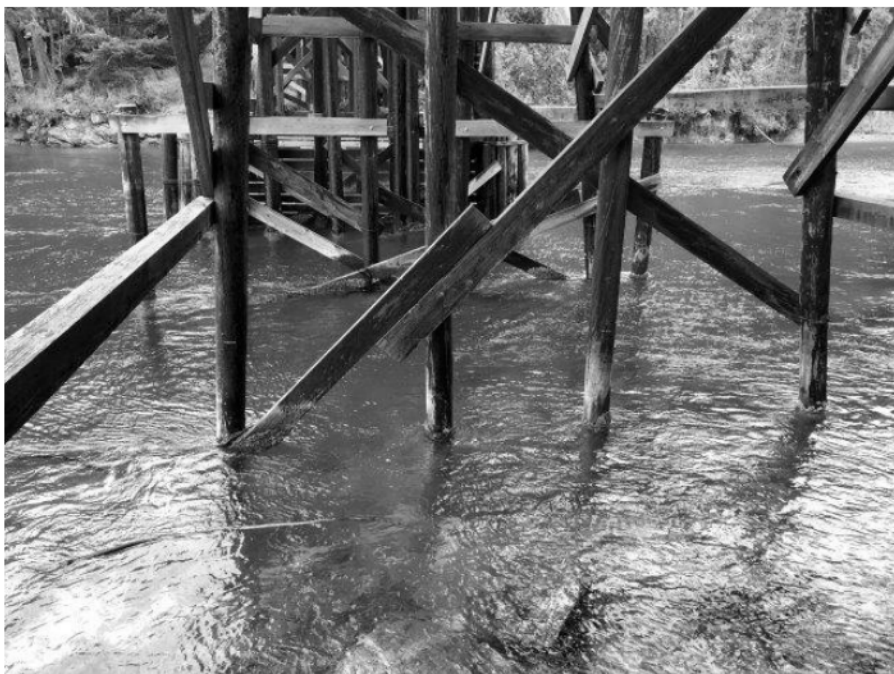
Photo 17 – Pier 6 Typical View at Waterline

Location	General Description of Condition	Recommended Action Items
Pier 6	<ul style="list-style-type: none"> Typical water ingress and minor localized surface fungal decay of the exposed timber elements (<i>Photos 17 to 18</i>). Previous WorleyParsons report identified significant deterioration of the timber piles in the submerged zone due to marine borer activity. 	Substructure Renewal
Pier 7	<ul style="list-style-type: none"> Typical water ingress and minor localized surface fungal decay of the exposed timber elements. Previous WorleyParsons report identified significant deterioration of the timber piles in the submerged zone due to marine borer activity (<i>Photo 19</i>). 	Substructure Renewal
Pier 8	<ul style="list-style-type: none"> Typical water ingress and minor localized surface fungal decay of the exposed timber elements. Previous WorleyParsons report identified significant deterioration of the timber piles in the submerged zone due to marine borer activity (<i>Photo 20</i>). 	Substructure Renewal

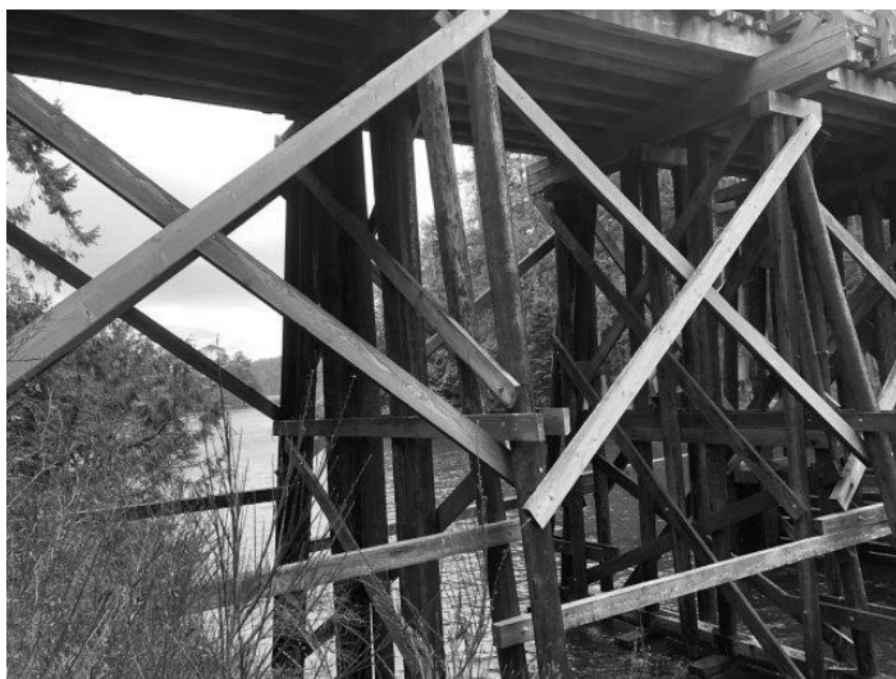
Photo 22 – Pier 11 Typical View, North Face

Pier 9	<ul style="list-style-type: none"> Typical water ingress and minor localized surface fungal decay of the exposed timber elements. Previous WorleyParsons report identified significant deterioration of the timber piles in the submerged zone due to marine borer activity. 	Substructure Renewal
Pier 10	<ul style="list-style-type: none"> Typical water ingress and minor localized surface fungal decay of the exposed timber elements. Previous WorleyParsons report identified significant deterioration of the timber piles in the submerged zone due to marine borer activity (<i>Photo 21</i>). Additional low pile caps and replacement piles have been installed since original construction. 	Substructure Renewal
Pier 11	<ul style="list-style-type: none"> Typical water ingress and minor localized surface fungal decay of the exposed timber elements. Previous WorleyParsons report identified significant deterioration of the timber piles in the submerged zone due to marine borer activity (<i>Photos 22 and 23</i>). 	Substructure Renewal

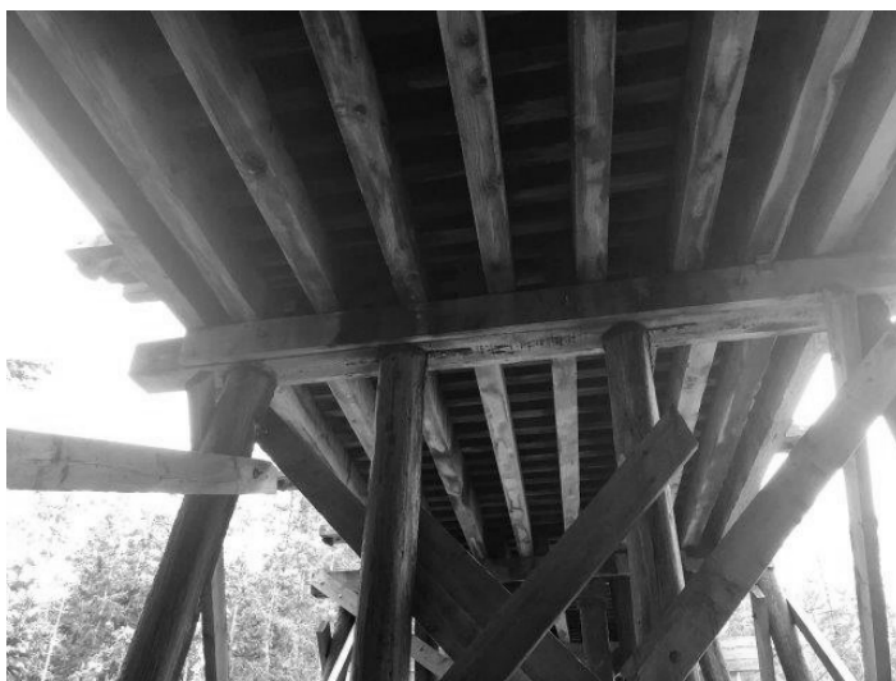
Photo 24 – Pier 12 Typical View

Pier 12	<ul style="list-style-type: none"> Typical water ingress and minor localized surface fungal decay of the timber elements (<i>Photo 24</i>). Cross bracing appears well secured to the timber piles. 	Monitor
Pier 13	<ul style="list-style-type: none"> Typical water ingress and minor localized surface fungal decay of the timber elements (<i>Photos 25 and 26</i>). Cross bracing appears well secured to the timber piles. 	Monitor

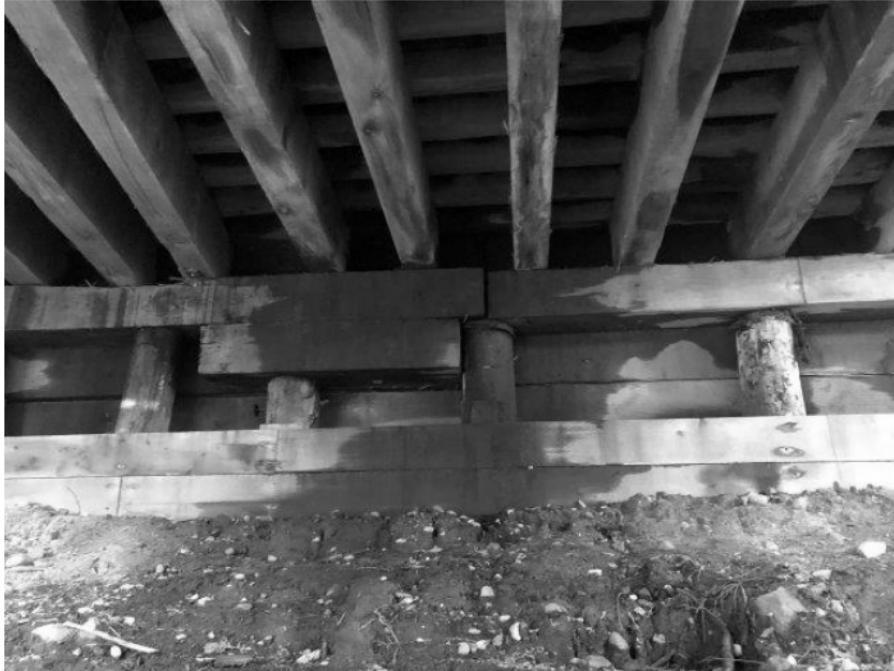
Photo 27 – South Abutment Typical View

Location	General Description of Condition	Recommended Action Items
South Abutment	<ul style="list-style-type: none"> Minor gaps in timber bulkhead wall with backfill water ingress. Typical water ingress and staining of timber deck and stringers (<i>Photo 27</i>) Minor slope failures of adjacent slope area. Pile cap and corbel block are not adequately secured (<i>Photo 28</i>). 	Install Steel Straps Between Adjacent Pile Cap Sections and Corbel Block.

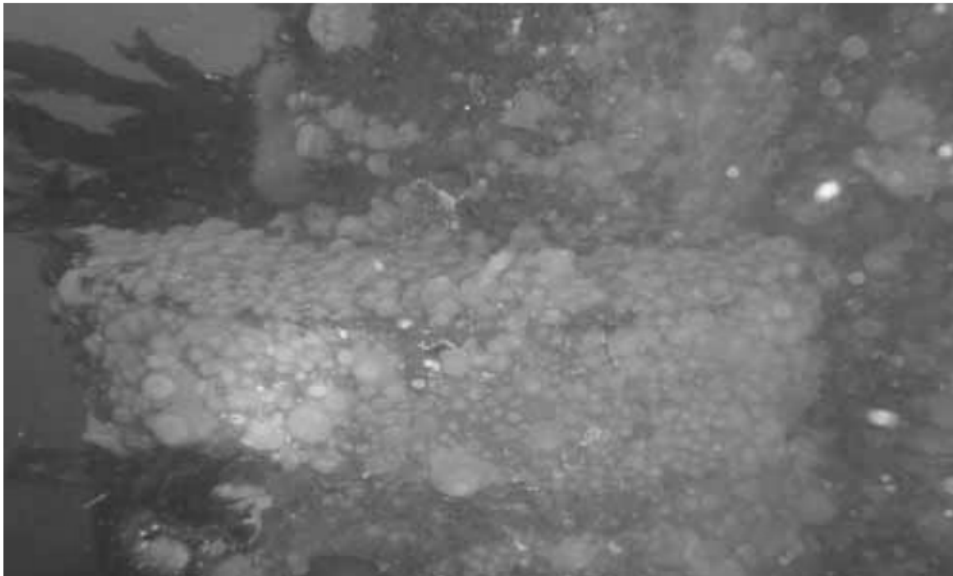
Photo 13: Canal Bridge No. 6880 - concrete collar on Pile No. 8 on Pier No. 8.
