July 19, 2012

Project No. 1014940294-001-L-Rev0

**REVISED GEOHAZARD ASSESSMENT PROPOSED SUBDIVISION OF PROPERTY NE1/4 OF
SECTION 27, TP22, RG.17 W6M KDYD PLAN B11979, WESTSYDE ROAD, NORTH OF KAMLOOPS, BC**

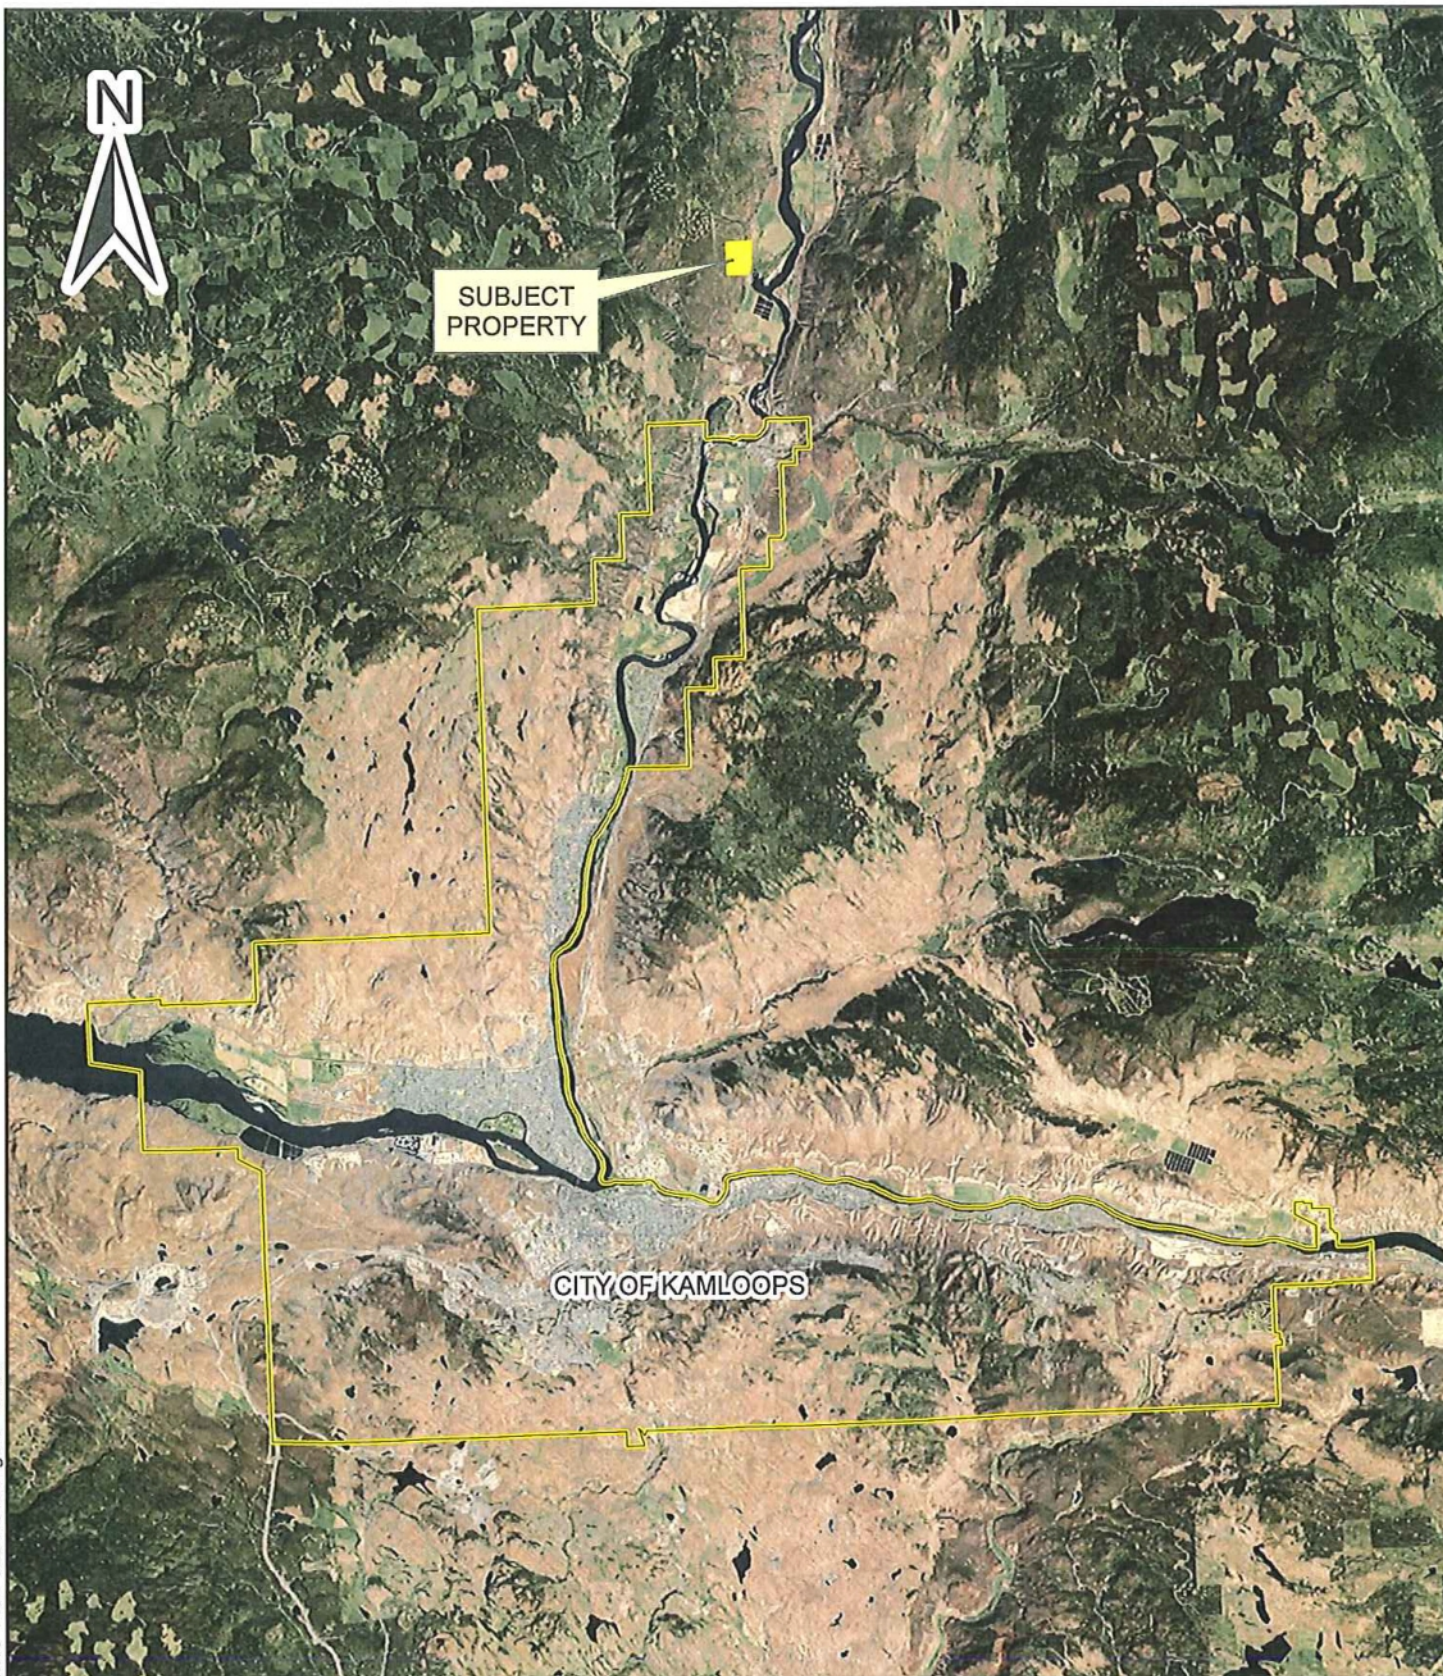
The site is located along the west side of Westsyde Road, approximately 30 km north of the downtown core of Kamloops, BC and about 3 km south of the Black Pines Settlement. The subject property is divided into four proposed lots (Lot A to Lot D) as shown in Figure 2.

The slopes above the proposed development area are incised by a series of well separated minor gullies oriented in the downslope direction. The gullies are assessed to be ephemeral drainage channels that terminate in colluvial fans, commonly coalescing colluvial fans, which comprise the gently sloping terrain on the eastern parts on the proposed lots. However, there were observed to be localized occurrences of steeply sloping fan deposits containing cobbles which have developed at the outlets of some of the minor gullies. At the time of the reconnaissance, the gullies were dry and the gently sloping terrain at the toe of the ridge (beyond any local steeply sloping fan deposits) was covered by grass with no observed signs of recently deposited material. There are reportedly two irrigation ditches on the lower slopes (only the lower ditch was observed in the reconnaissance) both of which were reportedly historically fed by diversion from Jamieson Creek in the early 20th Century. As reported by Mr. Cory, it is understood that the irrigation ditches have been abandoned and non-functional for in excess of 70 years. The lower of the two abandoned irrigation ditches crosses through the south side of Lot C (refer to Figure 2).
