GEOTECHNICAL FIELD REVIEW / SITE INSTRUCTION

Project No: 10943-1

Project: Dam Assessment

Project Address: Morningstar Golf Club – Parksville, BC

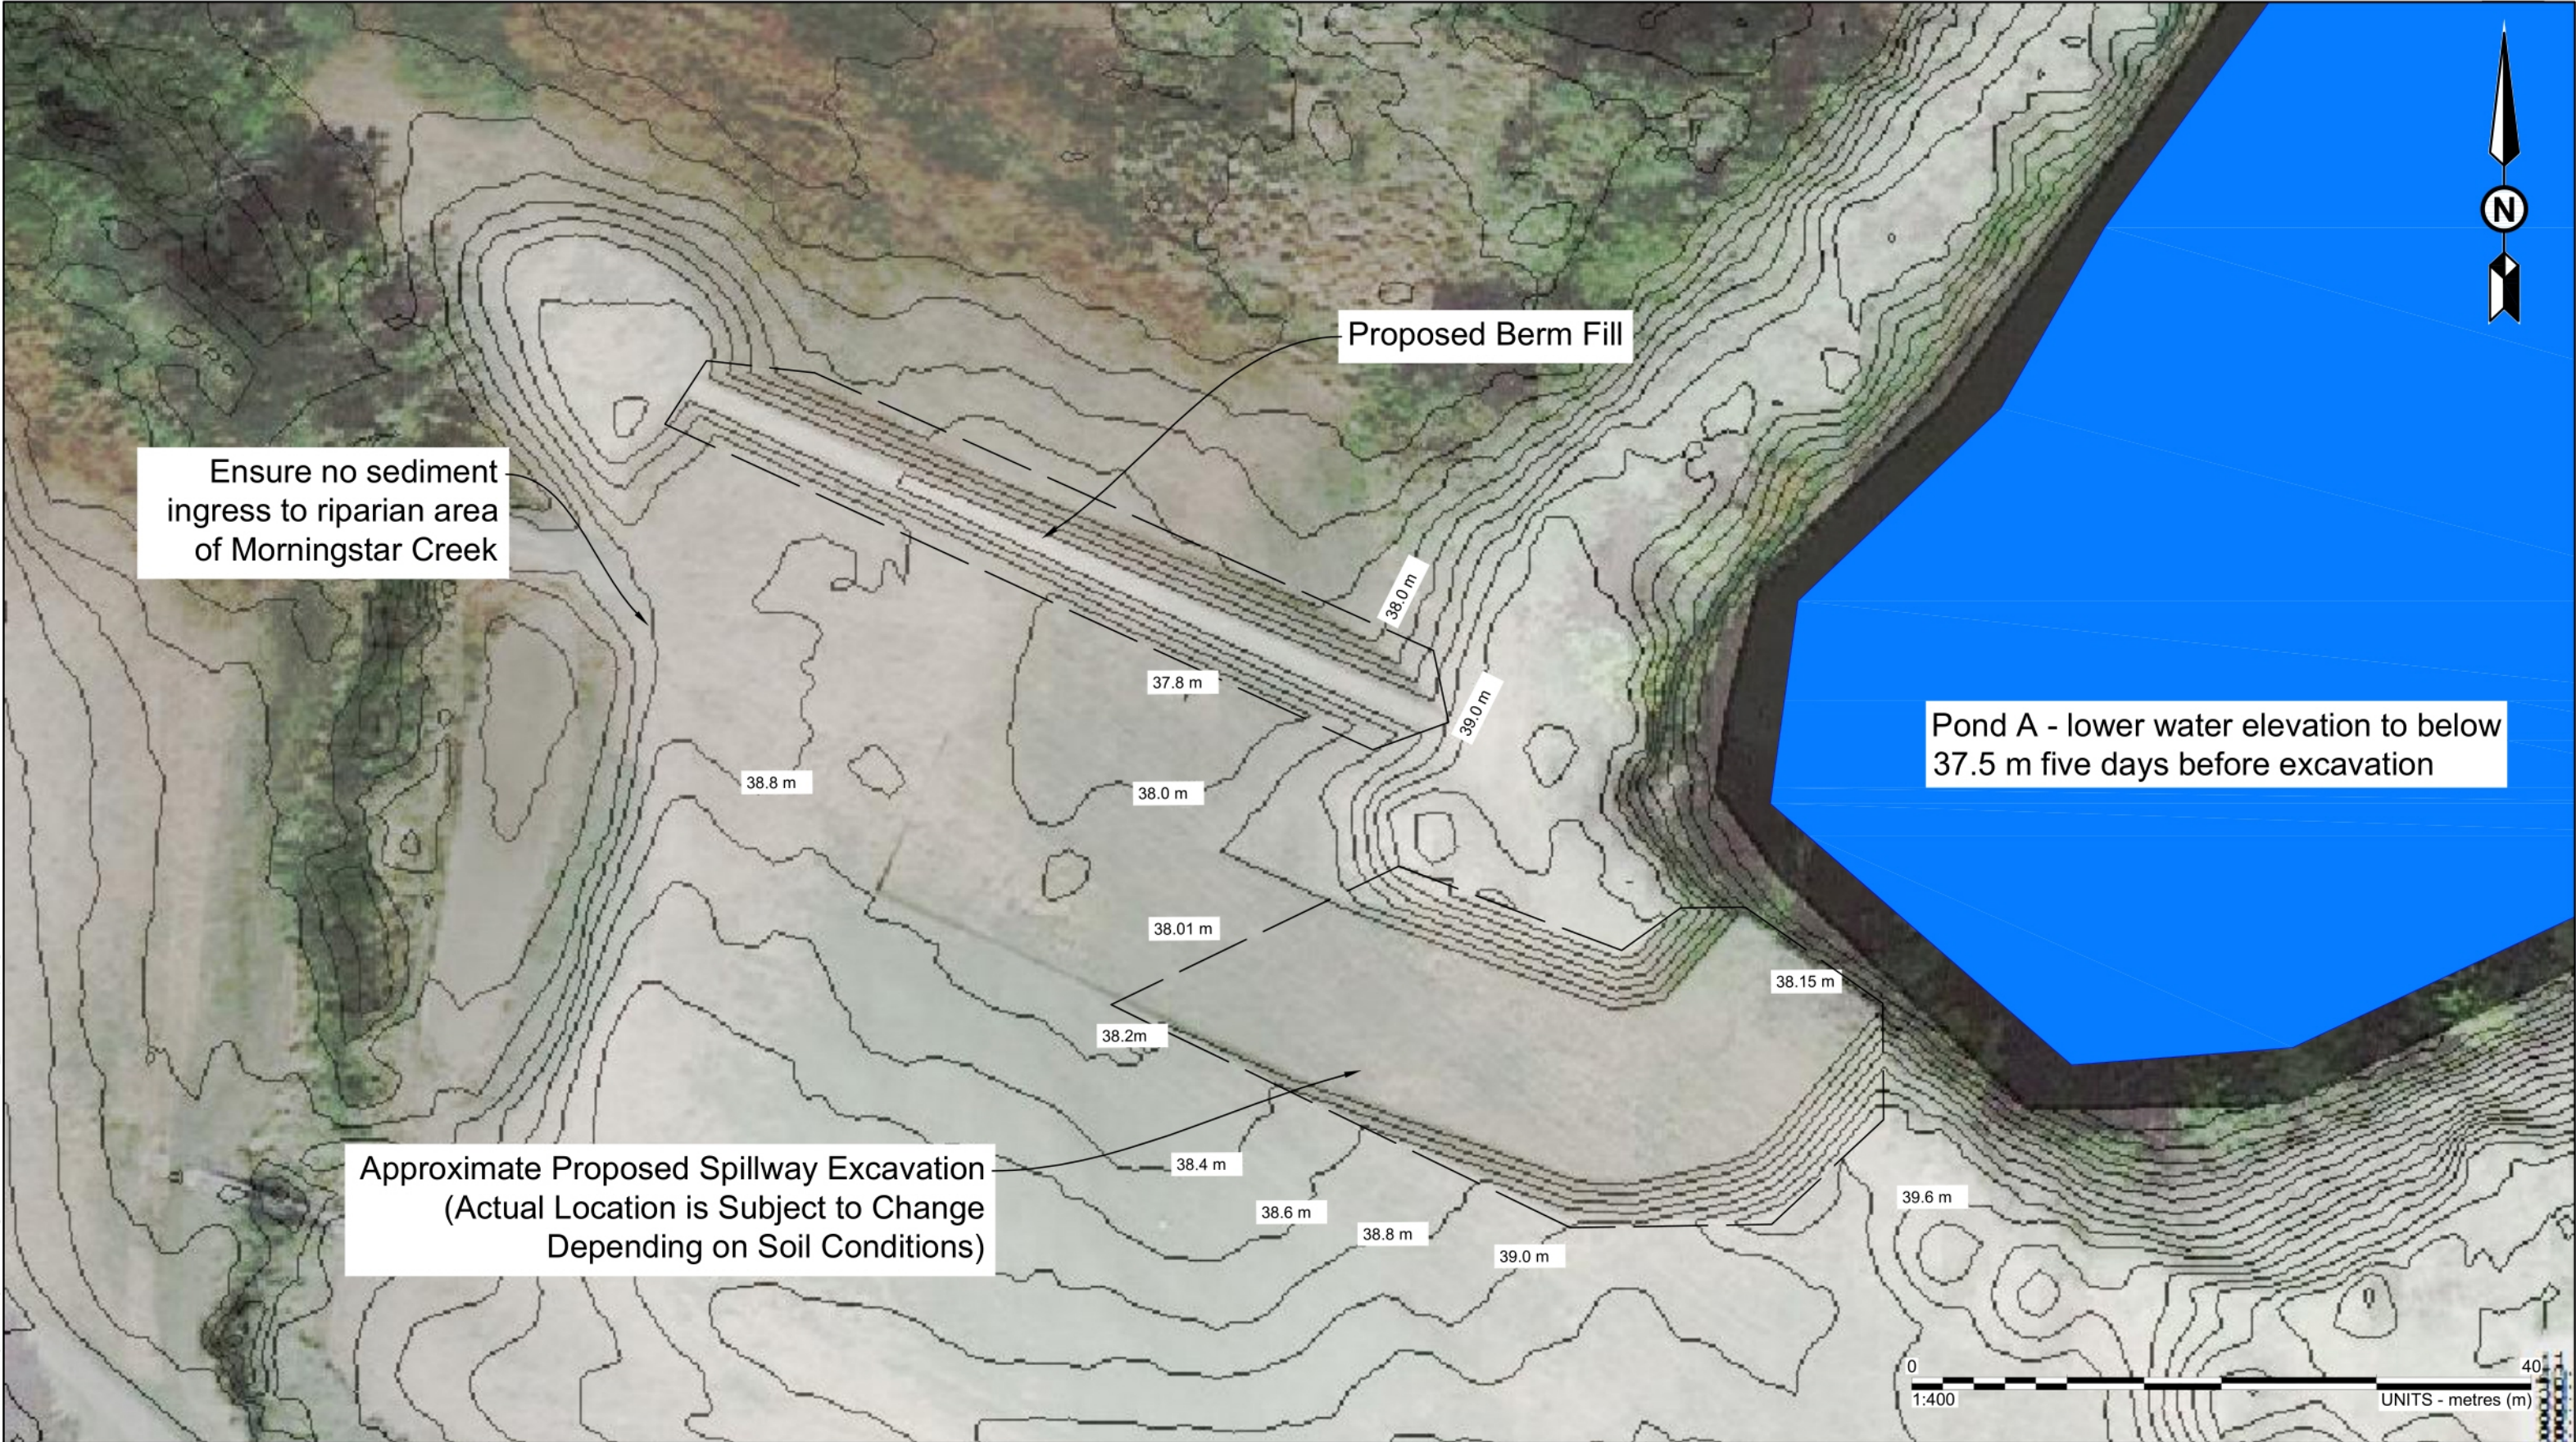
The recently acquired survey information indicates the existing 200 mm outlet pipe located at the western portion of Dam 2 has an invert elevation of 38.10 m (geodetic). As noted in the DSR, we recommended a spillway be installed to reduce overtopping risks of Dams 2 and 3 in the event that the Saddle Dam (Dam 1) were to experience a rapid failure and breach. This theoretical occurrence would be considered as the Inflow Design Flood (IDF) for the lower Pond A as the reservoirs are not part of the natural waterways and associated flood influence from distal precipitation catchments. Our previous understanding was that the outlet pipe invert was just below elevation 37.9 m (such that free board of 0.5 m was preestablished). With this new information, upgraded modeling software and BC Open LiDAR data, we have completed further analyses and design work for the proposed downstream improvements.

We completed dam breach modeling using HEC-RAS 6.3.1 to review spillway design and performance requirements assuming that Pond A was at full operating capacity (approximate elevation 38.15m). The model simulated a breach of the saddle dam at overtopping conditions (water elevation 40.4 m) with a breach channel of 9 m base width, 0.5H:1V (Horizontal: Vertical) side slopes and down cut to elevation 37.0 m (full dewatering of upper Pond B). The timeframe of breach was assigned 15 minutes and the dewatering effect of the Pond A outlet pipe was neglected. We note the input parameters for this breach event are considered to be conservative as a worst-case scenario.

1. Refer to Site Plan for the Berm location.
2. Ryzuk to inspect subgrade of the Berm area following removal of surficial organics.
3. Organic soils can be set aside for potential reuse as capping soils or for general terrain incorporation pending field review.
4. Mineral soils to consist of select compactable soils generated from spillway excavation. Soil quality and conditions to be assessed by Ryzuk at initial stages for determination of placement methodology with available equipment.
5. Topsoil/Sod to be prepared in accordance with Morningstar Golf Course specifications.
6. Ensure no disturbance or sediment ingress over riparian boundary by means of grading, silt abatement measures etc.

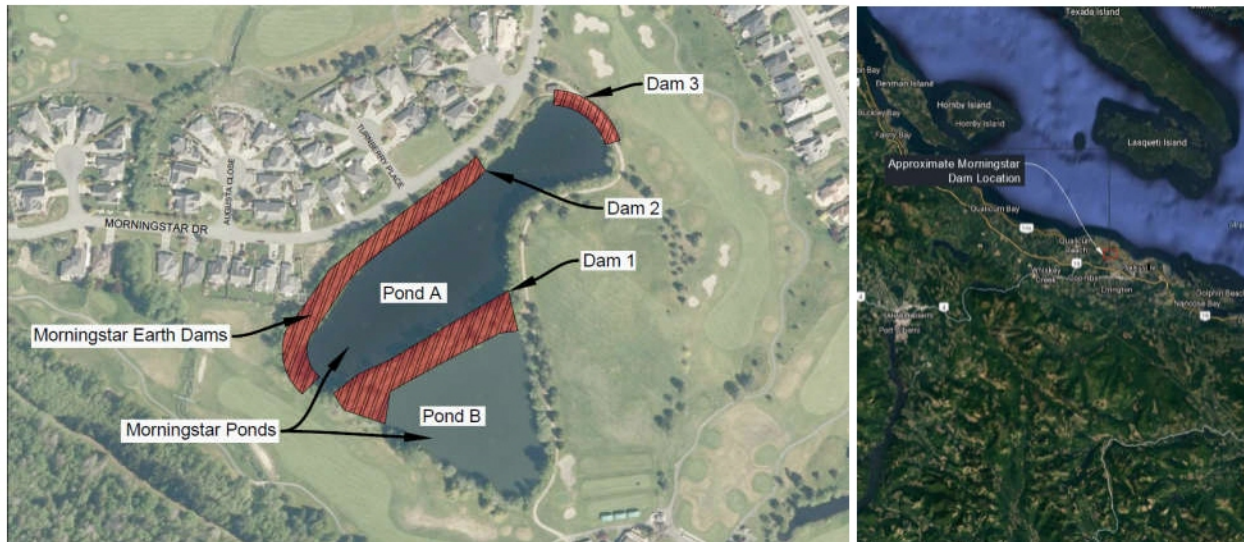
Figure 1. Morningstar Dams Site Orthographic Images.

The Morningstar Dams consist of three discrete earthen embankments, labelled 1, 2, and 3 in Figure 1 above. Dam 1 is a saddle dam located in between Pond A and Pond B, and Dams 2 and 3 bound the northern portions of Pond A. The dams range in length from 50 m to 300 m and have a typical height between 1.5 m and 2 m and a maximum height of 2.3 m above the surrounding grade. Crest width of between 3 m and 5 m and side slopes less than 30 degrees inclination from horizontal are typical. The ponds have an estimated maximum water depth of 3.0 m within the deepest localized dugout portion at the eastern side of Pond A proximal to the saddle dam. At full service load the retained pressure head is estimated to be up to approximately 1.5 m.

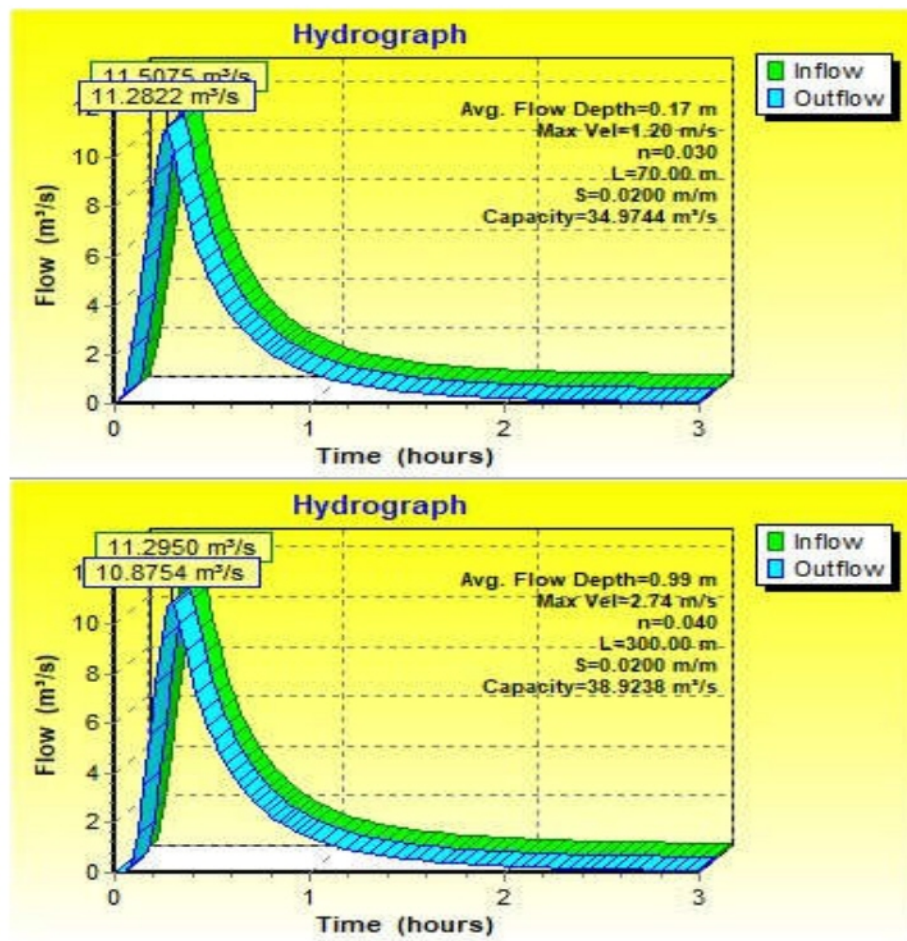
Figure 8. Hydrographs of breach inundation to southwest of Dam 2

Breach of Dam 2 would be limited to a height of approximately 1.6 m based on the dam section. This occurrence would result in inundation flow impacting the treed boulevard area and adjacent roadway, the residential lots along the southern side of Morningstar Drive, as well as the golf course rough/fairway to the west of the ponds. The modeling suggests that Q_p would be approximately $11.5 \text{ m}^3/\text{s}$ at the breach, but as the terrain is gentle and vegetated the flow would spread out radially from the hydraulic step and attenuate rapidly. In the case that the flow broke through the sparse woodland band within the central-eastern portions and spread onto the 10 m wide roadway bound by curbs and gently upsloped front lawns/driveways, the average depth (d_{avg})

and maximum velocity (V_{max}) was calculated to be 0.25 m and 1.3 m/s respectively. Routing through the woodland to the south of the residences onto the wide open golf course via the tall grasses, d_{avg} and V_{max} were calculated as 0.17 m and 1.2 m/s. In both of these scenarios the flow would inevitably be intercepted by the channel of Morningstar Creek, and some influence to the residential yards and low energy flow impact to the lower portions of the immediately adjacent buildings would be anticipated. The creek was calculated to have a conveyance capacity of approximately 38 m³/s, and in both of these cases the collected overland flow would result in a d_{avg} of approximately 1 m and V_{max} of less than 3 m/s, and the box culverts were shown to have a capacity of over 21 m³/s. Hydrographs showing the routing through the golf course/roadways (being similar) and Morningstar Creek provided below.

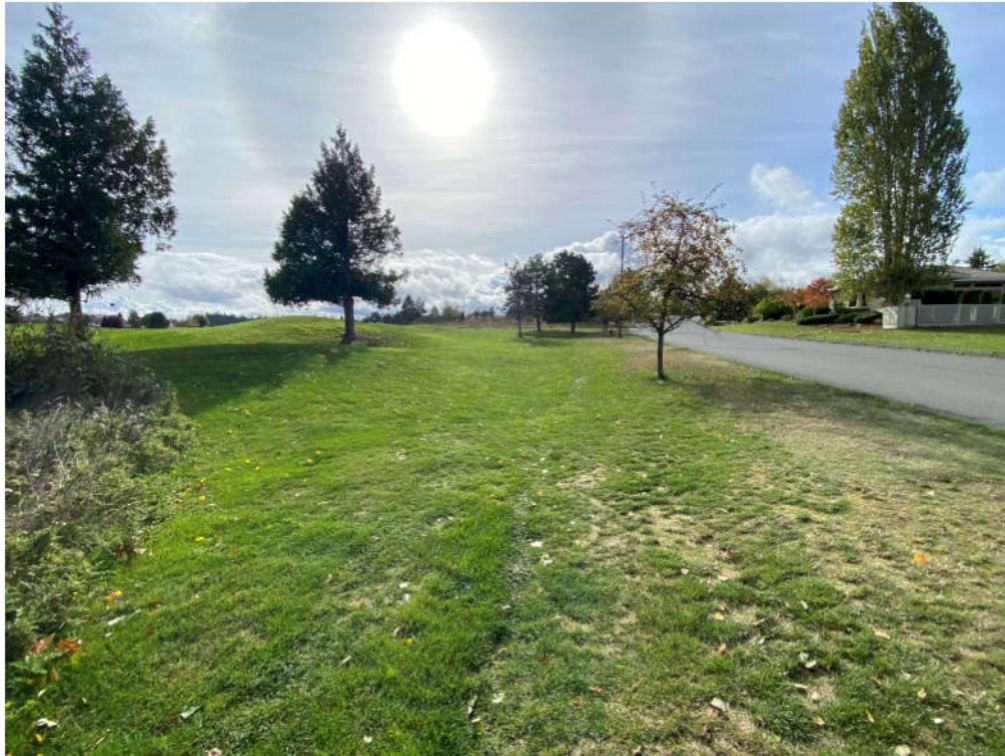
Figure 9. Photo view of northern inundation zone looking south towards Dam 3

Breach of Dam 3 would realize a dam section rupture holding up to approximately 2.3 m of head, being the highest embankment area around Pond A. Breach of this portion would result in flow inundation and attenuation within the golf course area spreading down a natural swath of 20 m to 40 m width for some 80 m length through the short grass, outfalling to the roadway. The route continues north down the road laterally bound by curbs and gently rising lawns and local ditches, and would be intercepted by Morningstar Creek approximately 80 m to the north of Robertson Boulevard. Q_p of this breach was calculated to be approximately $24.7 \text{ m}^3/\text{s}$. Within the golf course rough d_{avg} and V_{max} were 0.21 m and 1.92 m/s, and within the roadway d_{avg} and V_{max} were 0.23 m and 3.1 m/s. Morningstar Creek within the interception area is confined within a much deeper channel and d_{avg} and V_{max} were 1.8 m and 3.4 m/s. The moderately energetic flow would possibly spread up against the existing residences at the eastern sides of the intersection. Hydrographs of this routing are provided below.

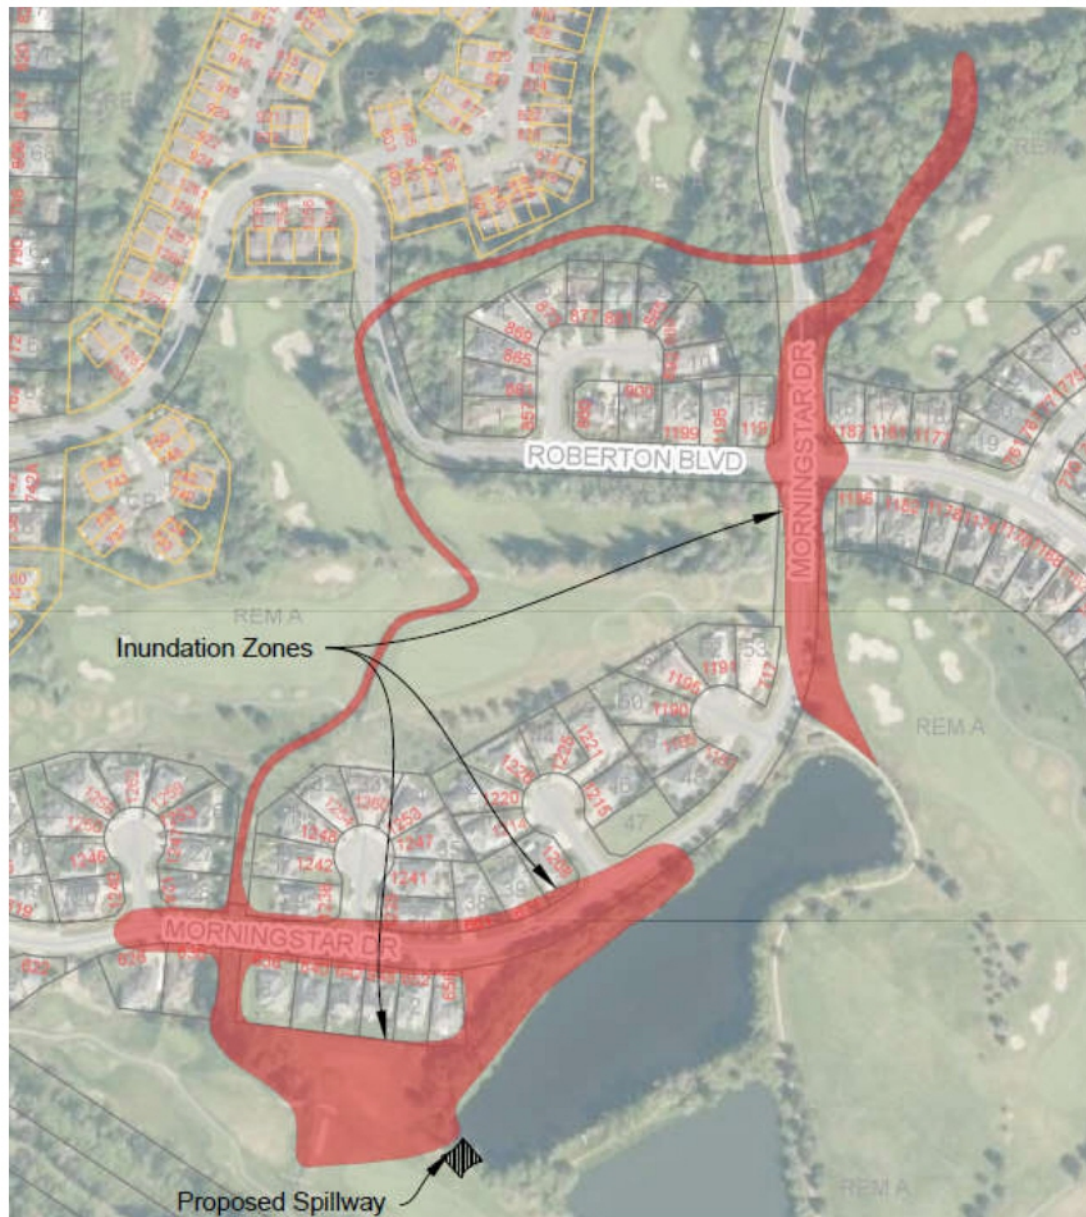
Figure 11. Potential Inundation Zone of Dam Breach Flood Water (Existing Dams)

Breach of Dam 1 was modeled to extend to a depth of 2.5 m. Q_p was calculated to be about $23 \text{ m}^3/\text{s}$ in this case and the resulting inundation to Pond A would initiate overtopping of Dams 2 and 3 assuming maximum service levels at the time. Overtopping breach initiation around Pond A could then occur as discussed above. The potential inundation zones are shown in Figure 11 below.

It is worth noting that when the minimum freeboard of 0.47 m was applied to the breach models Q_p was over 33% less than that of the overtopping condition. A similar reduction was observed if the breach development was modeled at a duration of 30 minutes. However, the model could not identify local variations in depth and velocity that may occur in reality. Further details of the dam breach modeling can be reviewed online at the HydroCAD web link provided in Appendix J.

1. Construction of a 6 m wide spillway with the sill set at the same elevation as the maximum service elevation of the water within Pond A (as shown in Figure 11). The spillway to be located at the southwest side of Pond A such that, if activated, the discharge would be directed onto the grass fairway area leading towards Morningstar Creek. The engineered spillway could be lined with an armored bed of riprap over heavy geotextile, or lined with concrete.

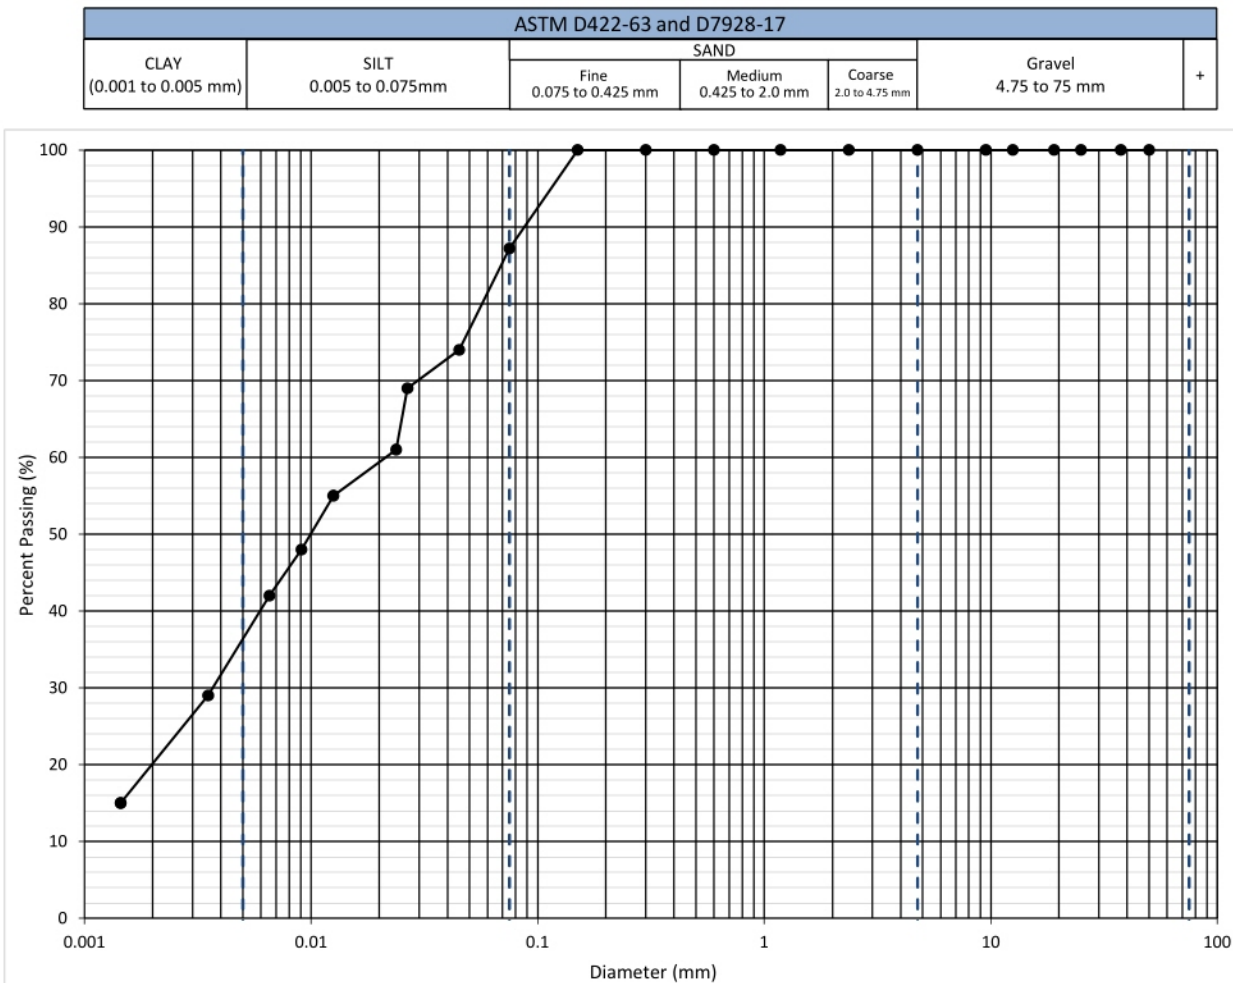
We completed hydrometer tests on the dam fill materials collected on site at two test holes (TH21-02, 07), attached in Appendix E. The sample results indicate the bulk dam fill material comprises an average of 36.5% clay, 48.6% silt, 14.9% sand, with the maximum particle size noted around 0.6 mm. This soil is classified as a clayey silt with some sand. Based on our experience with these materials as well as published values the hydraulic conductivity is likely between 10^{-7} cm/s and 10^{-9} cm/s, classified as having very low permeability.

Borehole No.	Sample No.	Depth(m)	Gravel	Sand	Silt	Clay	Moisture
TH21-02	L# 1187	1.3	0.0	12.8	51.2	36.0	32.2
