Purpose of Investigation: Requested by Fire Chief David Hearn to assist in determining origin and cause of a fire that occurred at the Salmo Hotel

From physical findings, photographs, and video evidence, the area of origin for this fire is on the exterior Alpha wall, below the roof peak, and just above the roof that covers the 2nd floor walkway. The point of origin is an electrical light fixture and outlet box which was externally mounted against the wall and immediately next to the cedar shake shingles which covered the roof. Cause of the fire appears to be internal heating of the electrical device which ignited the cedar shake roof and the exterior wall coverings.

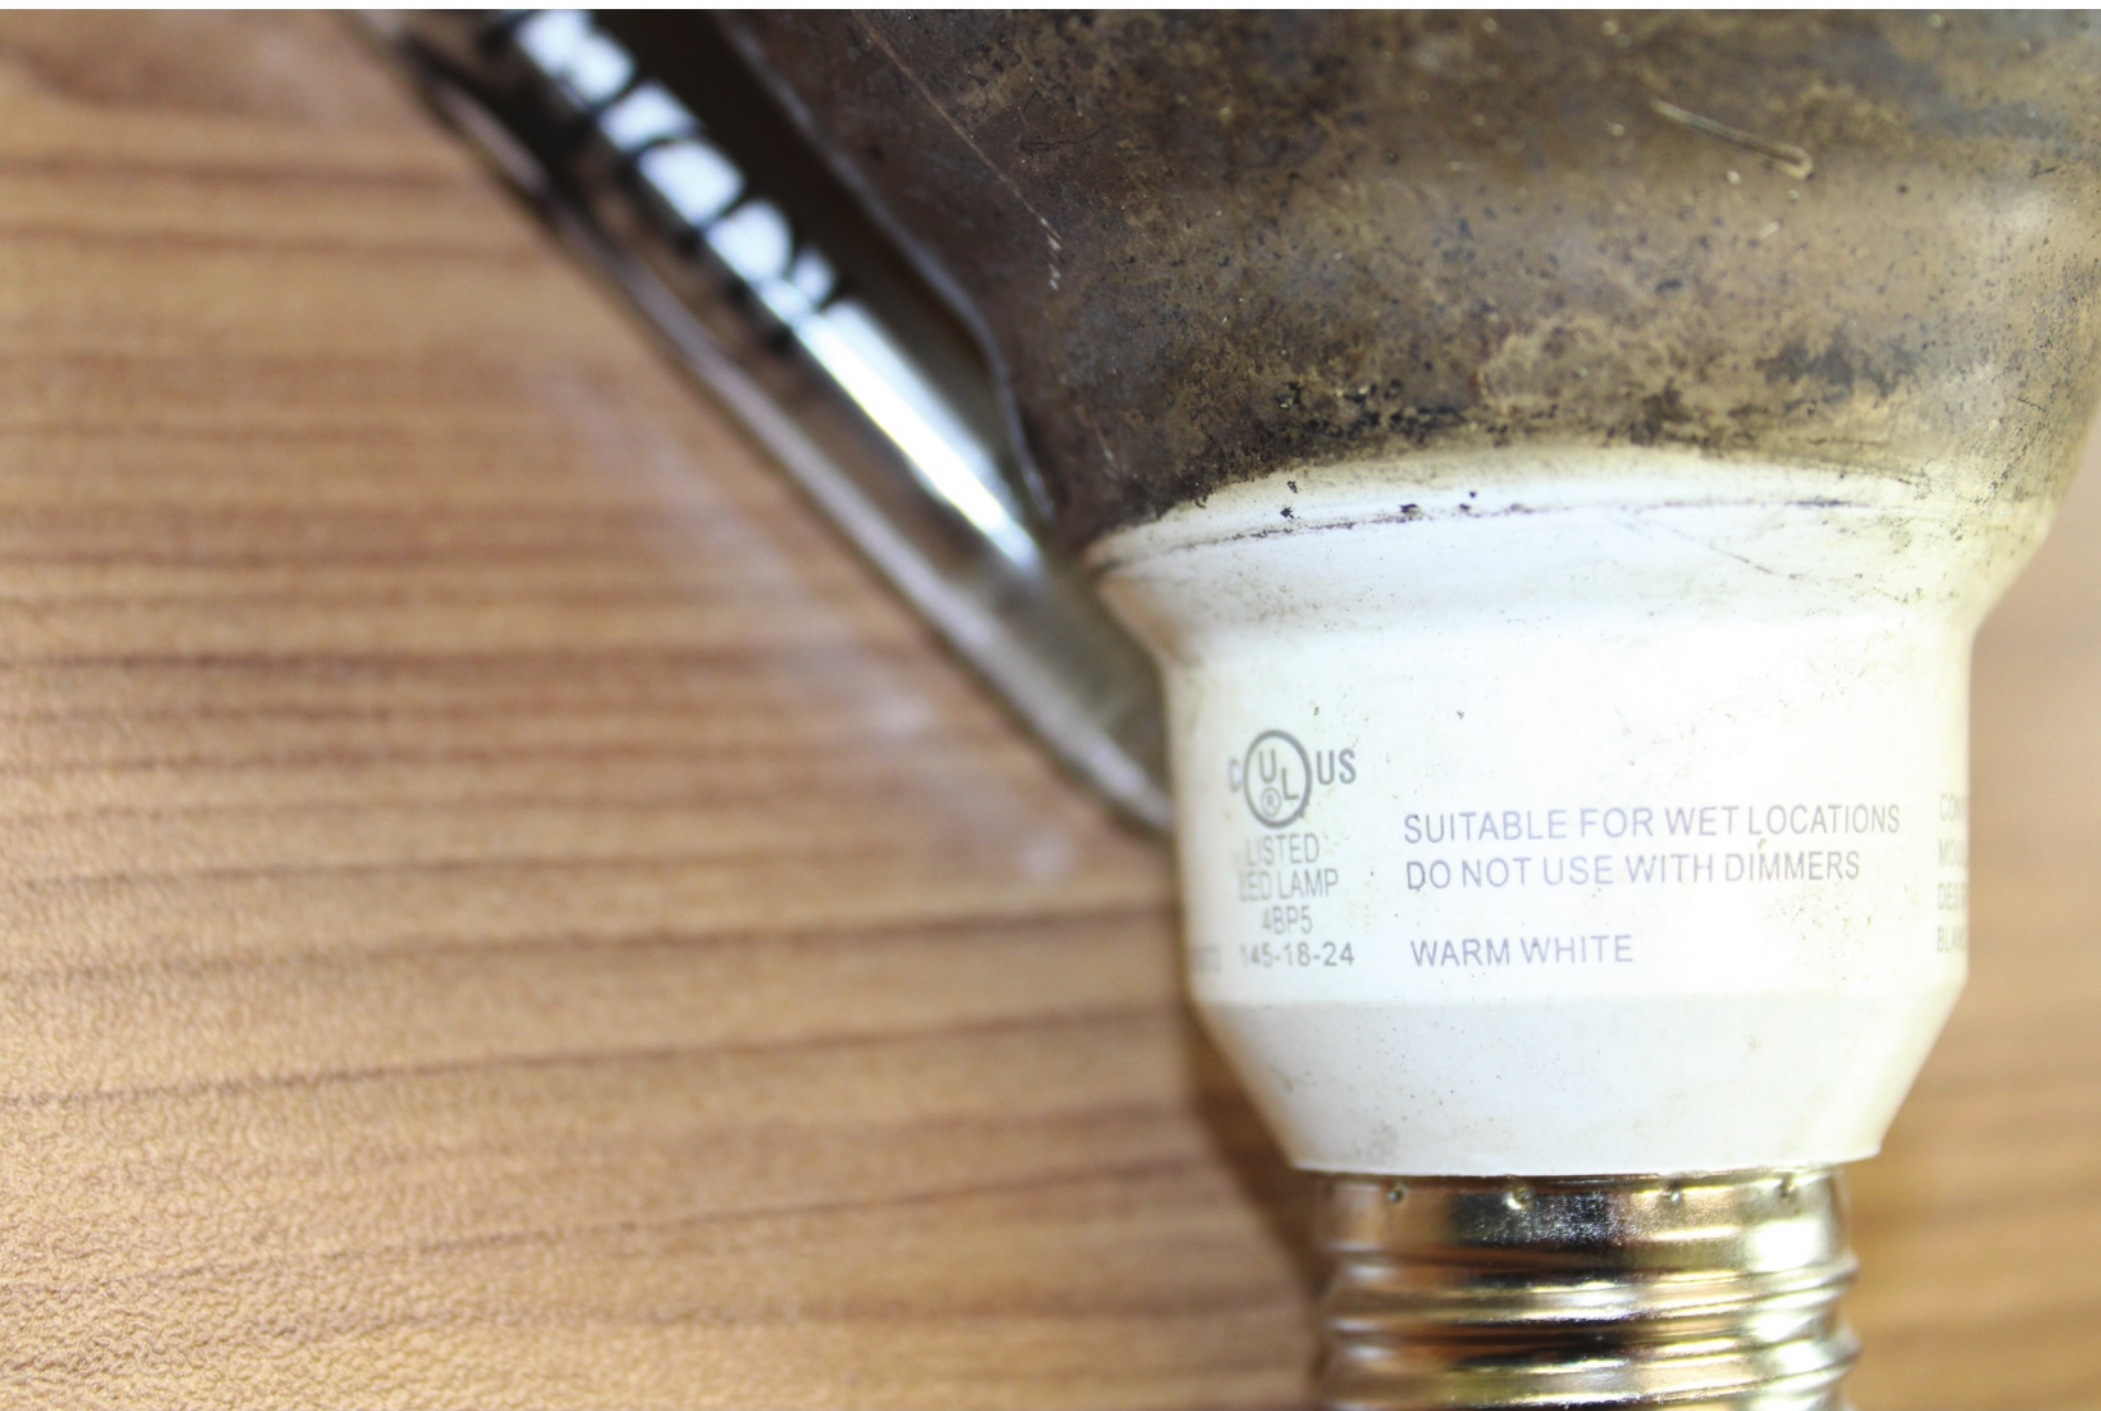
38° BEAM ANGLE
FEIT
ELECTRIC
PAR3875/10KLED/2(L)
10.5W/3000K/750lm
120VAC 60Hz 152mA UL#E330072
C^UL^US
LISTED
LED LAMP
4BP5
145-18-24
SUITABLE
DO NOT
WARM

- The fixture was a cast aluminum 2 head flood light type of fixture. The bulbs were FEIT LED flood bubs. The bulbs were indicated for exterior use. Orientation of the fixture heads were pointed in an upward direction which could allow moisture to enter the socket assembly.

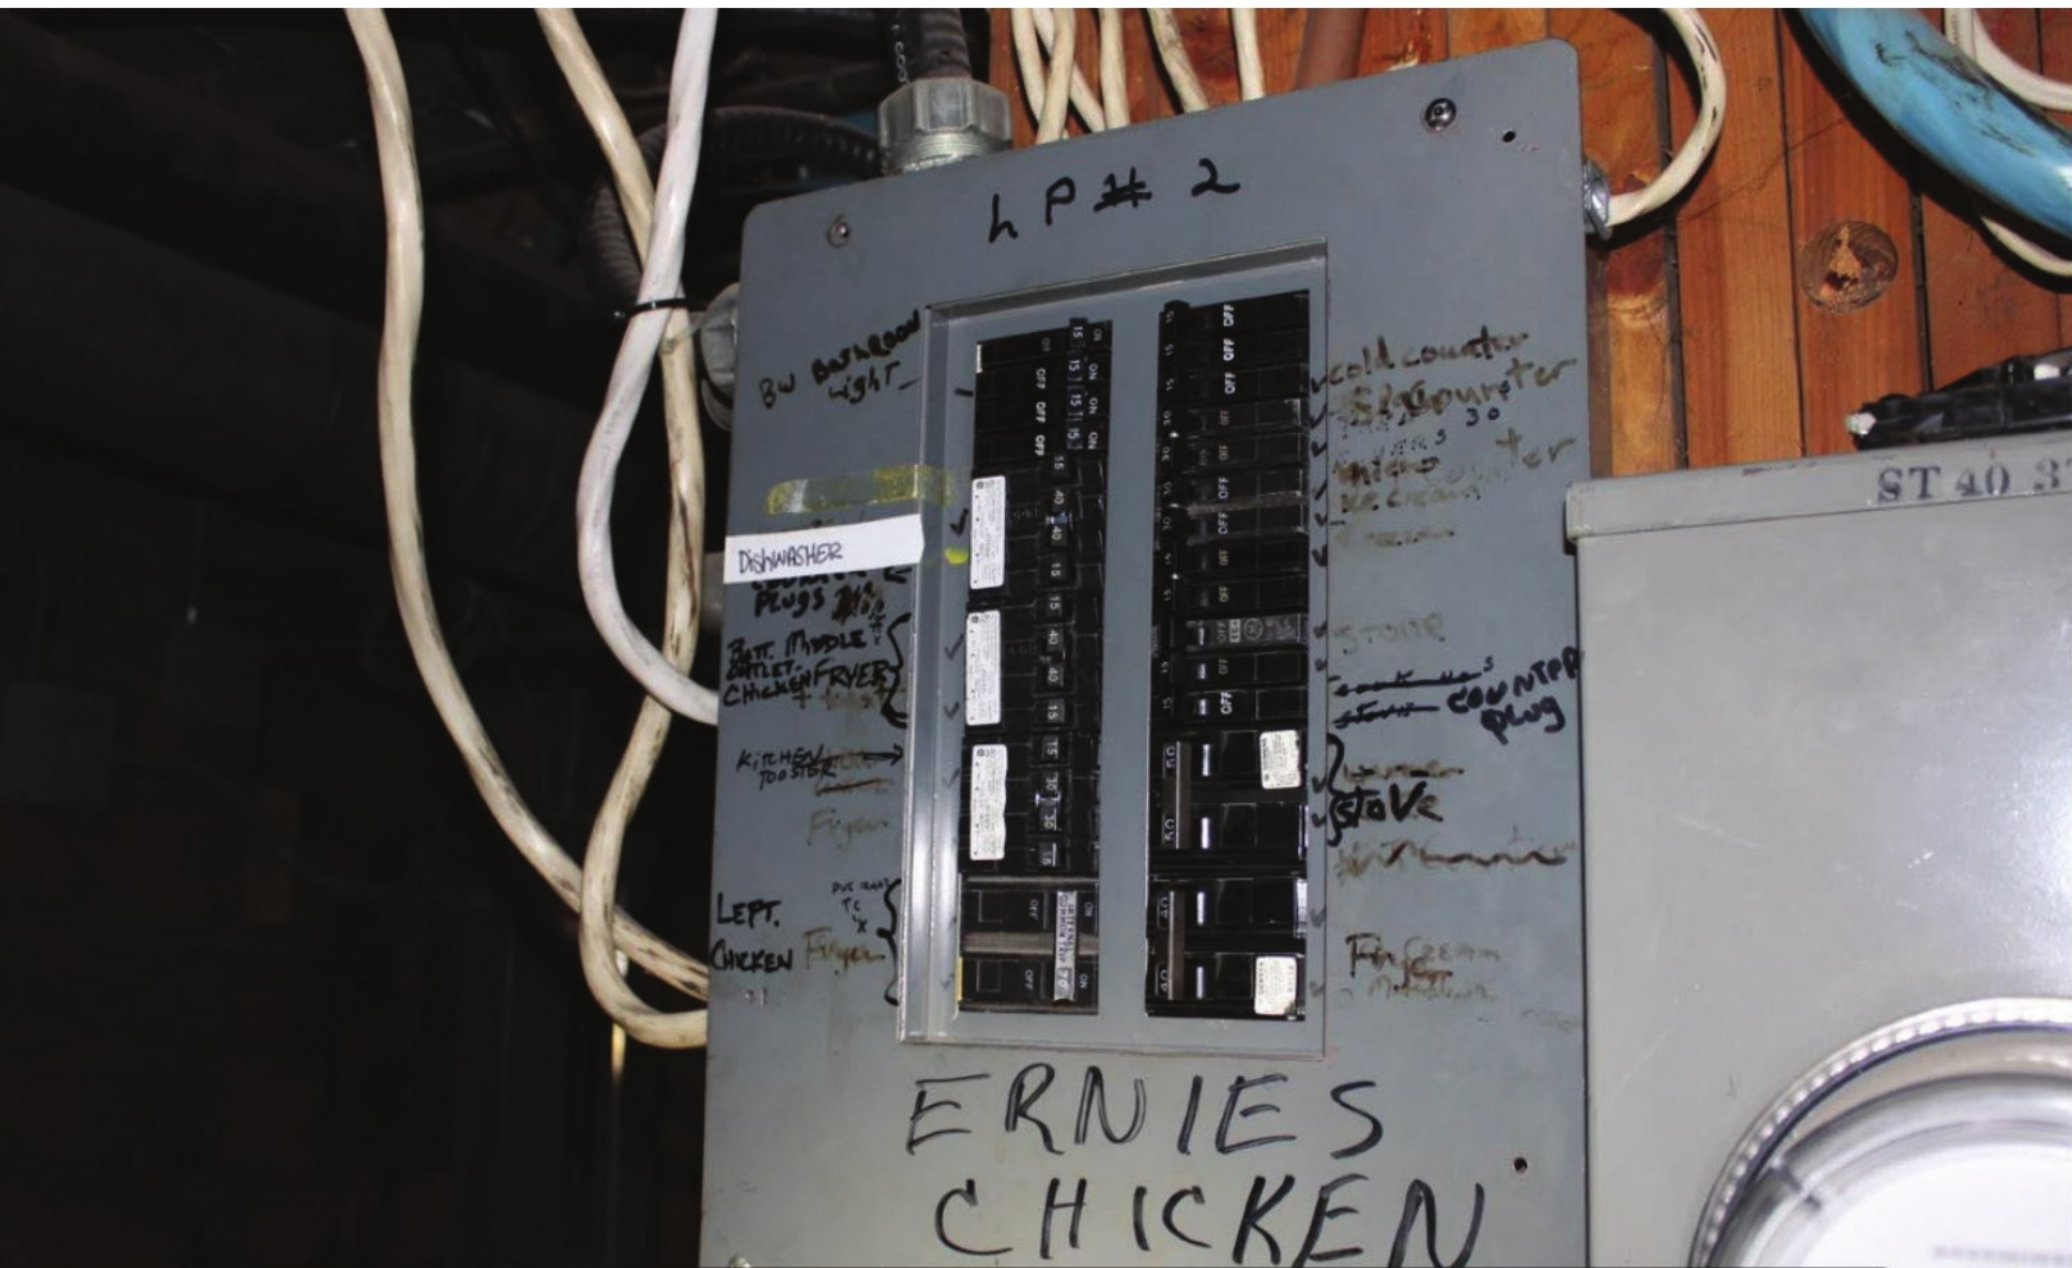
1	TOOL ROOM	ROOM-LIGHTS	2
3	BAR-DIMMER-LIGHTS	PLUGS	4
5	T. ROOM PLUGS	FANS	6
7	ROOM-PLUGS	WOMANS-LIGHTS	8
9	STAT-LIGHTS	BASE-LIGHTS	10
Pushmatic		ELECTRI-CENTER	
11		Boiler-LIGHTS	12
13			14
15			16
17			18
19			20

- **Basement** – No fire damage located in the basement. 3 electrical panels are located in the basement, from my observations I could not see that any of the breakers had tripped due to electrical faults.
