Subject: Requested Assurances - Vancouver Island Rail Corridor Infrastructure Improvement - Project Funding Request

VANCOUVER ISLAND RAIL CORRIDOR (VIRC)

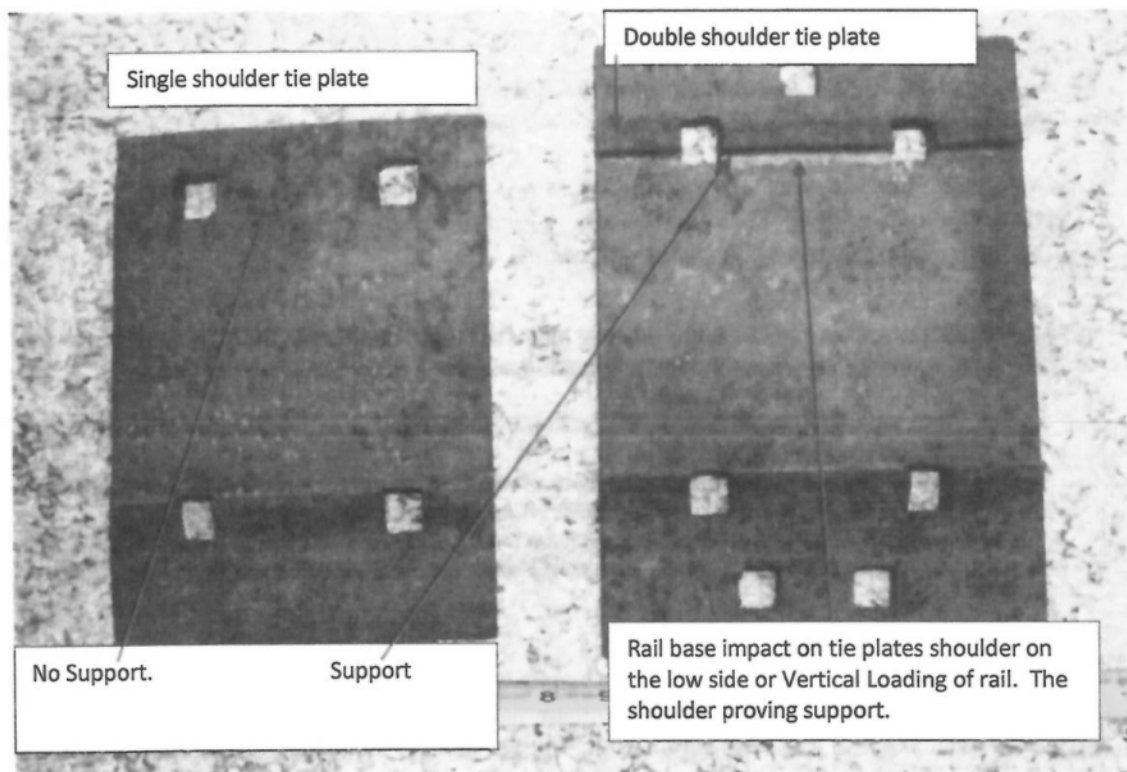
In the third paragraph on page 20, with regard to single shoulder tie plates, the RTC Report states, "...there is not support on the low side of the plate for the lack of a shoulder. This transfers all forces to the spike(s) trying to hold the rail from rolling over." This statement is technically inaccurate.

I don't understand how this is technically incorrect. Refer to the photos above.

Dynamic track forces under train loading are directed to the outside of the track, forcing the rail outward with a tendency to spread gauge and potentially roll the rail to the outside given certain speed, loading and track conditions. That is why the shoulder on a single shoulder tie plate is placed on the outside of the rail and that, as the RTC Report states, "The tie plates presently in track meet the requirement of the Rule." The primary function of the tie plate is to transfer load to the tie over a greater surface area, thus reducing tie wear under dynamic load and over longer periods of operation. Additional support and reduced wear on ties through the use of tie plates are recognized as a safety enhancement and therefore regulations require the use of tie plates (not specifically "double shoulder" tie plates) as part of the track structure.

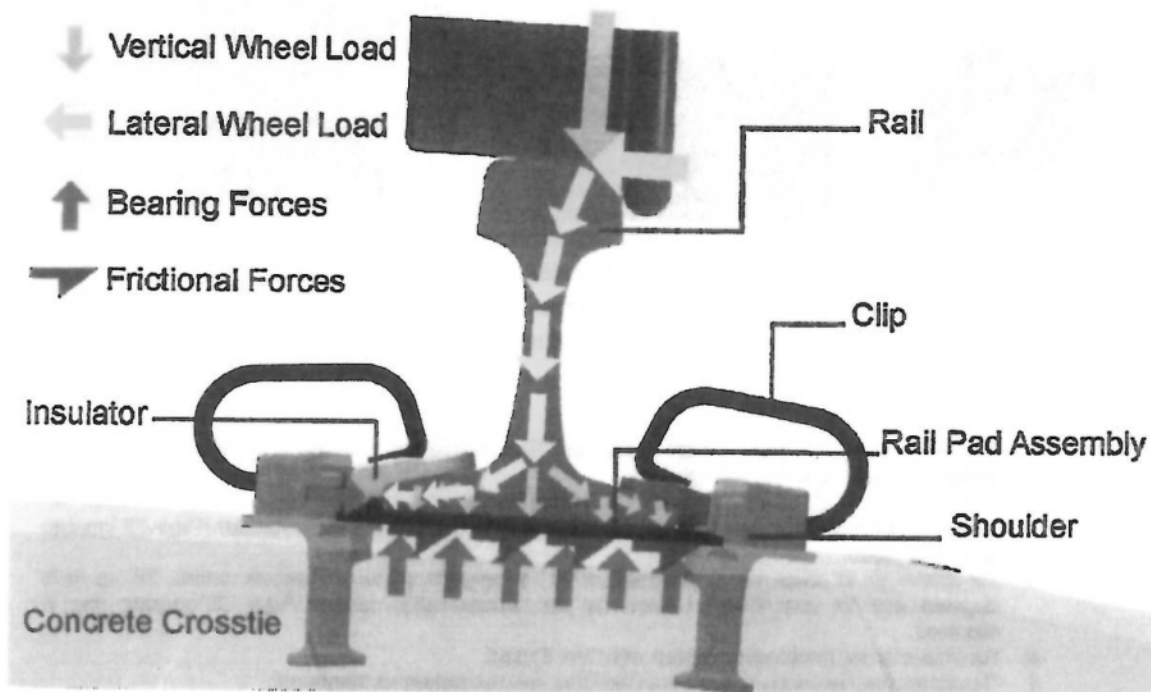
Slide 4

Defining the Vertical and Lateral Load Path

2014 International Crosstie & Fastening System Symposium
Urbana, IL
3 June 2014

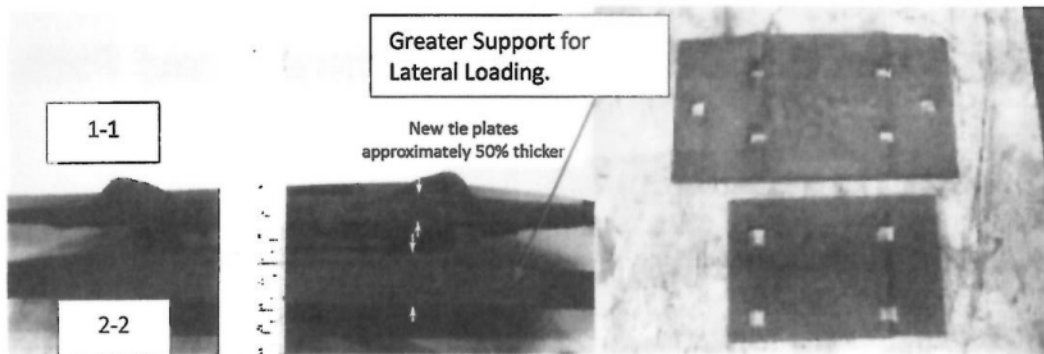
The last paragraph on page 20 states, in part, "Double shoulder tie plates are about 60% larger than single shoulder tie plates." This statement is also technically inaccurate and over-stated. The standard single should tie plate used on the VIRC is 9 inches wide by 6 ½ inches long or 58 ½ square inches in area. The standard double should tie plate used is 7 inches long by 10 inches wide or 70 inches in area. This represents an increase in surface area of less that 20% for double should plates in comparison to single shoulder plates. This does represent a greater bearing surface on the tie however the magnitude of that change (and resulting effect) has been significantly over-stated.

Do note that in the above photos illustrated 1-1 is a double shoulder plate which is normally thinner than a single shoulder. Additionally both photos illustrate a 5 ½ inch base used for 100lb rail. Rather than the 5 3/16 for 85lb rail presently in place at the VIRC. As per below this reinforces the importance of not only better tie plates but rail upgrades to at least 100lb. in key locations.

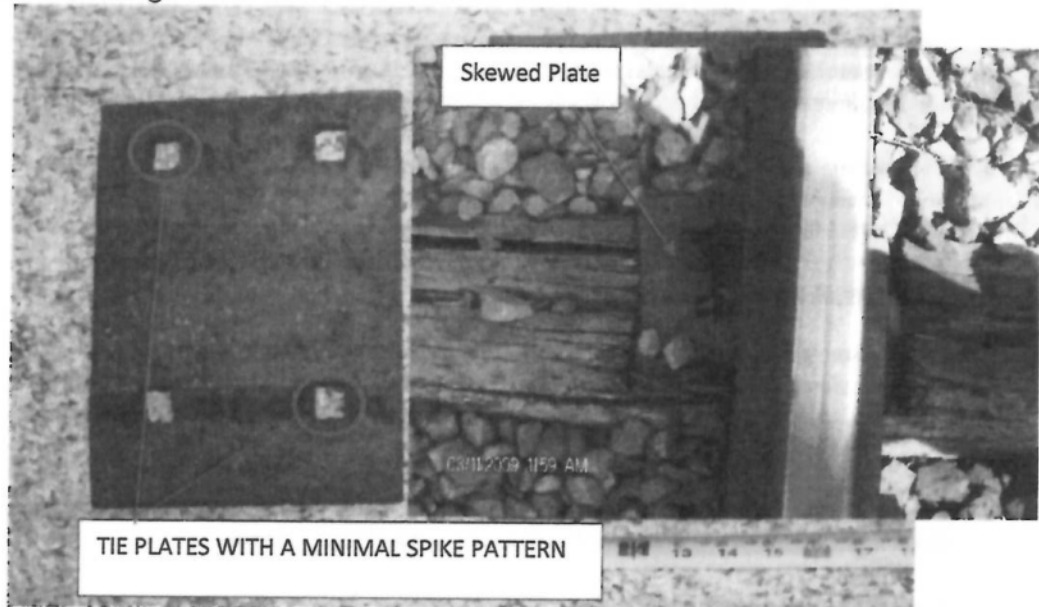
Track forces under traffic are toward to outside of the rails and therefore the outside shoulder of the tie plate have the highest function in transferring lateral forces to the spikes and to the tie. The function of additional inside shoulder on double shoulder tie plates is to contain the rail in a fixed "seat" and lessen the likelihood of "skewing" of the tie plates. The RTC Report also states, "However, again in Industry Standards, the minimum requirement is double shoulder." This statement is misleading.

The statement above is correct but not complete. As per the Photo above when rail is spiked, spikes are applied opposite to each other, this prevents the plate from "skewing". However, if the tie on which the plate sits is in poor condition or if there are surface issues at that location, the spike is lifts out or breaks and allows the tie plate to skew. There is no misleading here.
