TECHNICAL MEMO

TO: Jeff Spruston **DATE:** 28 Nov 2017
CC: Dave Weatherby, Will Gowen, Ronan Spillane **FROM:** Meiric Preece
EGRT Technical Director
PROJECT: Evergreen Line Rapid Transit Project - 511325 **DOCUMENT NO:** 511325-12220-S2SL-43EB-0001_(0)
SUBJECT: Inspection report for Bored Tunnel Liner Segments with Concrete Curing Temperatures over 70 C

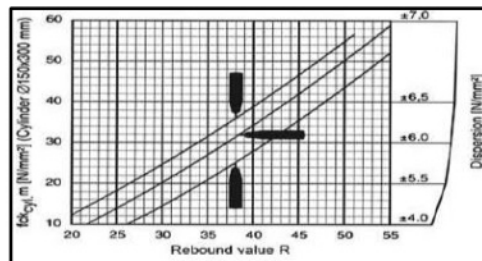
Specified Concrete Strength: 50 MPa @ 28 days

Aggregate Size: 12 mm

(i) Manufacturer conversion curves covers rebound values up to 55, Metro has calculated estimated strength based on curve equations.
