Incident Investigation Reporting Form

Incident Title	Evergreen Rapid Transit Project Super Beam					
Incident Number	2014061714	2014061714-01				
Incident Date (yy-mm-dd)	2014-06-17					
Was a Business Unit confere	ence call held?				Yes	
Was this activity / task identif	ied in the Risk	Registe	er?		Yes	
Does a standard / procedure	Does a standard / procedure exist to control the risk? Yes					
If yes, was the standard / procedure adhered to? Yes						
Was this incident a system failure? No						
Was there any property damage? Yes If yes, what amour					it?	Less than \$5k
Modified Work Injury	No If yes, how many days modified wor				k?	Click to enter number of days
Lost Time Injury	No If yes, how many days lost time? Click to enter number of days				Click to enter number of days

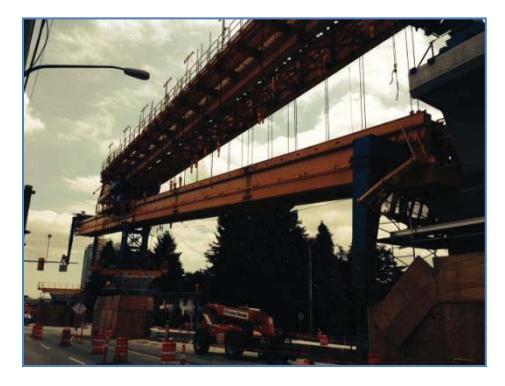
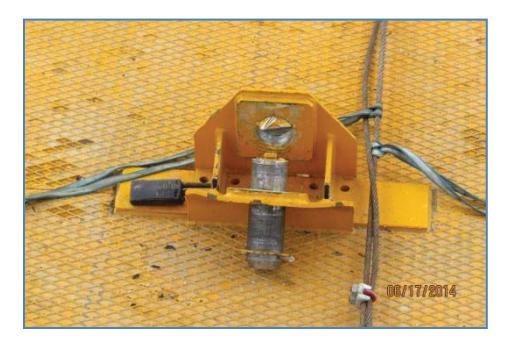
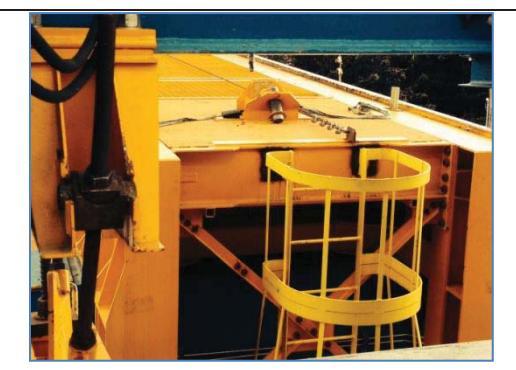
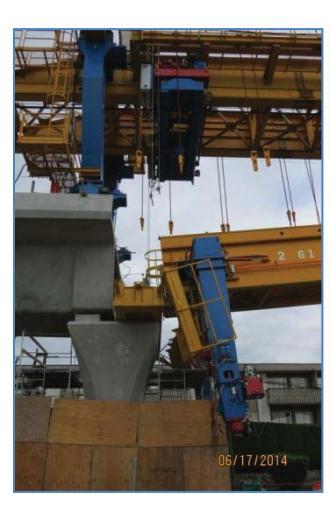
Insert Pictures / Sketches / Diagrams of Incident:

The point of failure was the connection between the support beam and the winch. Inspections and photos confirm that the connecting pin and the support beam saddle were damaged.

Deal Engineering conducted a thorough inspection of the launching truss and all ancillary equipment on June 23rd, 2014. It was confirmed that the winch pin and saddle were the only point of failure on the Launching Truss. It was further determined that the winch was lagging behind the support beam anchor assembly by approximately 550 mm. This misalignment would have caused the rigging to be at an angle of approximately 42 degrees and would account for the lateral loads on the lifting pin and saddle which caused the failure. The only plausible explanation for the misalignment of the winch is operator error.

Absent or Failed Defenses Safety Device Operation	Description: The saddle and pin which secured the winch to the support beam failed. This was due to lateral load imposed on the pin. The saddle and pin do not appear to be designed to withstand significant lateral loads.
Absent or Failed Defenses Control Systems	Description: There is no inter-link between the controls on the 5th wheel and the winch control pad. The winch operator is tasked with matching the winch trolley speed to the support beam speed which is driven by the fifth wheel. If the operator makes an error it could cause the winch trolley to travel slower or faster than the fifth wheel which then applies a horizontal force against the lifting assembly and anchor point.
Absent or Failed Defenses Hazard Identification	Description: The horizontal loads imposed on the pin and saddle does not appear to have been considered in the design of the pin and saddle. No incident of this nature has been reported in the world wide fleet of launching trusses, however; in light of this incident it is apparent that the loads can be significant enough to cause failure.

The design of the lifting pin and saddle did not appear to be sufficient for the horizontal loads imposed by the 5th wheel.

The controls between the 5th wheel and the winch are not interlocked and as a result of human error resulted in a horizontal loading to the connecting pin and saddle.

Action	Responsible Person	Due Date
The Truss engineer provided a new design for the installation of a new lifting pin and connecting saddle. The new system will withstand the maximum horizontal loading applied by the fifth wheel motor. This design, placed under a maximum load from the fifth wheel motor will tow the winch trolley with it regardless of winch operator failures. Additionally, an emergency stop button will be installed at the winch connection area so that the operator or crew members can shut the fifth wheel down should they observe that the winch is traveling behind the speed of the fifth wheel.	Gianni Bonassi & Cem Akkaymak	2014-06-25
The Job Safety Analysis was revised. The two ironworkers who stand beside the winch operator tasked with moving dywidag bars away from the support legs are also tasked with observing the winch position between the bar movements. They are equipped with radio communication to the 5th wheel operator. In the alternative these workers are able to activate the emergency shut off switch to stop all movement of the beam and/or truss.	Cem Akkaymak	2014-06-25
