SECTION 1 : TRACKING DETAILS

DATE: (dd:mm:yyyy)	05/01/2020	NCR #:	19-004
SERVICE AREA:	S.A.13	CONTRACTOR:	AIMRoads
REFERENCE AUDIT #:	Monitoring Report Jan 5 th , 2020		
REFERENCE AUDIT TOPIC:	Maximum Accumulation		
DATE DISCUSSED WITH MC:

NON-CONFORMANCE REPORT

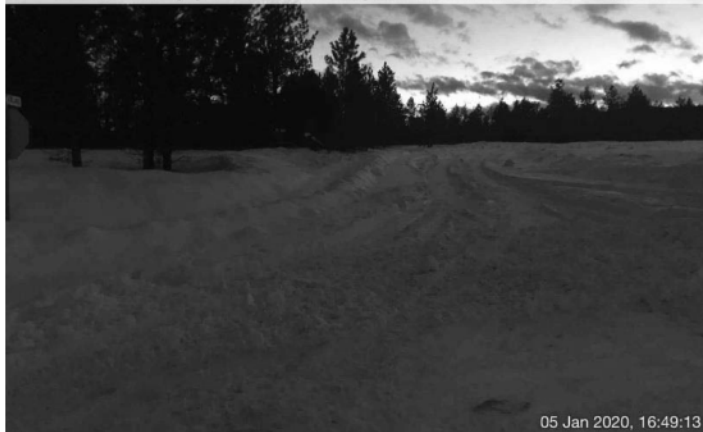
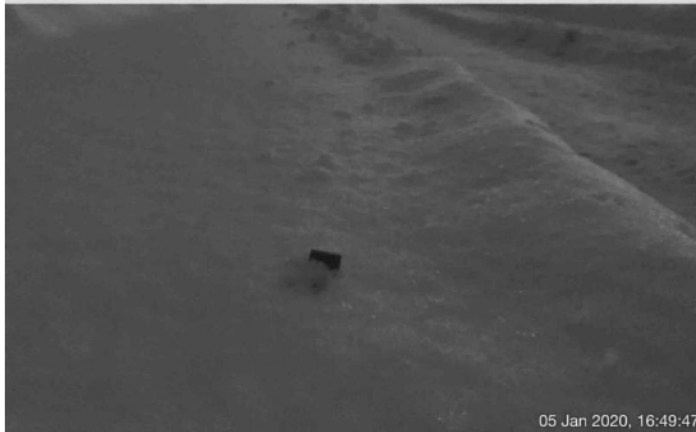
Siwash Creek road off of Six Mile Creek Rd is a class C and contained 29cm of snow on January 05, 2020 at 16:49. The specification in PM3.01.2-1 states a 10cm maximum accumulation.

The quality management system process to document and communicate which roads had been plowed and which roads had not yet been plowed following a winter storm event was not well implemented.

1) Improvements have been made to the quality management system process of documenting and communicating which roads have been plowed during and after a storm event. Smart Roads was initially planned to identify the status of roads that have been plowed, but the system is not fully implemented.

Plow blocks were re-introduced as a stop gap to correct this problem. The Plow Block hardcopy documents have been printed and organized for employees (copies are available in the base coffee room). There are over 10 unique plow blocks available for employees in the Armstrong yard. Each employee completes a hardcopy Plow Block document for the specific area they are working in. This sheet is completed during each shift and is passed to the Foreman when the employee returns to the yard. The Foreman then goes through the plow block sheets to determine which roads still require plowing.

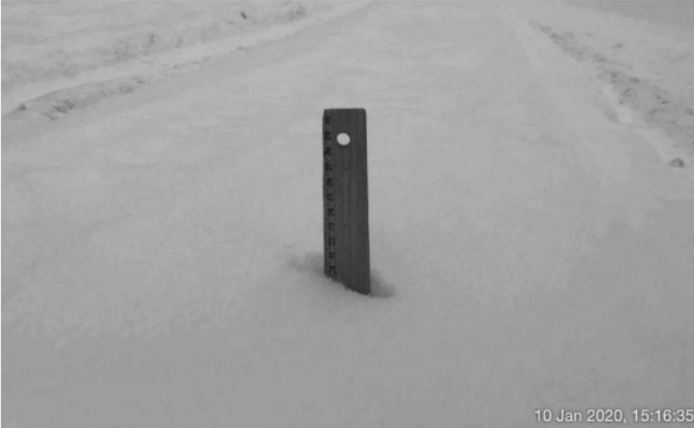
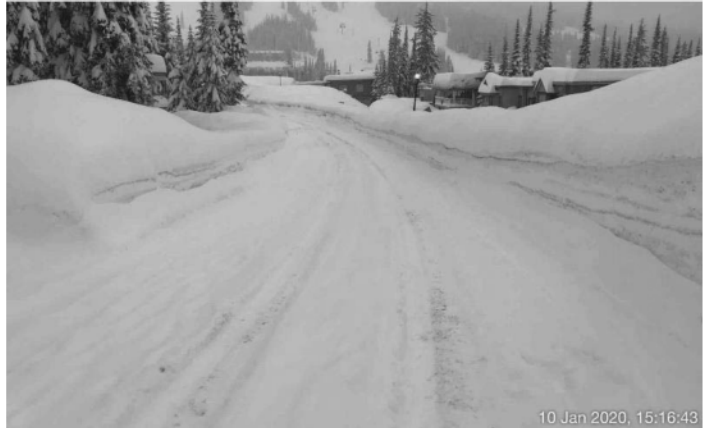
Silver Queen Road road is a class C and contained 12-20cm of snow evenly spread across road on January 10, 2020 at 15:16. The specification in PM3.01.2-1 states a 10cm maximum accumulation.

The quality management system training process did not adequately train and communicate the related MOTI specifications to the employees working the Silver Star area. Because the MOTI specifications were not fully understood, the call was made later than was possible to have additional resources dispatched and present on scene to meet the specifications during the storm event.

1) The quality management system training process has been improved to better communicate MOTI specifications. Education has been provided on the MOTI specifications using the AIM Roads 'Tool Box Talk' process (completed March 5, 2020). The Tool Box Talk included information on the Highway Maintenance Agreement and related MOTI Winter Specifications. Hardcopy MOTI Winter Maintenance specification information is available at the base locations for employee reference. The Winter Awareness training presentation (communicated in the Fall to all field employees) has been changed to include a greater emphasis on the MOTI Winter Specifications:

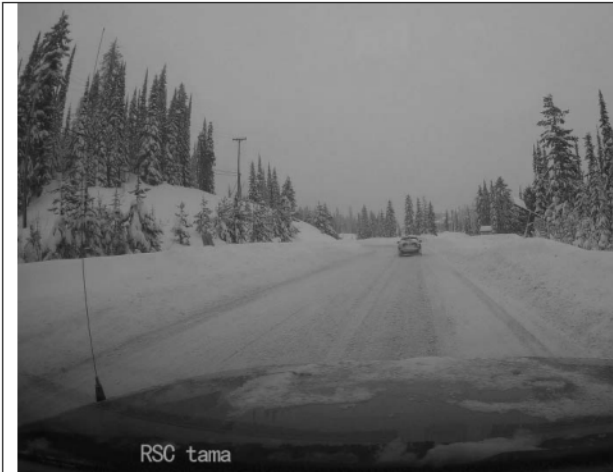
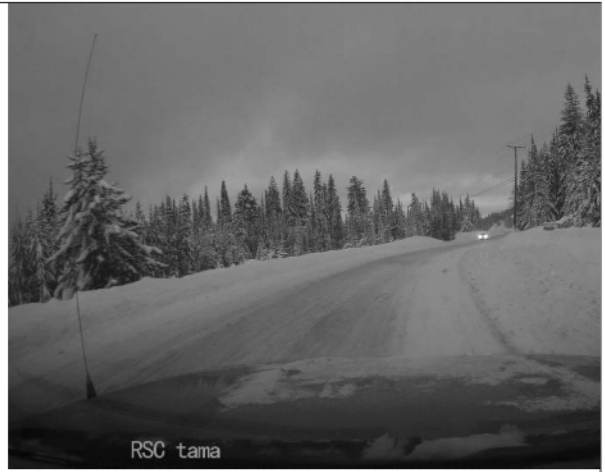
Photos 2020/01/10

Regulatory and Warning Signs on Silver Star road are buried and not visible. Phone call reporting buried signs made to AIM Call Centre at 10:12am Jan. 9th to report signs. Signs monitored at 15:00 on January 10th noting no change in sign visibility. Maintain Sign Systems so they are clean, repaired, legible, visible, erect, and properly placed. (PM5.01.2-1)

- 1) The quality management system internal communication process to follow up on PCR's was not well implemented.
- 2) The quality management system internal process to train employees to identify Short Response Type items using Smart Roads was not well implemented.

The snow has been removed from the applicable signs, and the signs are now fully visible for travelling motorists. In addition:

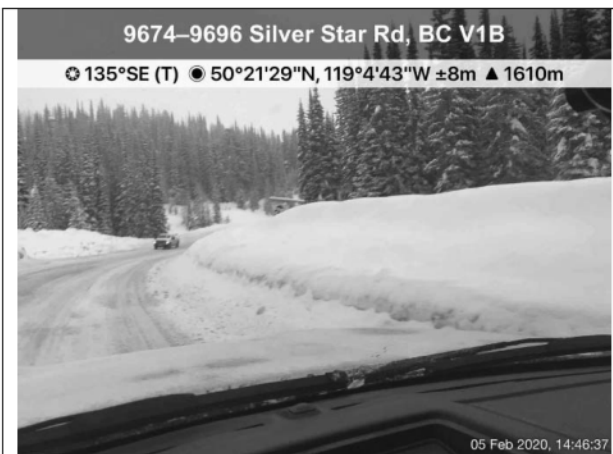
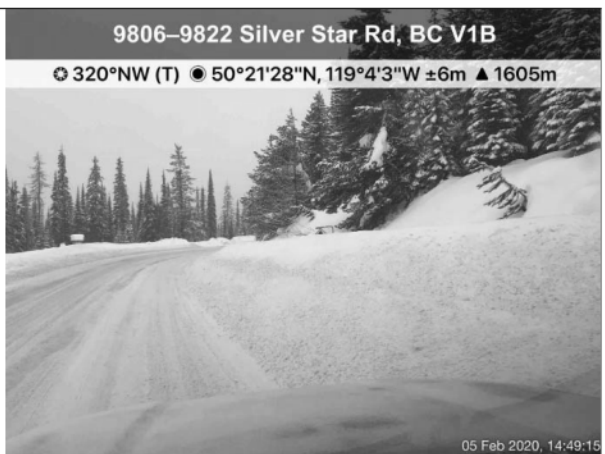
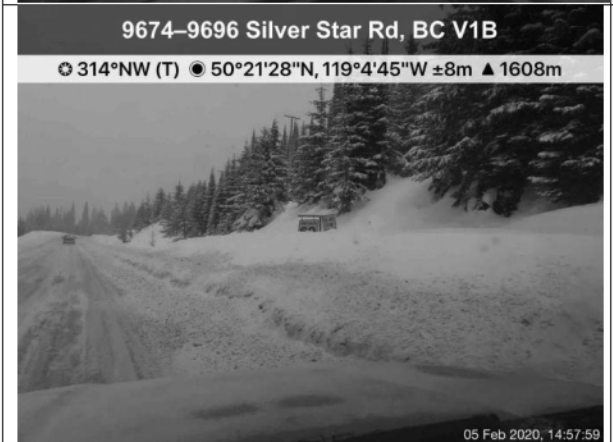
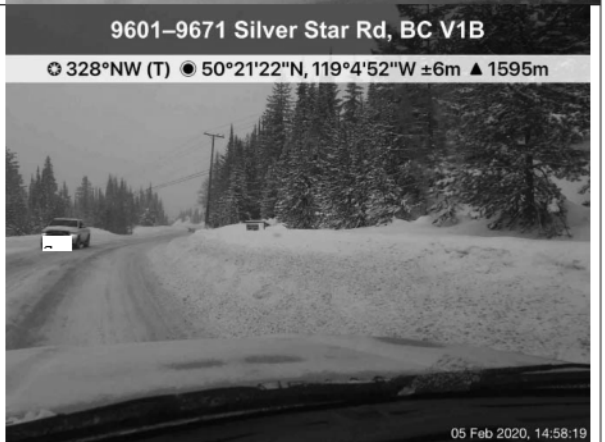
Photos 2020/02/05

Signs monitored on February 5th, 2020 showed no change from January 10th monitoring. Deadline for correction was 24hrs from notification.

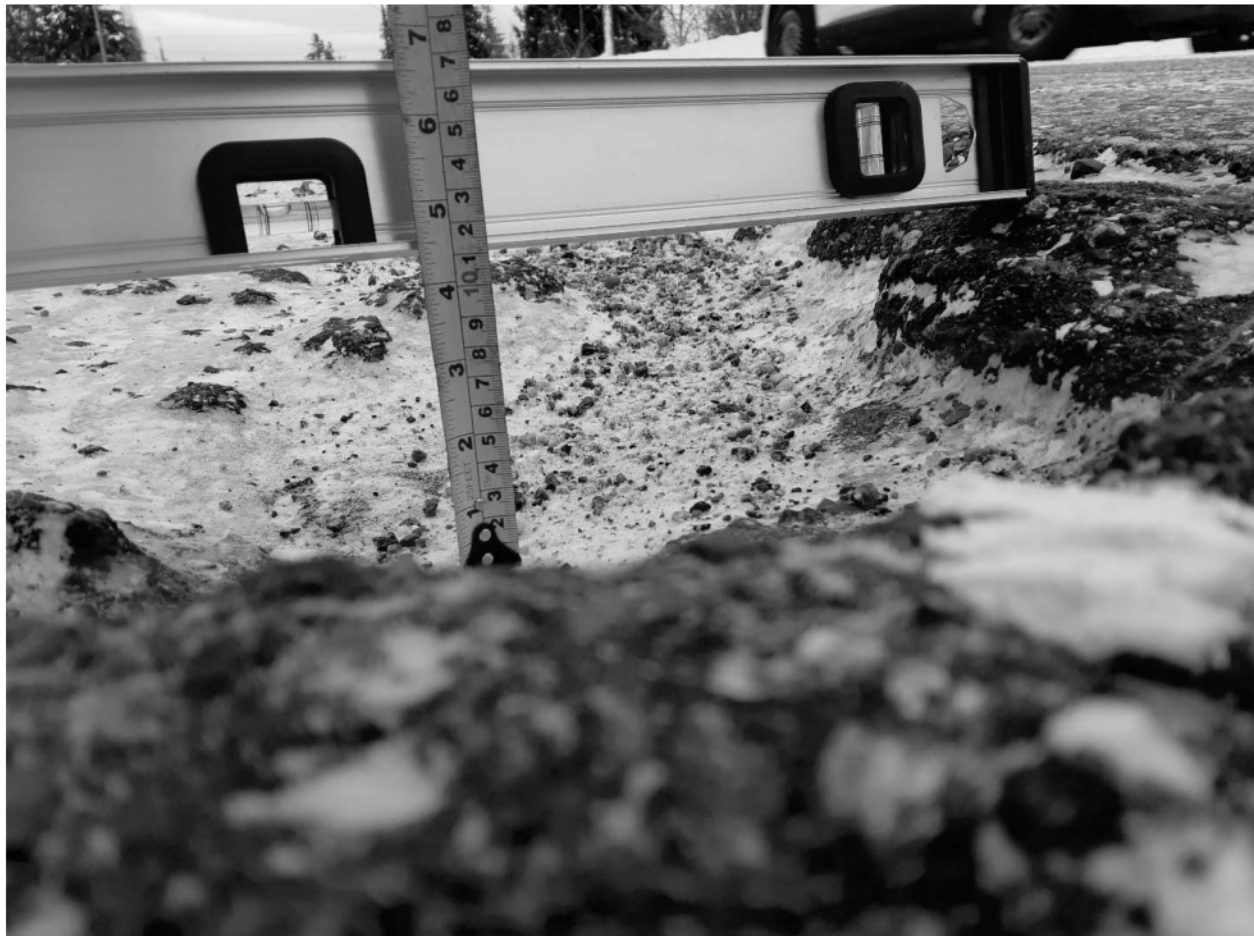
Many high severity potholes have been on Highways for over a week with many more present since December. Response times are extremely overdue. PM 1.01.2-1 has a response time of 1 day for Potholes on the Travelled Lane on these Highways. Locations include but are not limited to Hwy 97 near Bailey Rd, Hwy 97 on top of Hospital Hill, Hwy 97 through Vernon, Hwy 97 near Swan Lake junction, Hwy 6 near 25th Ave, Hwy 97B between Hudson Rd and Sonora Rd, and Hwy 1 on the Tappen end of Kault Hill. These potholes present serious safety issues for the travelling public and they have already caused damage to countless vehicles.

The pothole above is on the Northbound Travelled Lane of Hwy 97B and is over 100mm deep.

The highway 97 pothole (near Bailey Rd.) and a number of other smaller severity potholes are related to a delamination problem with the pavement. The pavement is failing in multiple areas and rehabilitation of the pavement is needed.

Yes, construct Temporary Patches on all numbered route Highways that are over 50mm deep.

and repairing potholes within the MOTI specification timeframe. A third party contractor has been hired to perform pothole repairs. The contractor was working on Highway 97B with traffic control on the evening of January 15 to complete pothole repairs. The contractor continues to work on pothole repairs and has been working within Vernon on Highway 97 and on Highway 97 repairing potholes on a priority basis. The most significant potholes are being repaired first and then less significant potholes are being repaired. In addition to the third party contractor, AIM Roads crews (both night shift and day shift) have been dispatched to perform pothole repairs on multiple locations including: Highway #1, Highway 97, Highway 97 W, Highway 97 S and downtown Vernon. In addition – pavement patching work is being conducted by a third party contractor to repair whole sections of road that contain numerous potholes.

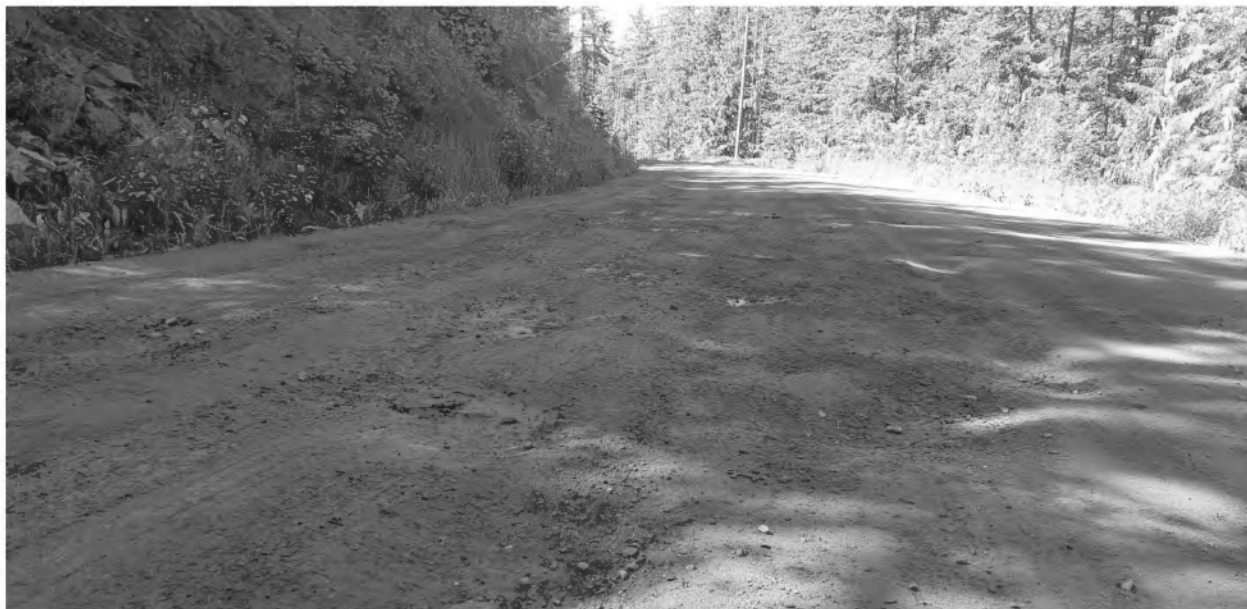
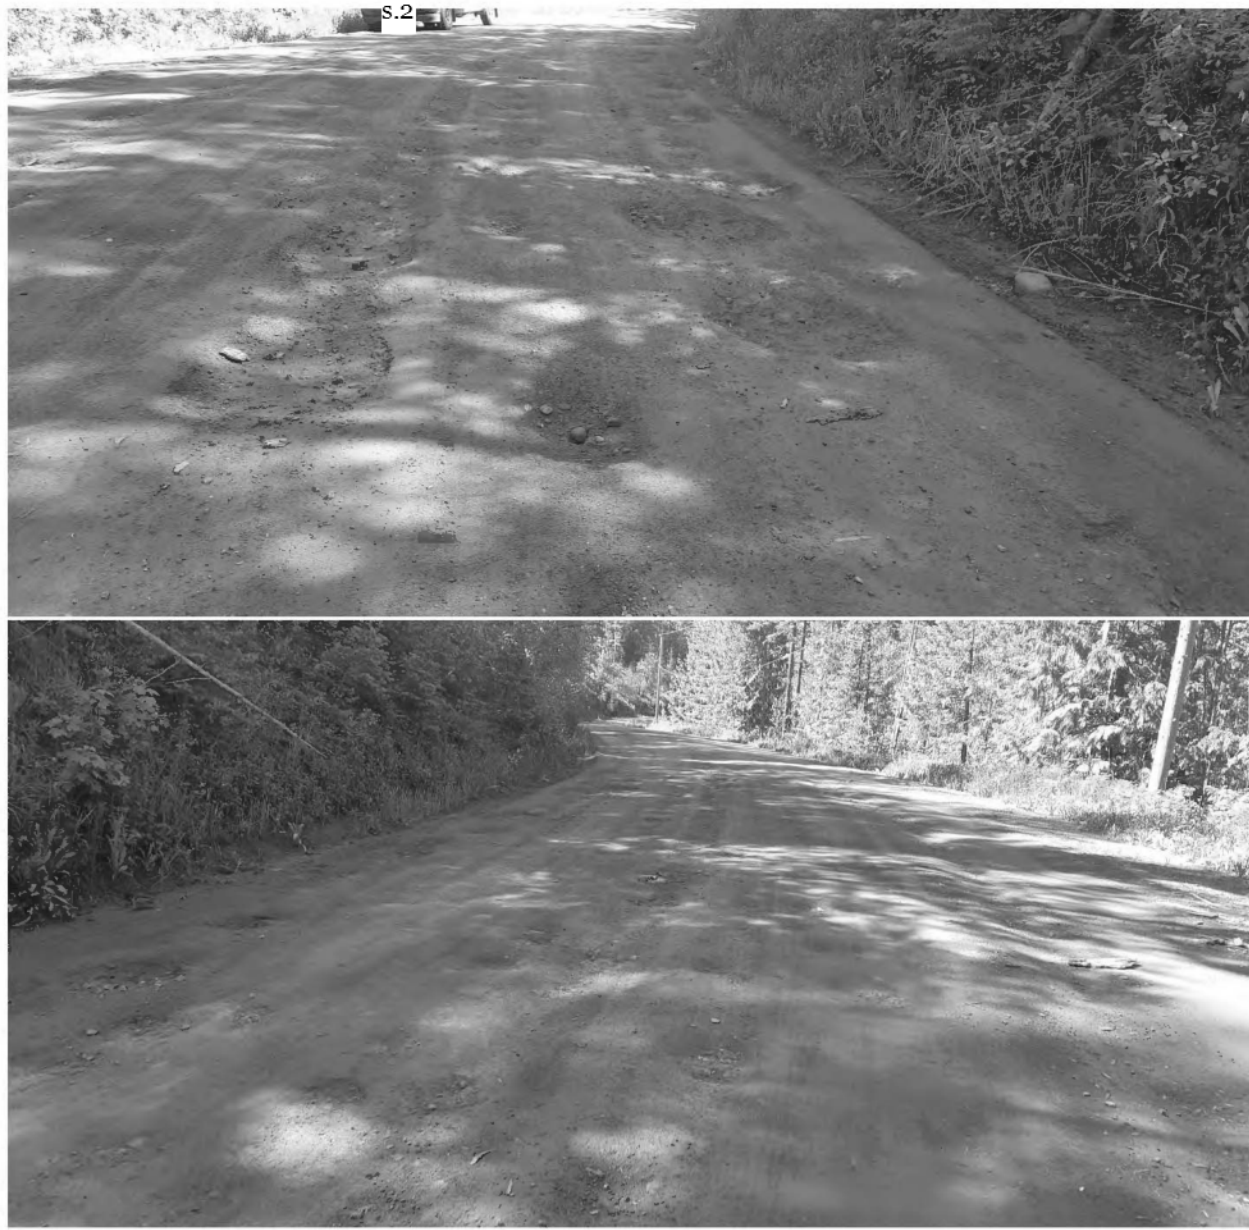
Trinity Valley Rd #130 is a Class 4 road that spans both the Cherryville and Armstrong foreman areas. The road was found to be in an acceptable condition on the Lumby (Cherryville yard) end, with minor infrequent potholes on the gravel portion. The Enderby (Armstrong yard) end was in a deplorable state, with frequent, high severity potholes that presented serious safety issues for road users.

The potholes averaged far more than 1 per 25 metres, and they spanned across the road width on many sections for well over 2 days. The response time for a Class 4 gravel road in this condition is 2 days to provide a safe, smooth, stable, compacted and free draining surface. MoTI was given a low level of confidence the road would be graded anytime in the near future due to the grader needing to be on other roads in the large Armstrong foreman area.
