7300-20
2004
Happy Valley Elementary School
5291 Happy Valley Road
Langford, BC
Incident #NLG 04/10/14/10/01

FIRE/CAUSE DETERMINATION REPORT

Submitted by Ray Aitken, Fire Investigator
Office of the Fire Commissioner
Northern Regional Office (Prince George)
November, 2004

INCIDENT # - NLG 04 10 14 10 01
HAPPY VALLEY ELEMENTARY SCHOOL
3291 HAPPY VALLEY ROAD
LANGFORD, BC

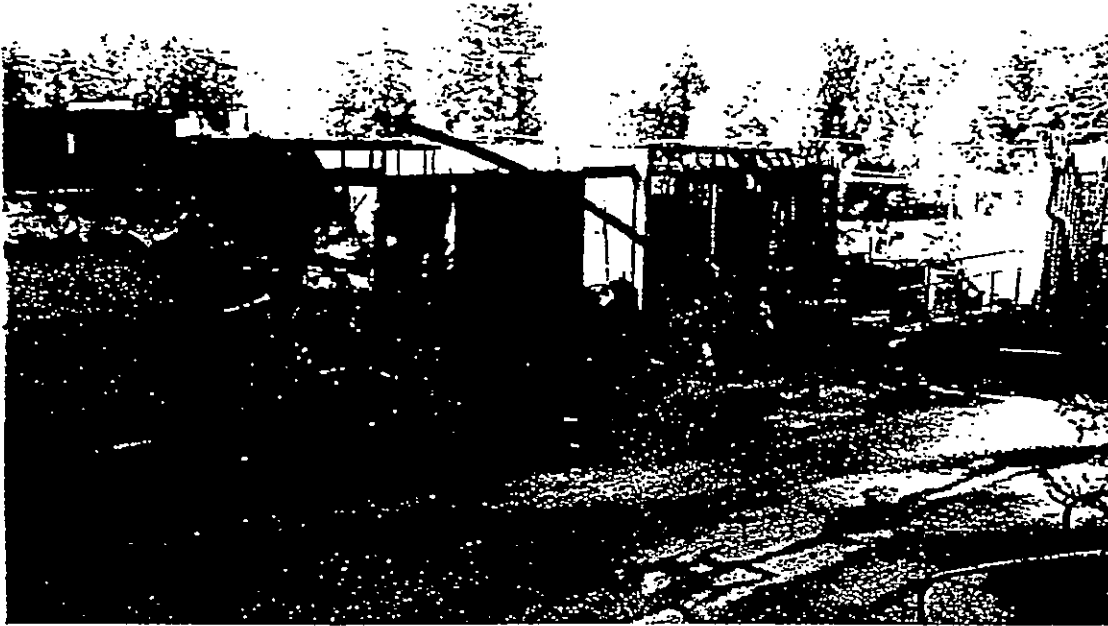
Figure 19 - Bravo Sector - showing exit route of staff and students from classrooms 2018/2019 **

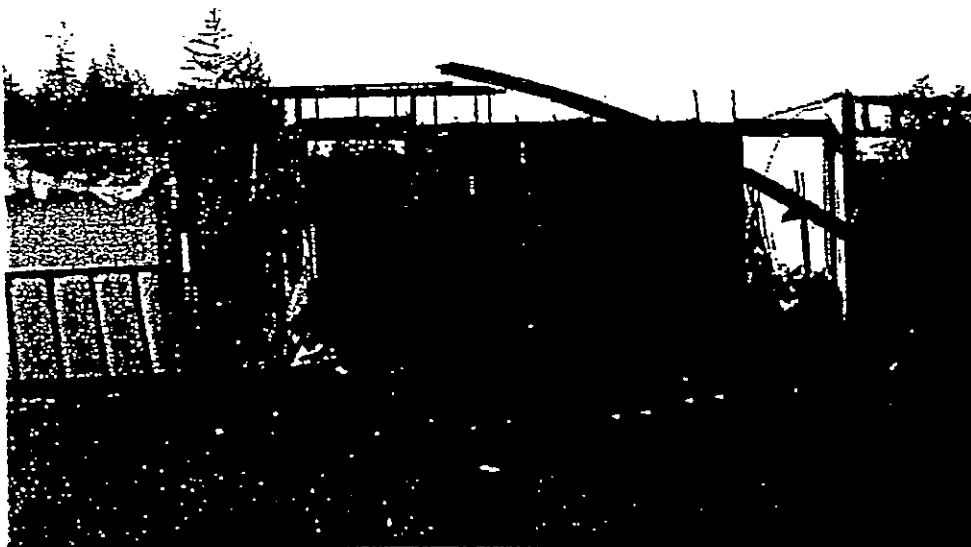
Figure 22 - Bravo Sector - Exterior Multi-Purpose Room 2010 prior to reconstruction **

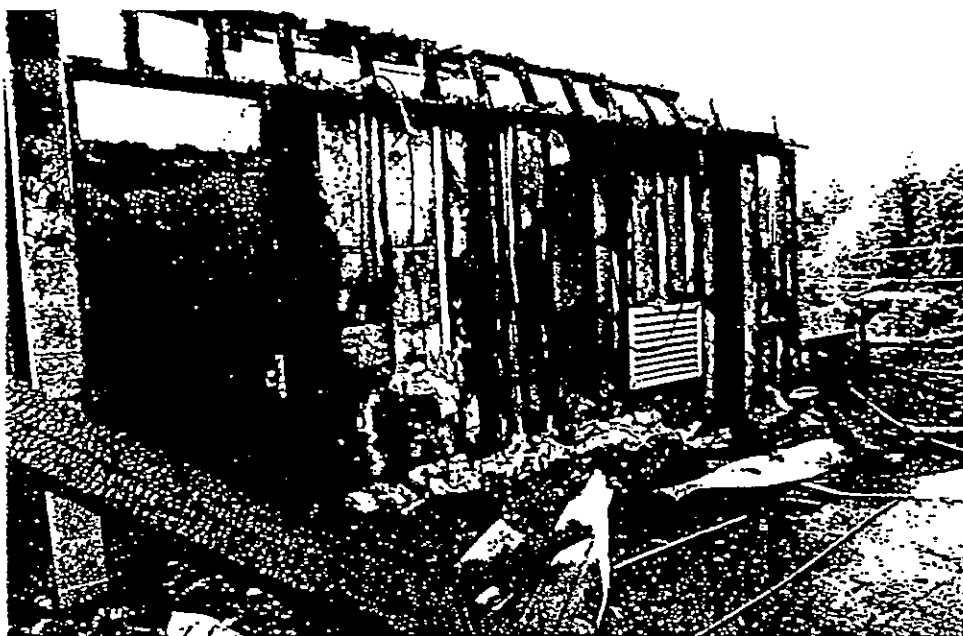
Figure 23 - Bravo Sector - Exterior Learning Assistance Room 2017 prior to reconstruction **

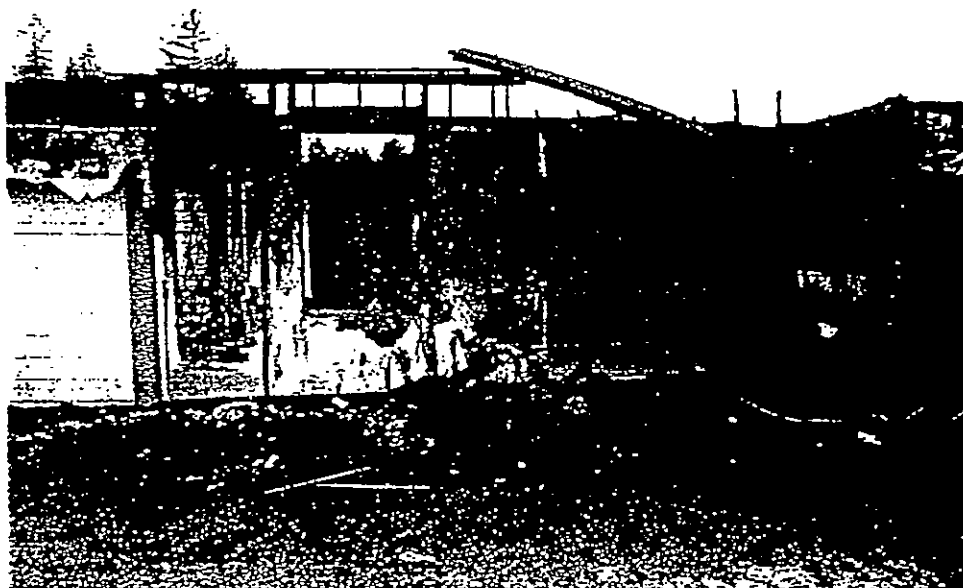
Figure 24 - Bravo Sector - Exterior Multi-Purpose Room 2010 during reconstruction **

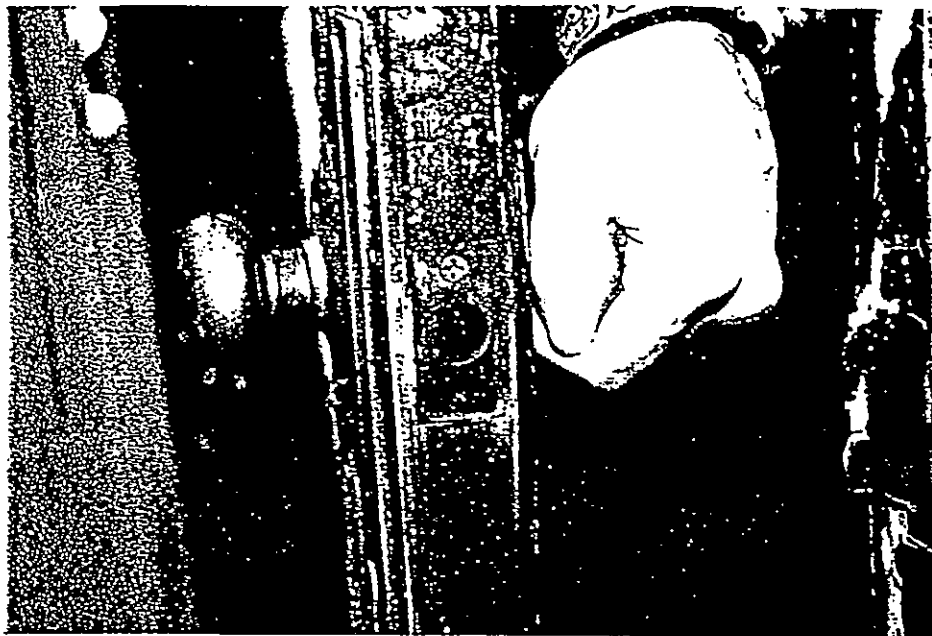
Figure 29 - Bravo Sector - Exterior door latching device - Multi-Purpose Room 2010 **

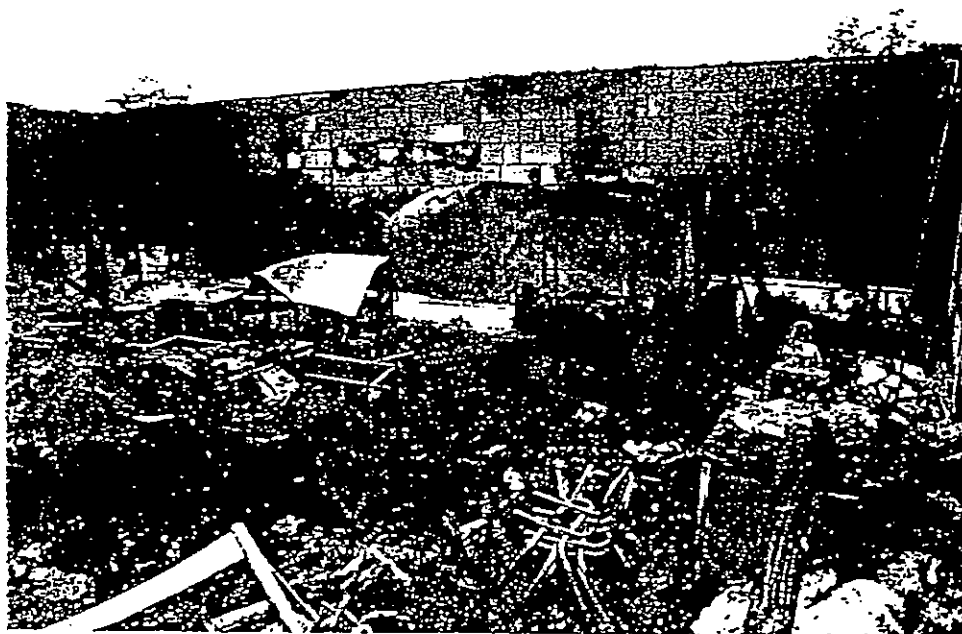
Figure 32 - Area of Origin - Multi-Purpose Room 2010 prior to reconstruction **

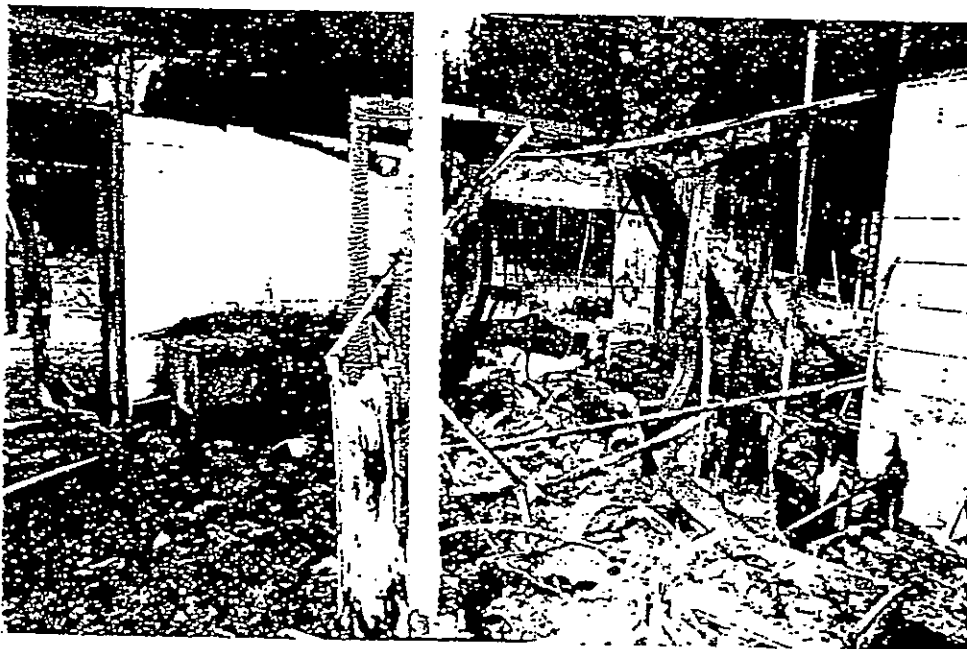
plate intact) and 2 wall mounted duplex outlets with plastic faceplate consumed by the fire (1 wall outlet with 2 black lights plugged "in" and 1 wall outlet with a light duty extension cord plugged "in"). All the indicators present indicated that the fire damage to these different electrical audio and duplex wall outlets, the appliances plugged "in" and their conductors (wiring) were external rather than internal and caused by the fire as it progressed and spread. (See drawings A/2,A/12,A/13 and photographs 31,34 and 38).

Figure 34 - Area of Origin - Multi-Purpose Room 2010 prior to reconstruction **

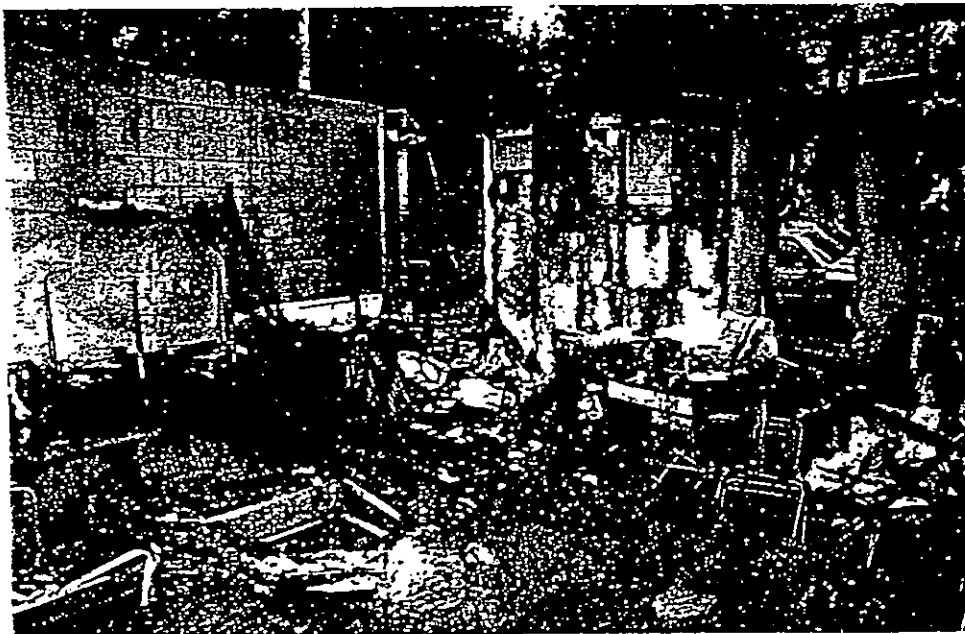
It is the opinion of the undersigned that a "target fuel" namely the combustible paper product (black construction paper) that had been placed on the interior surface of the 2 window units (glass glazing) prior to the fire was ignited in the initial stages by a DIRECT FLAME impingement from an undetermined location and contributed to the rapid growth of this fire in the beginning or incipient stages. Upon ignition of the combustible paper product (black construction paper) the fire rapidly traveled upward (vertically) in a "plume" using the black construction paper affixed to the inside surface of the windows glass glazing as the main "target fuel" source and upon reaching the exposed surface of the combustible fiberboard acoustical ceiling tile (affixed to wood strapping by an adhesive) the fire began to roll over and spread outward laterally in a north / south direction by attacking the highly combustible fiberboard acoustical ceiling tiles. Eventually, the fire ignited the combustible fiberboard ceiling tiles along the intersection with the exterior wall (south sector of the room) causing them to weaken and fail and thus provided an opening to allow the fire direct access into the structural wood roof / ceiling joist assembly located above Multi-Purpose Room 2010 and into the adjacent roof overhang on the BRAVO sector of the school. (See drawings A/2,A/7,A/8,A/9,A/15,A/19 and photographs 33,36,37 and 40-42).

Figure 40 - Area of Origin - Multi-Purpose Room 2010 along exterior wall showing fire and heat pattern indicators **

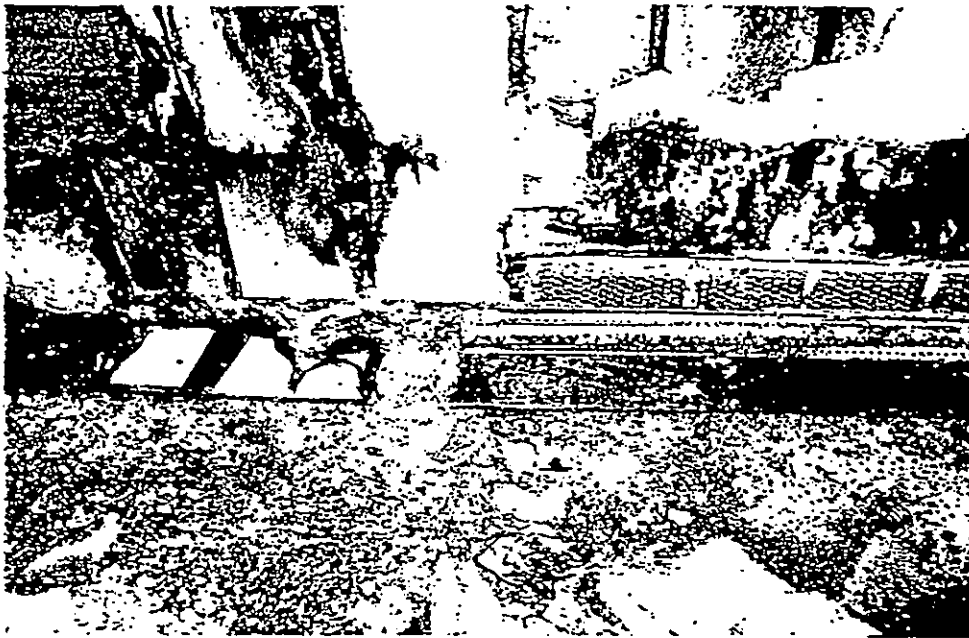
Figure 43 - Area of Origin - Multi-Purpose Room 2010 showing close-up of wood shelving unit and electrical baseboard heater *

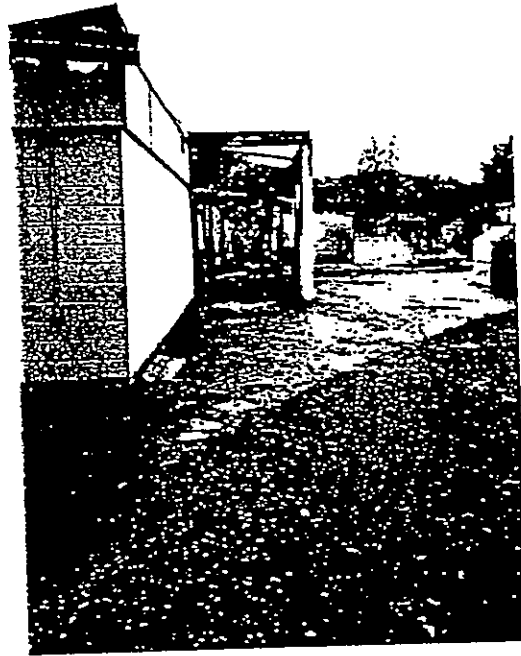
Figure 51 - Charlie Sector - Corridor 2027 - looking at roof mounted electric heating unit position *
