2012 INSPECTION COMPLIANCE FORM FOR OWNERS OF HIGH, VERY HIGH & EXTREME CONSEQUENCE DAMS

By Fax at: By email at:	250-952-6792 dam.safety@gov.bc.ca)52-6792 safety@gov.bc.ca		N, NL, WL, PG
MCCUDDY CREE	KRESERVOIR #2 SADDLE DAM	Is Contact N	ame and Address corr	ect?
KEVIN TULAK MCKINNEY RD W	ATER USERS COMMUNITY	YESNO_	Piease correct belo	w:
s.22		· .

Small earthfill saddle dam at north end of reservoir.

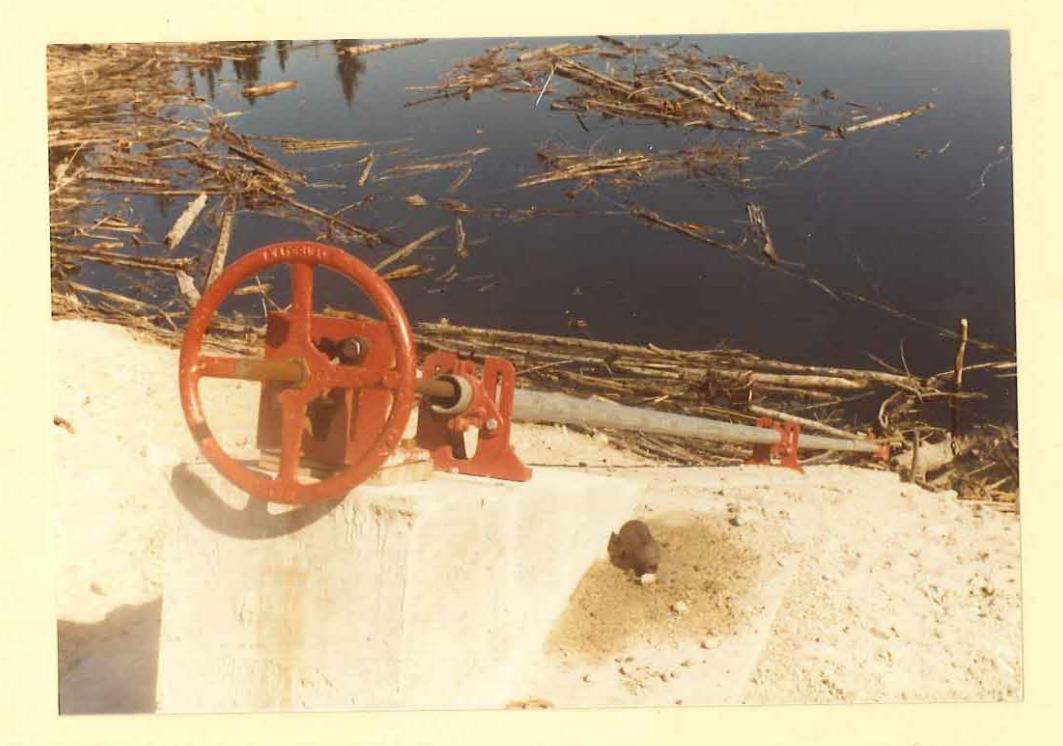
Gate valve located on upstream face. Note considerable debris in area.

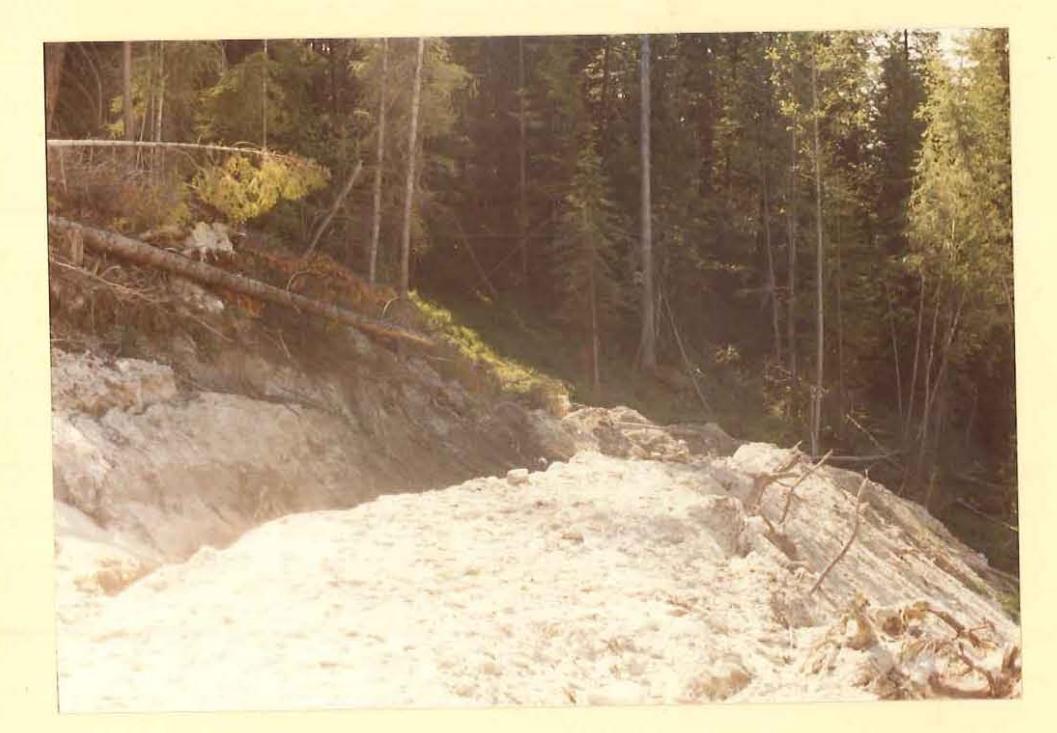
Lower spillway channel on left abutment.

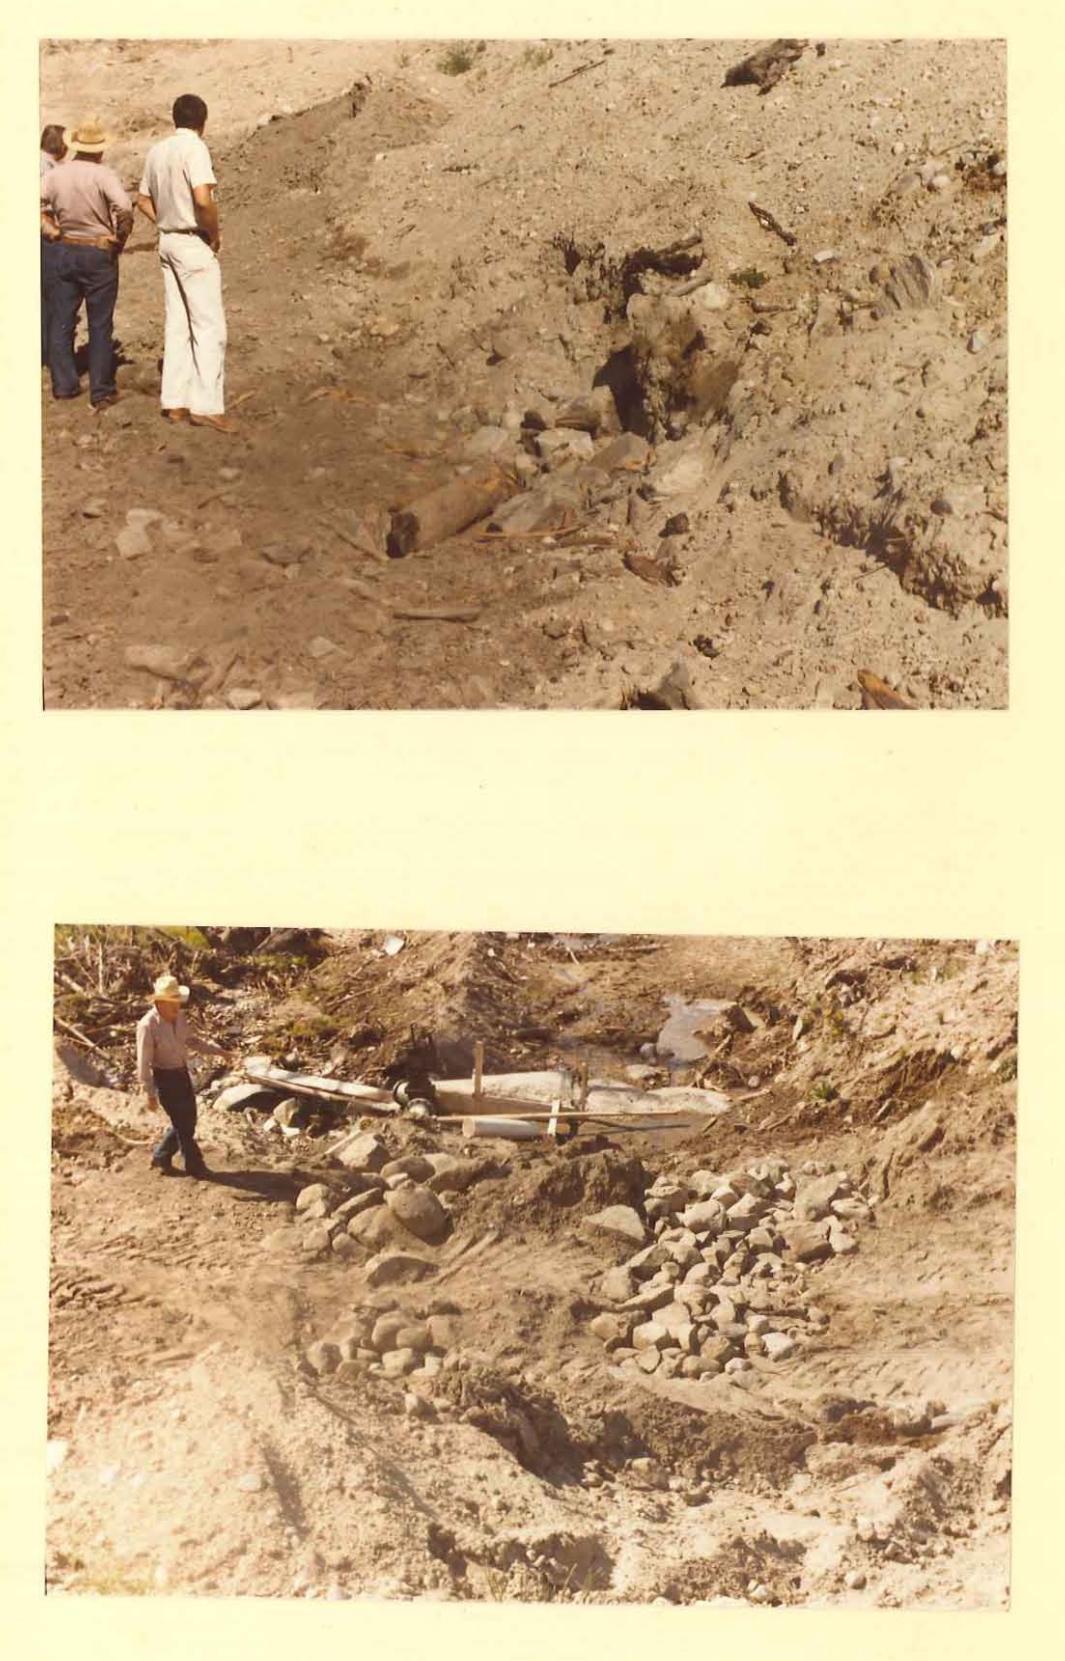
Stabilizing berm placed at downstream toe.

French drains installed through stabilizing berm.

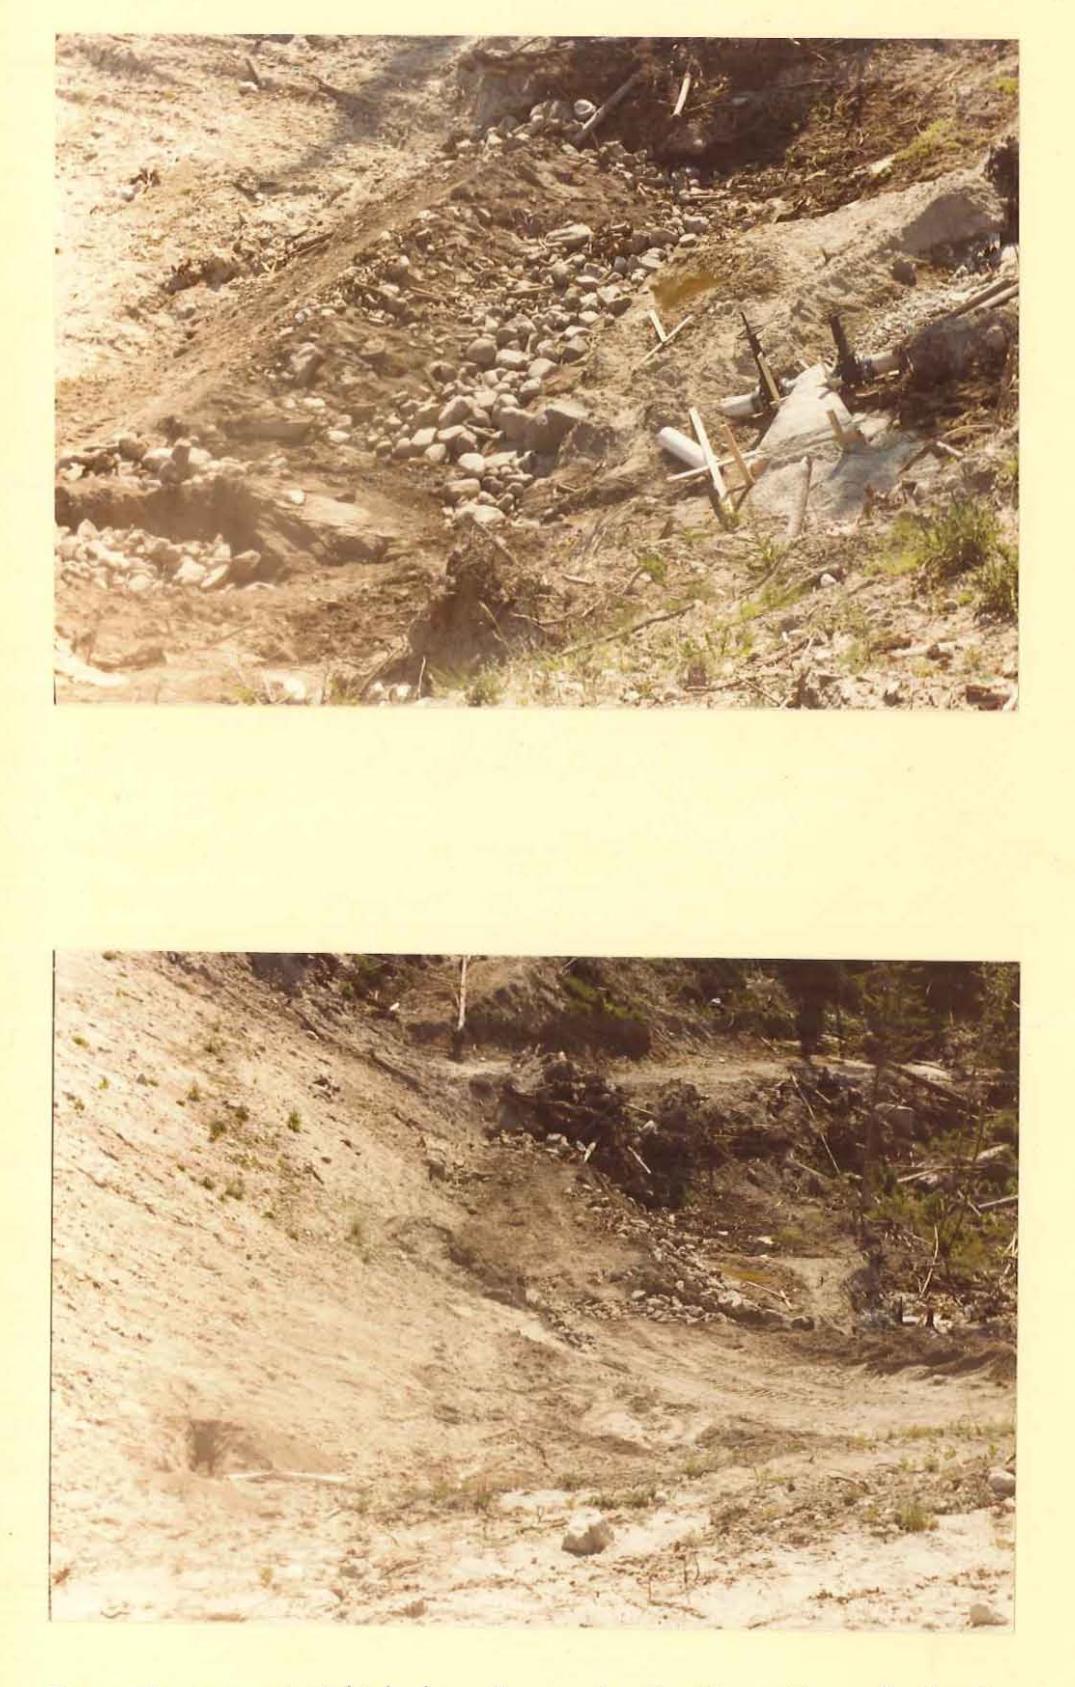
Stabilizing berm from right abutment.

Downstream stabilizing berm including French drains.

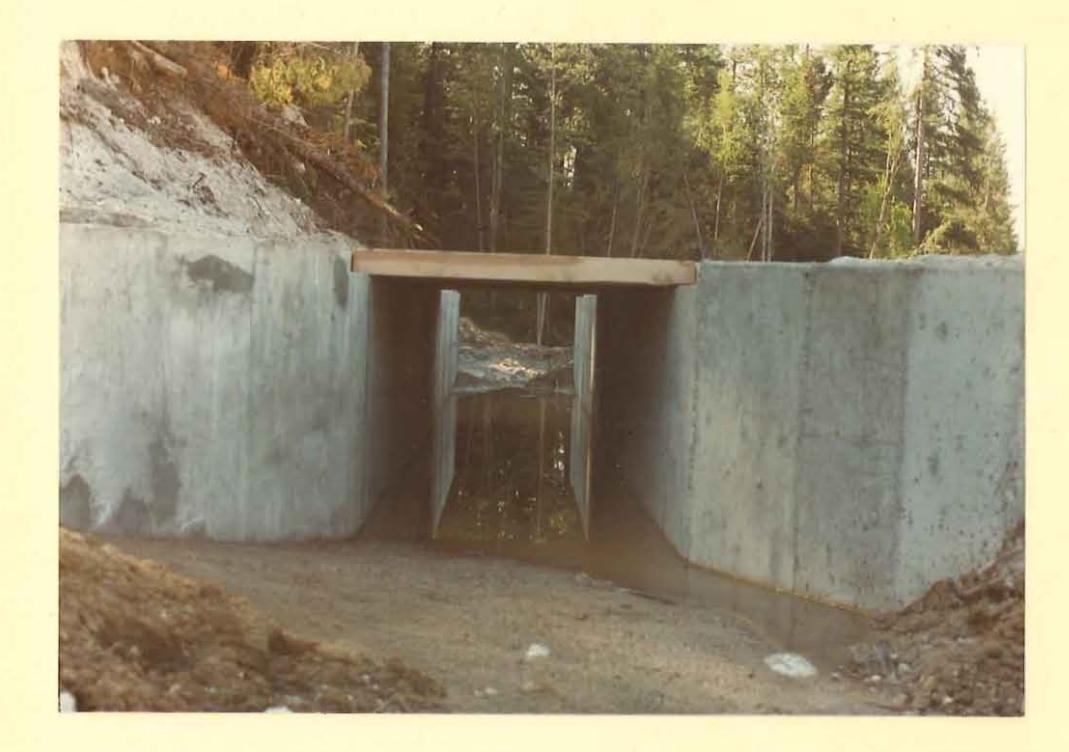
View of concrete spillway from upstream end. Note fines travelling into upper end of spillway channel.

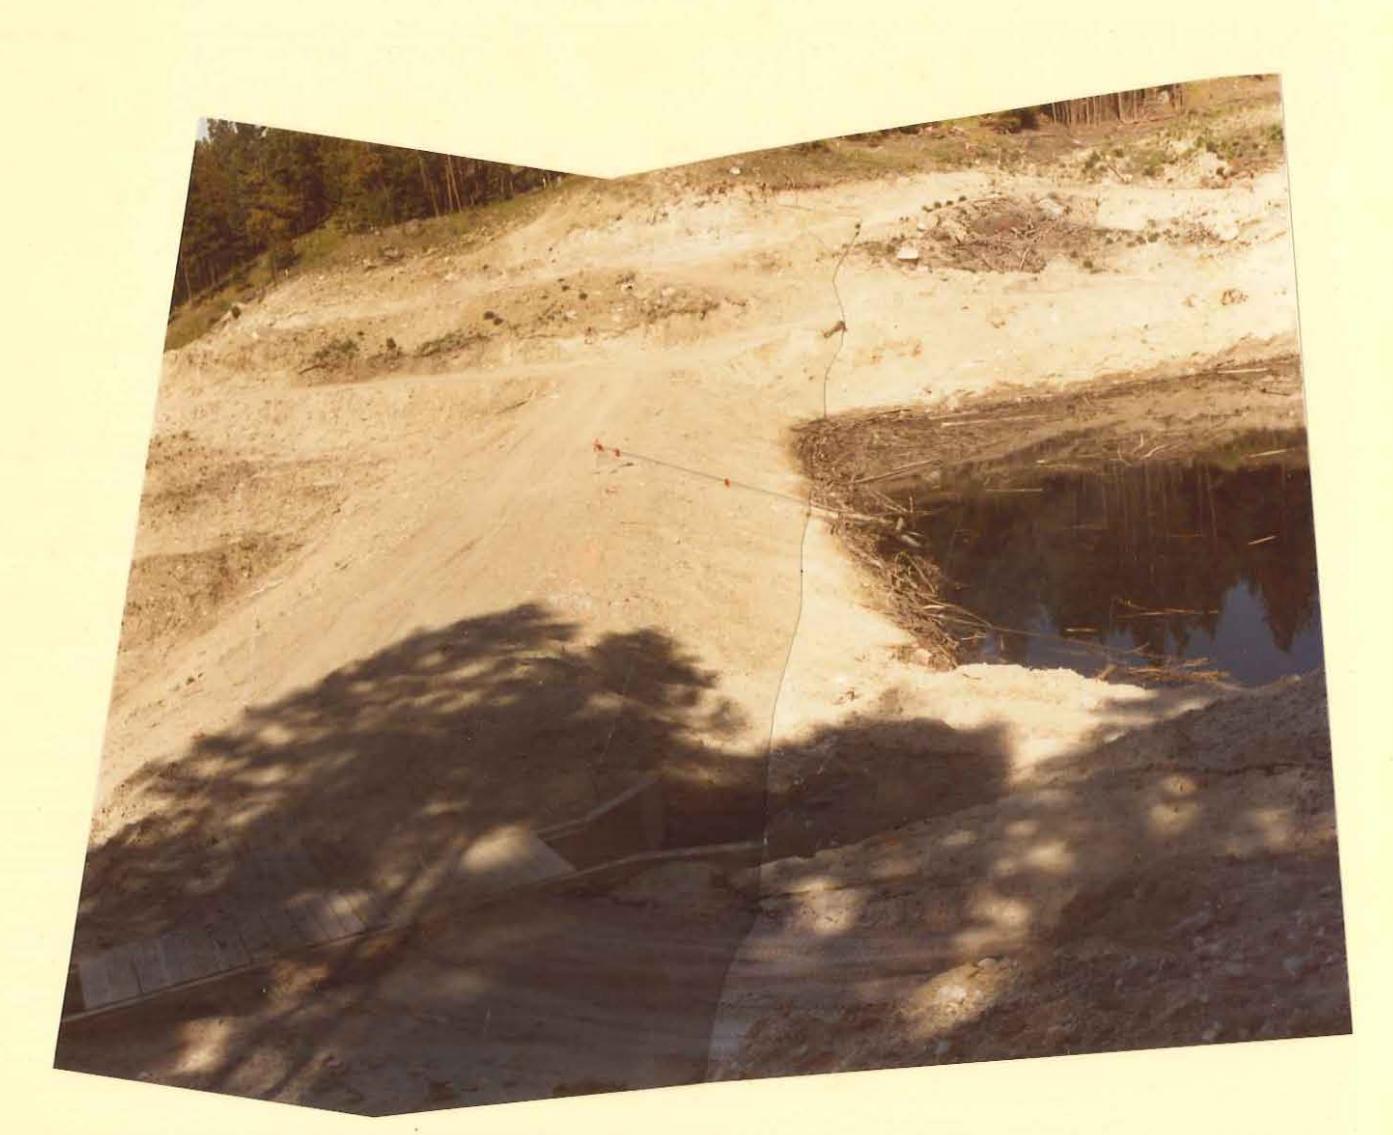
Upstream face of dam requiring protective log boom.

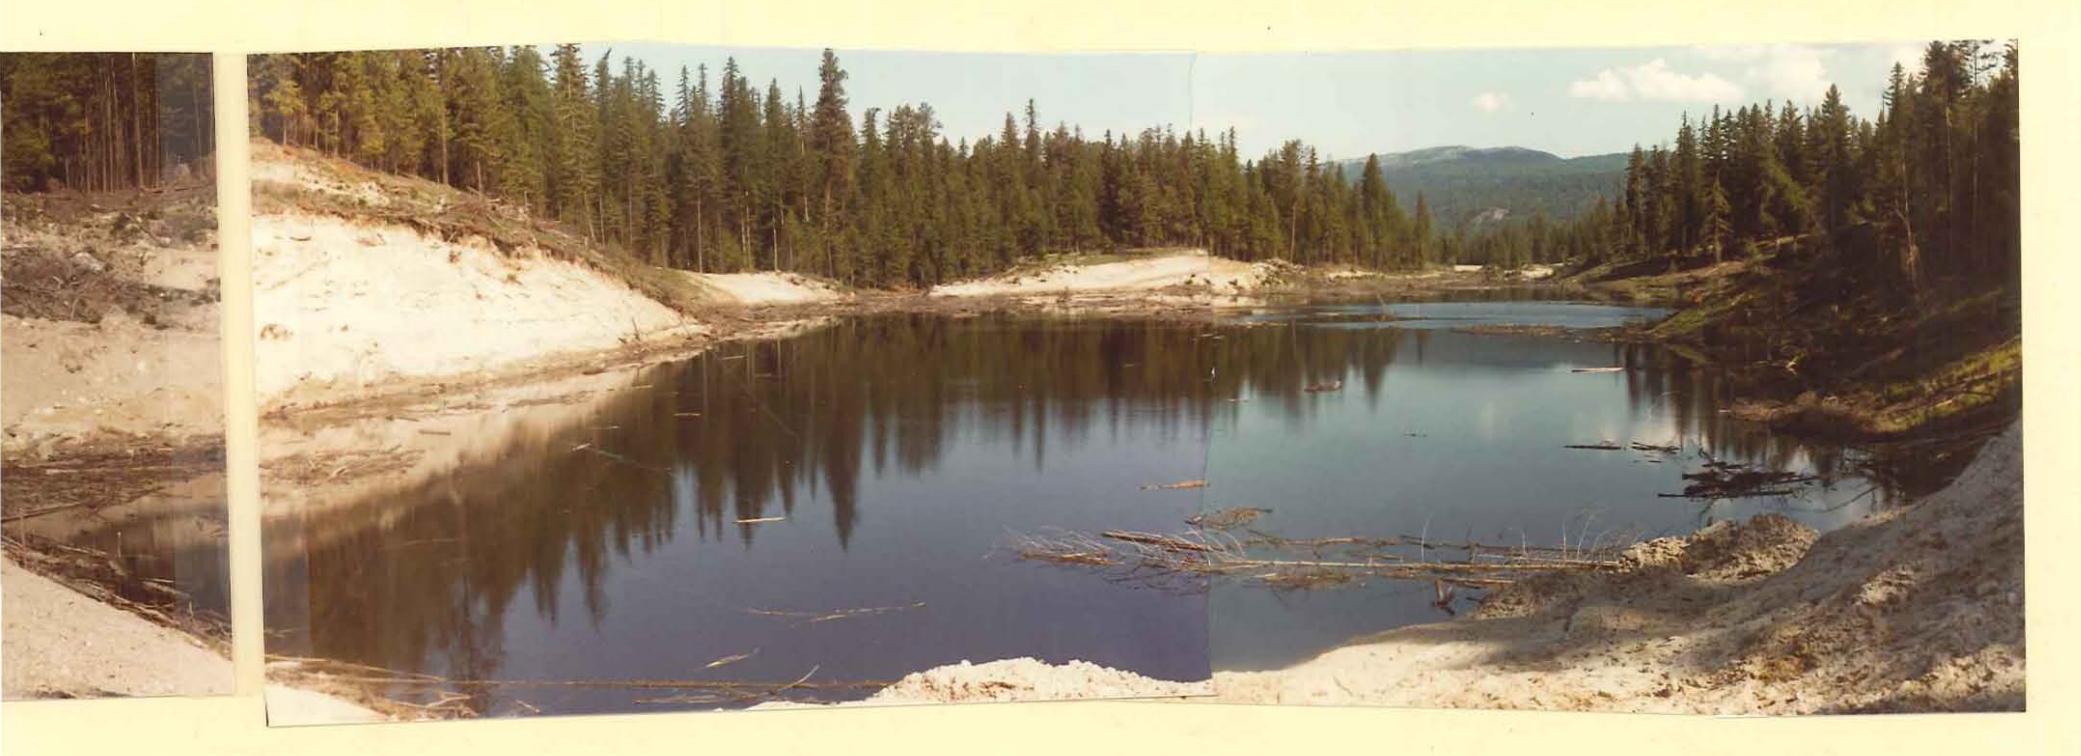
Reservoir site seen from left abutment (note debris).

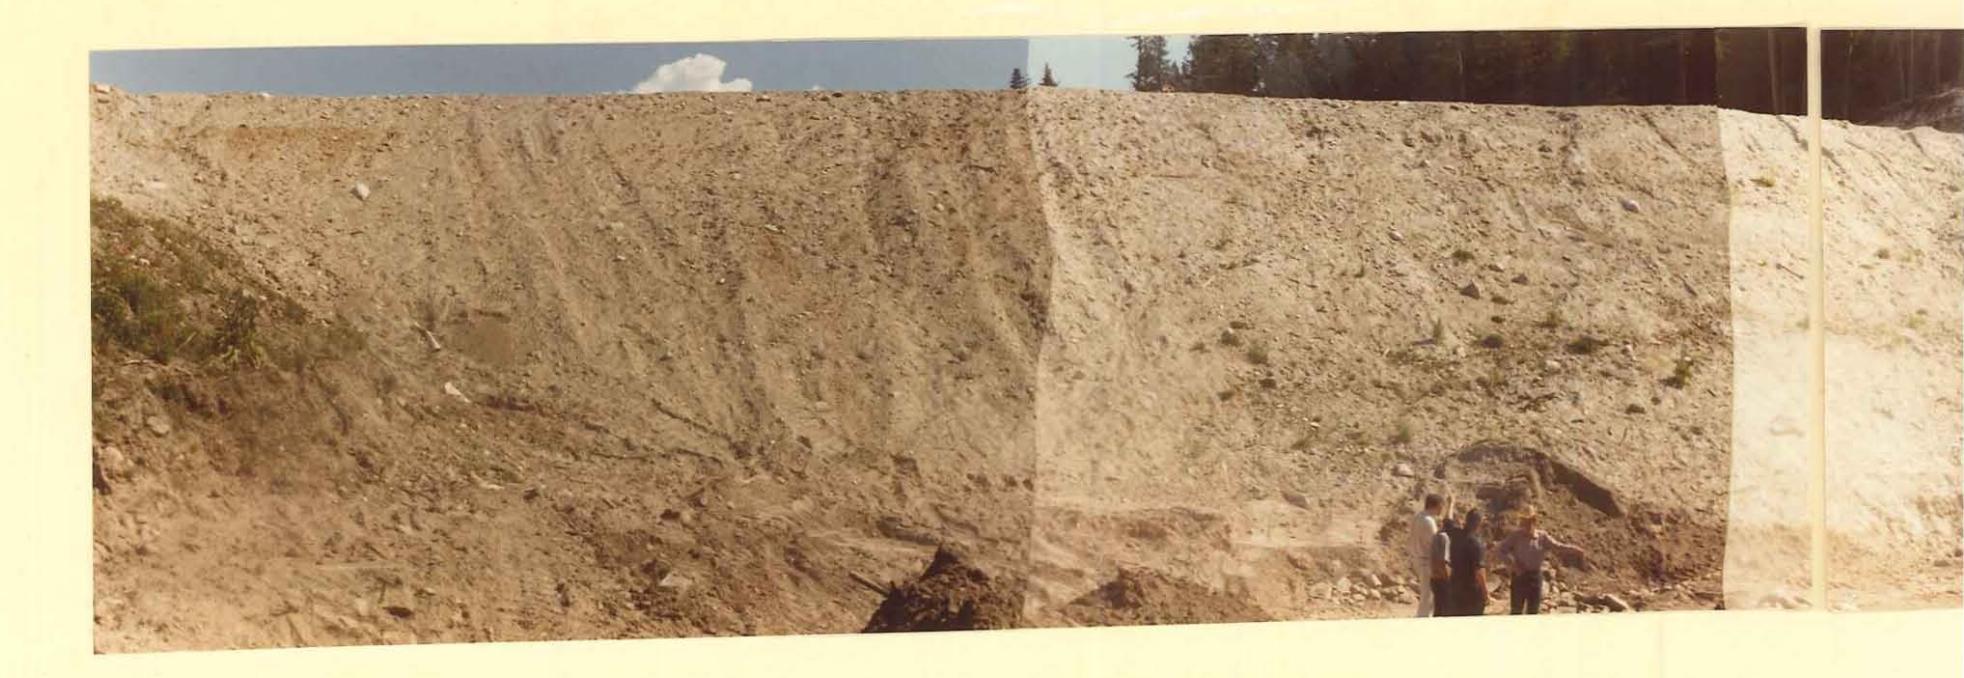
Downstream area of dam showing sluffs at berm contact.

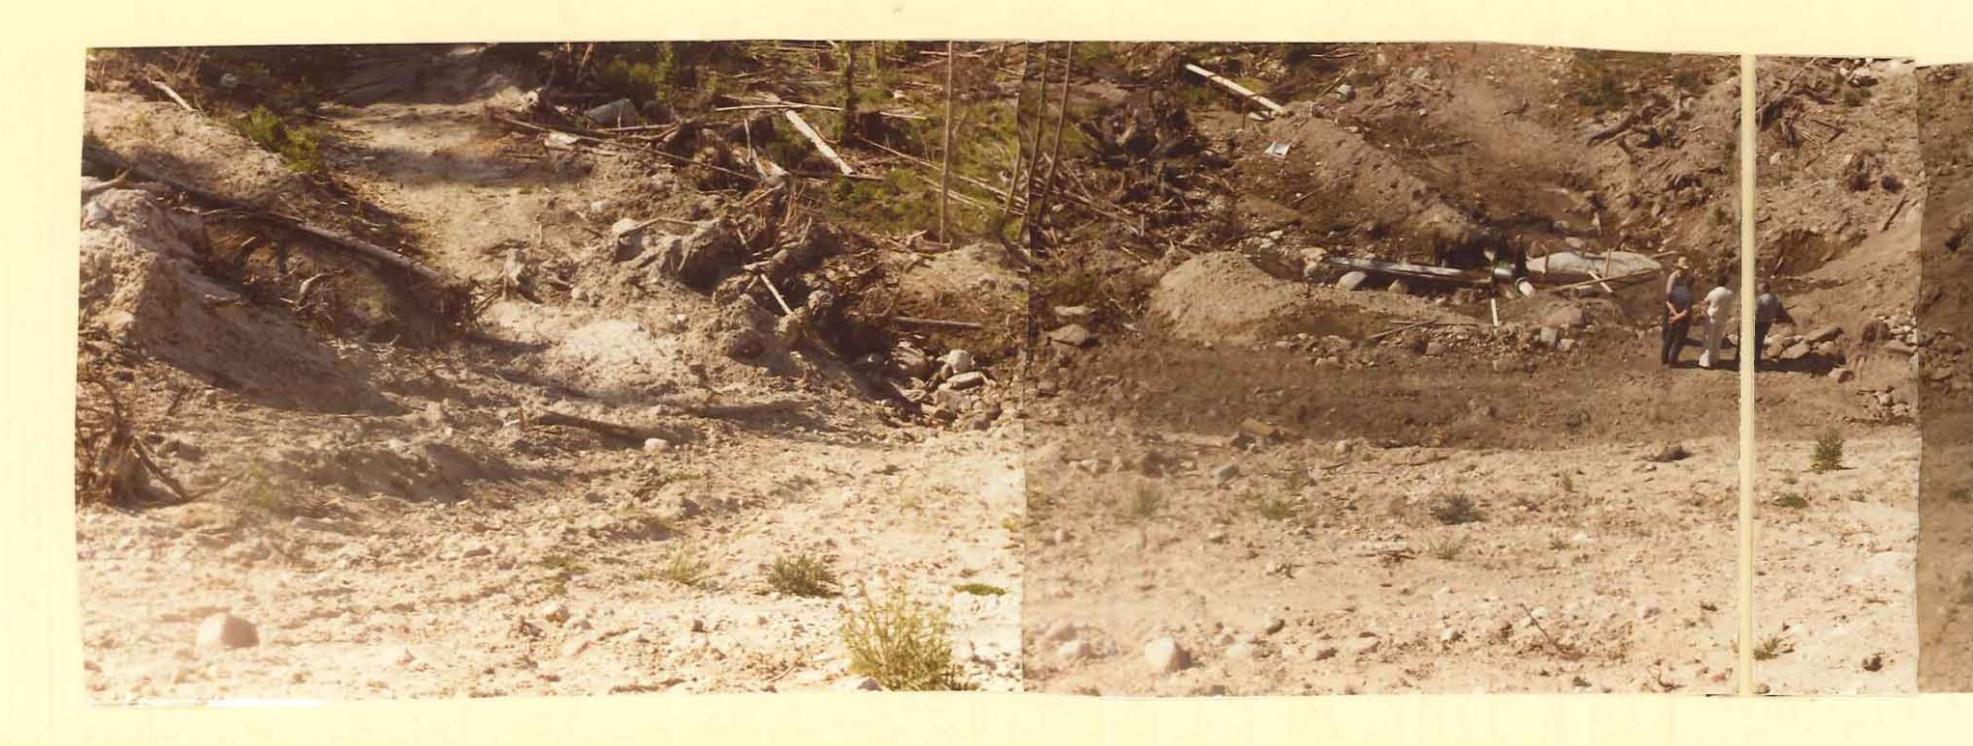
Downstream toe and groin areas seen from dam crest.

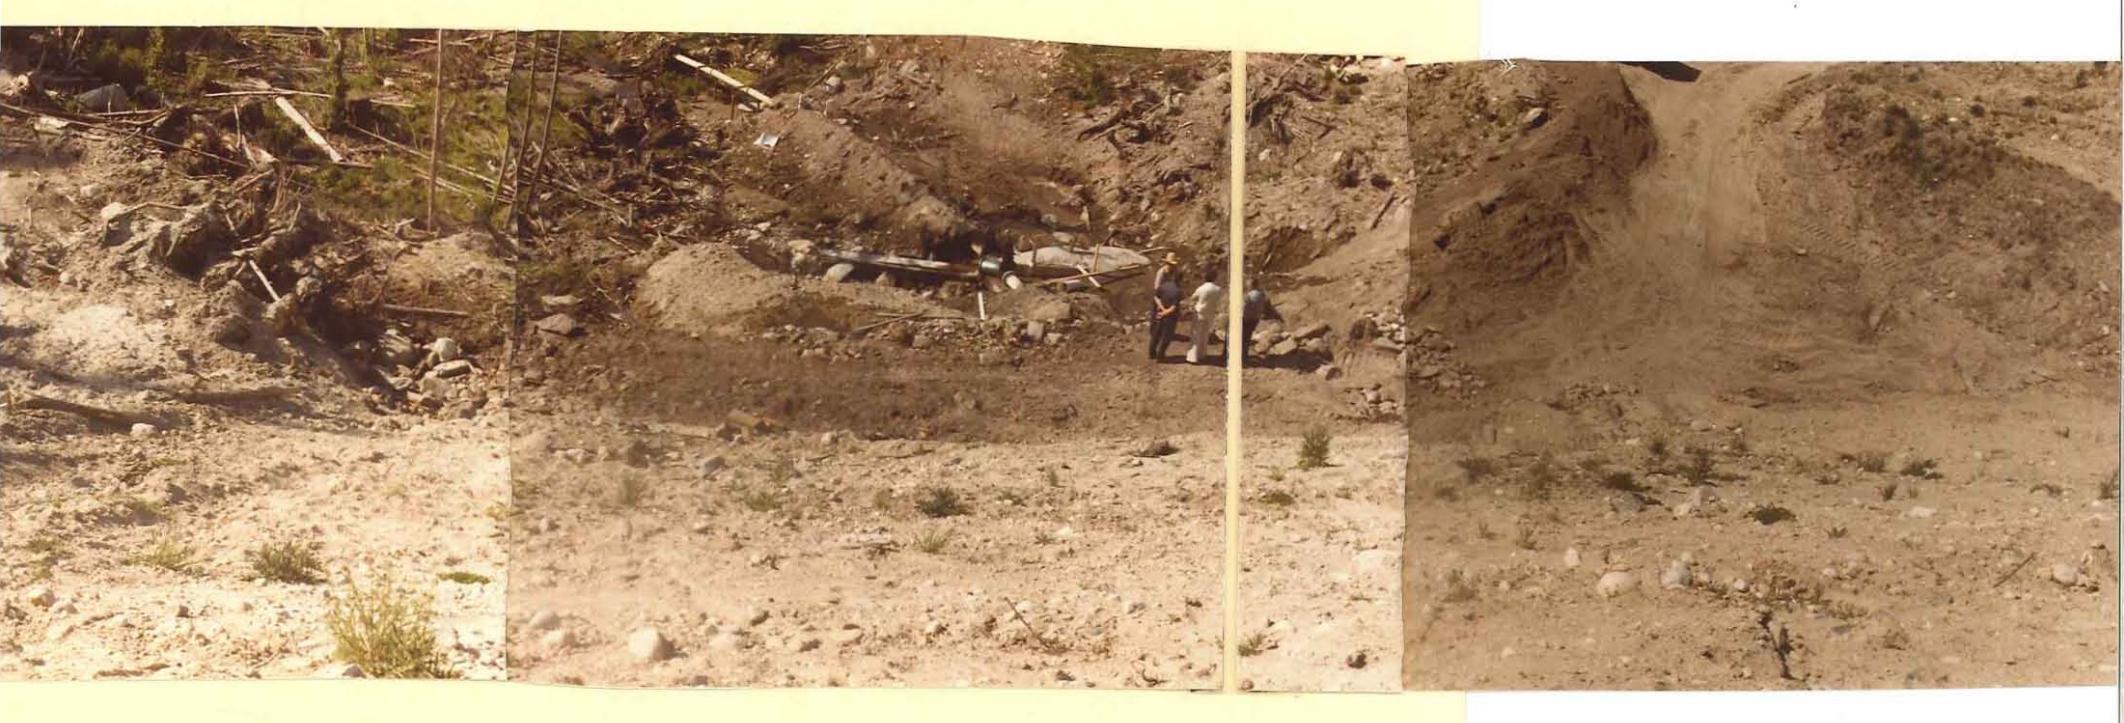
toe and groin areas seen from dam crest.

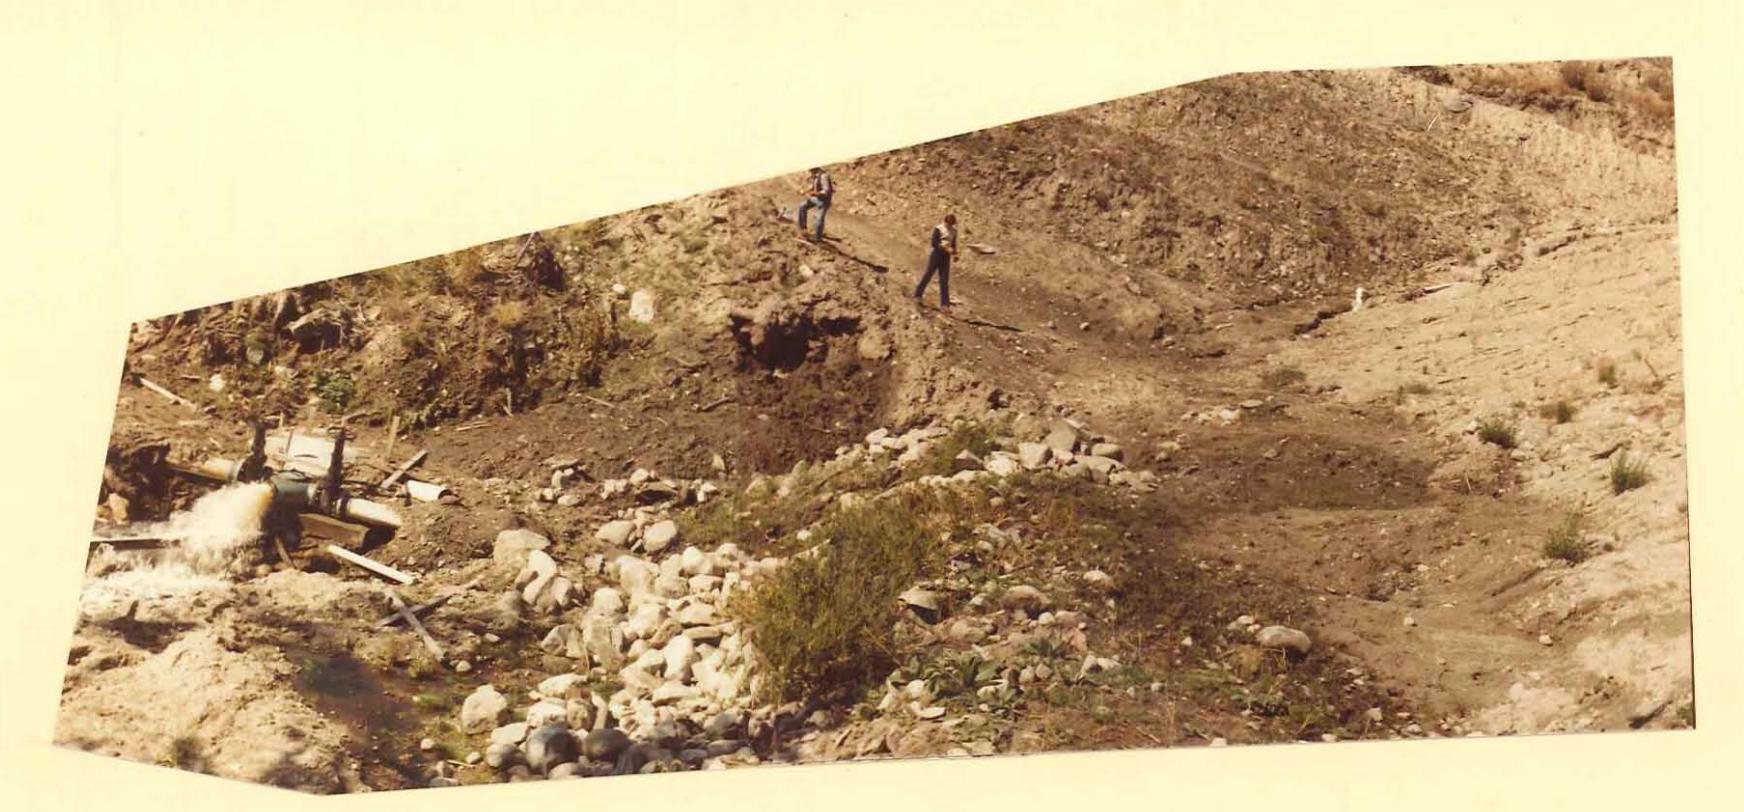
Close-up view of saturated toe area.

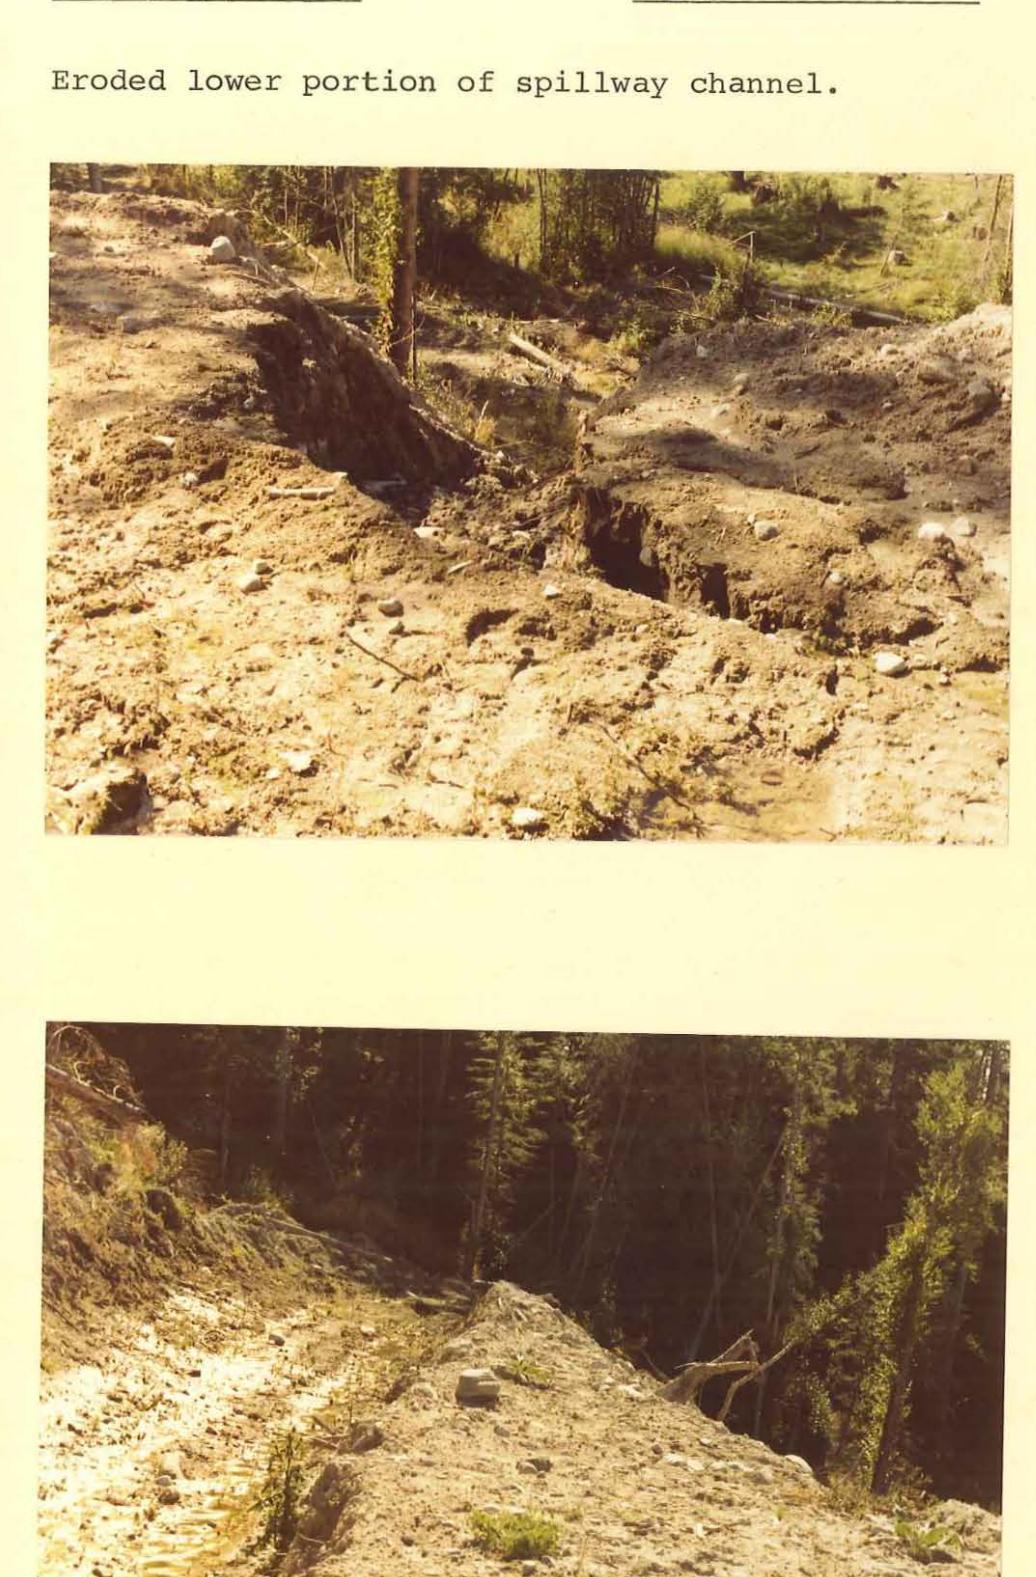
Spillway channel in left embankment.

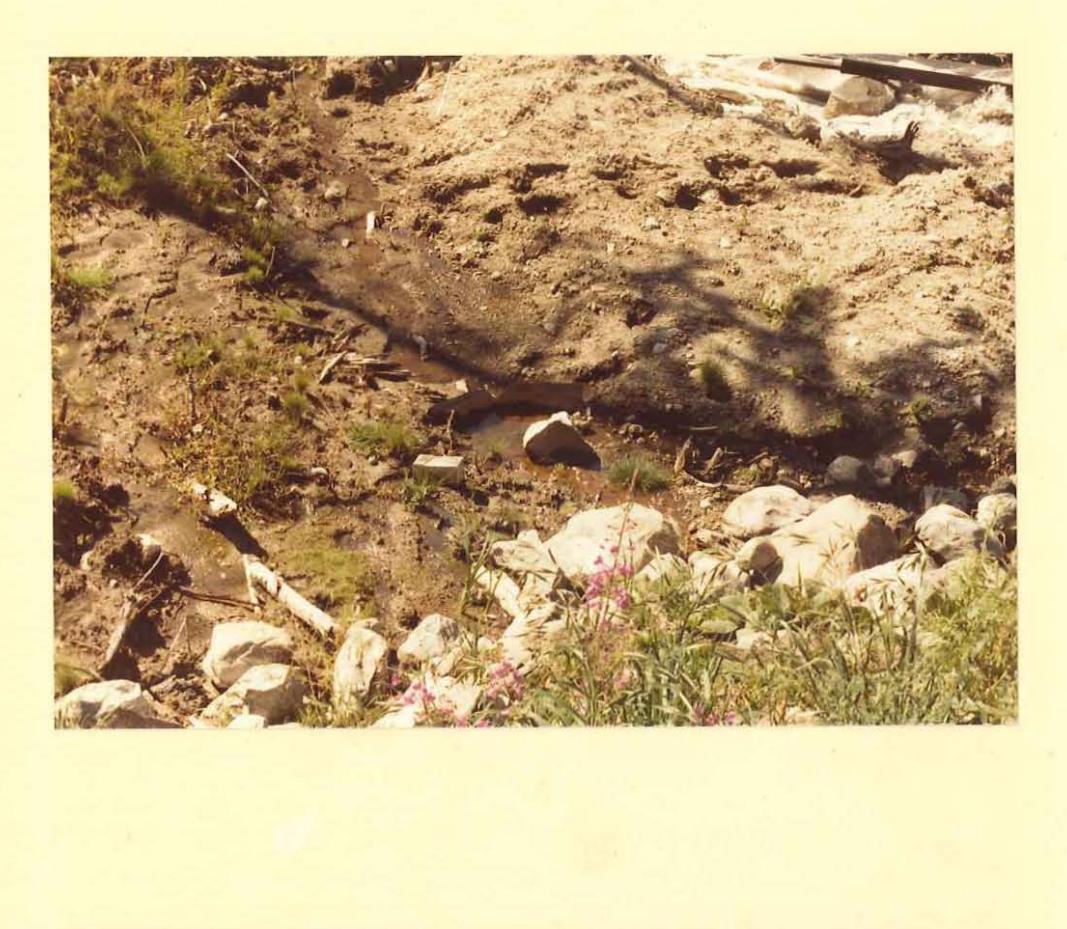
Seepage at downstream toe.

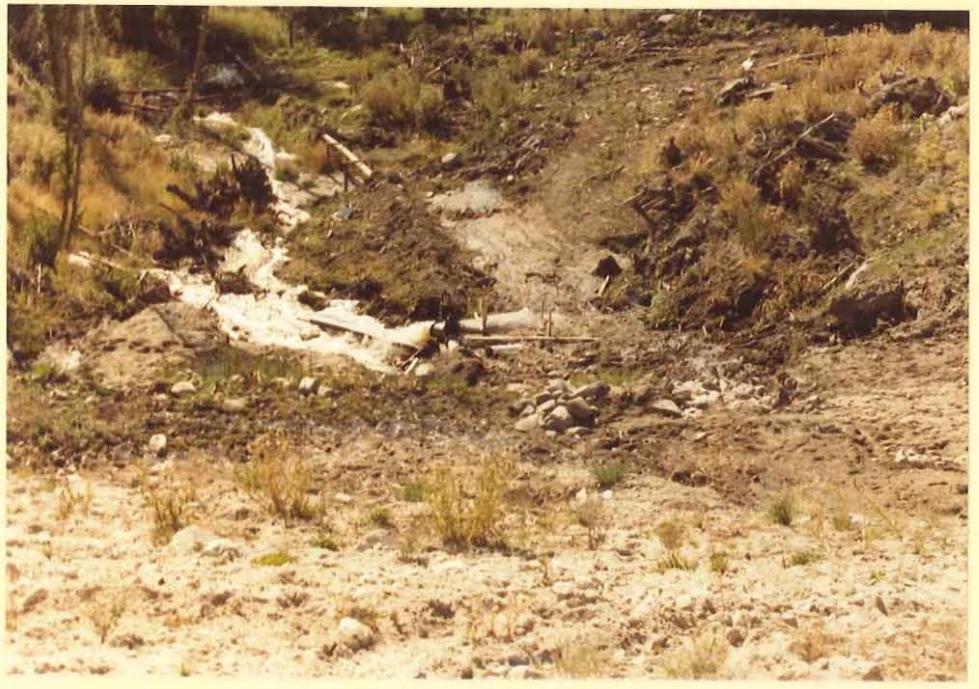
Saturated berm at downstream toe.

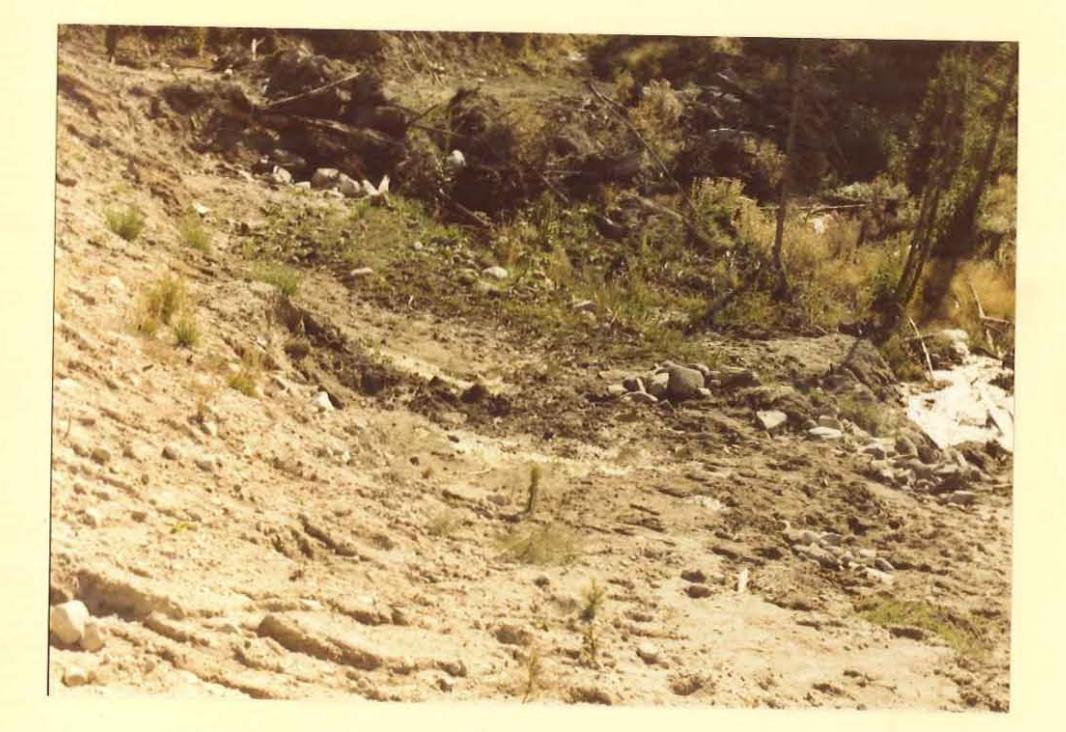
Saturated downstream toe.

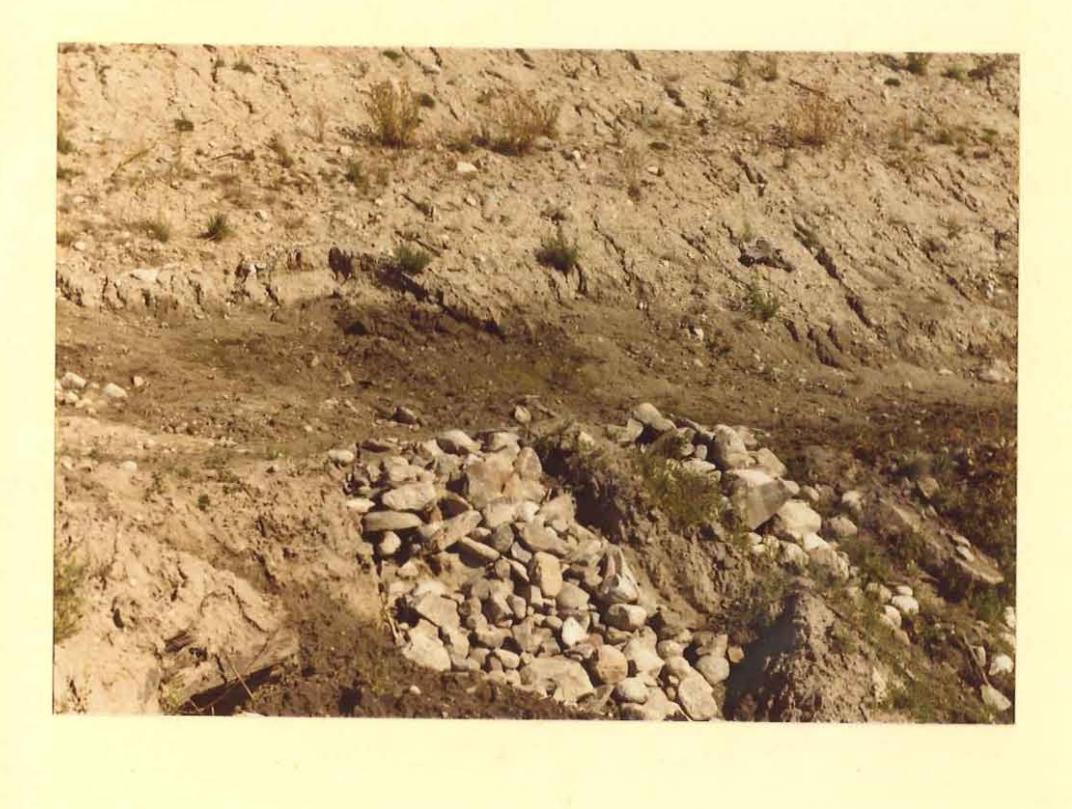
Rock drain from berm.

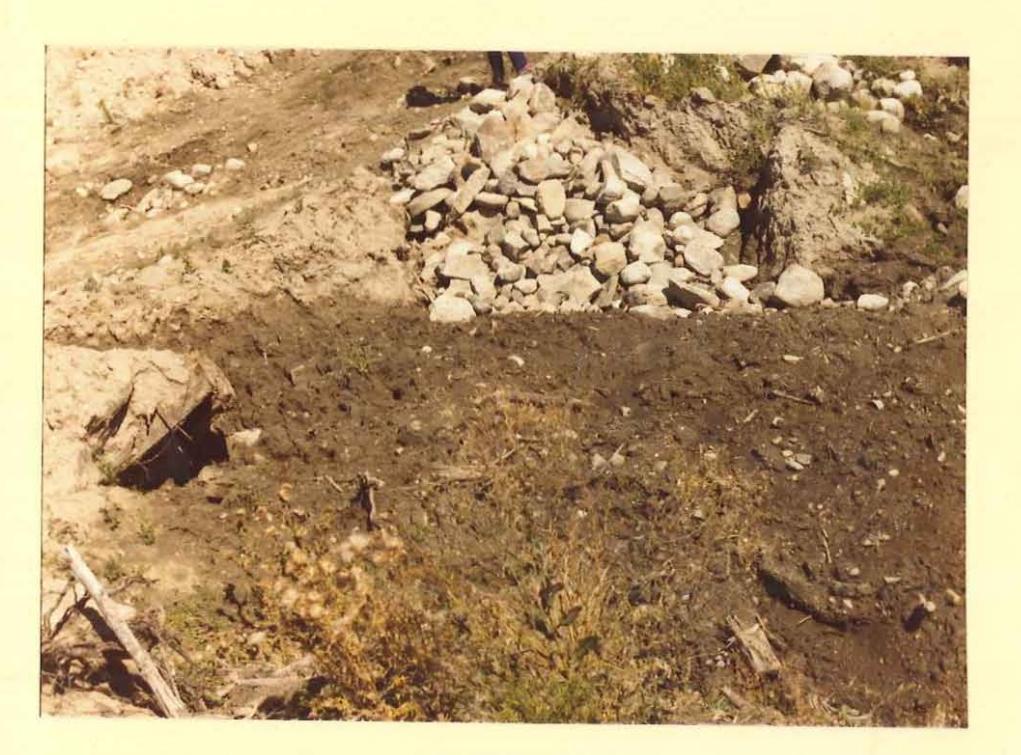
Sluff from left groin area.

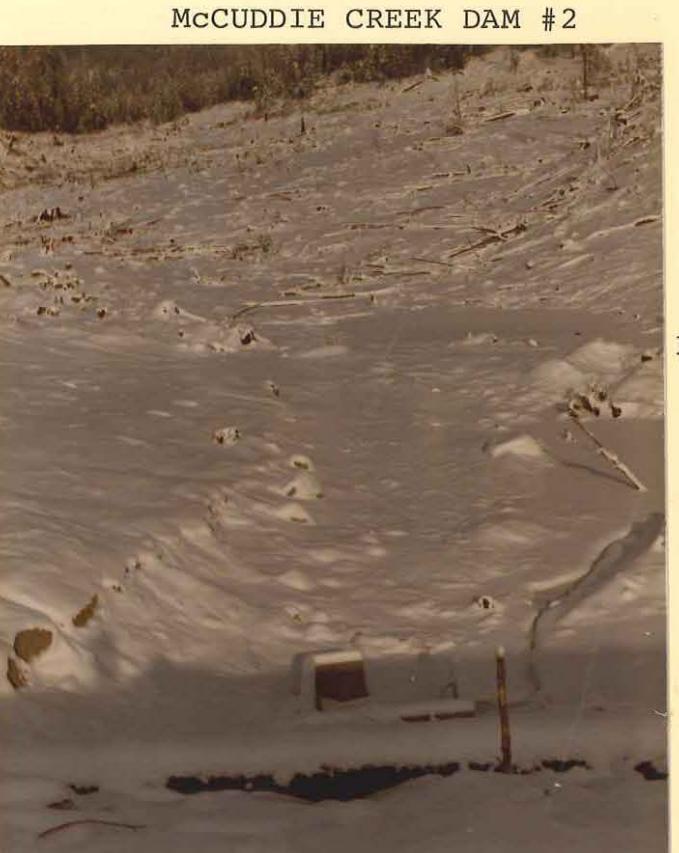
Crest and downstream face with considerable debris at left abutment contact.

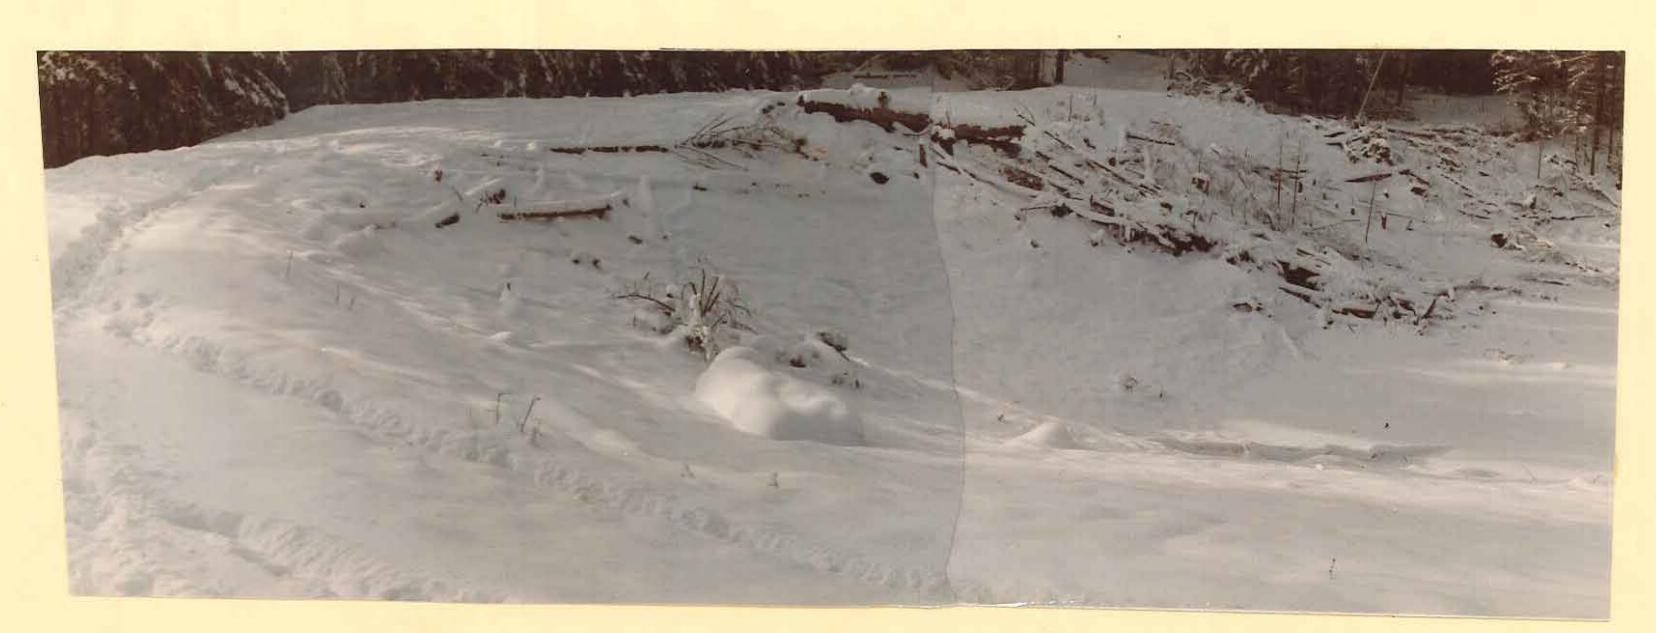
Upstream face of dam seen while walking into McCuddie Creek #2 Dam.

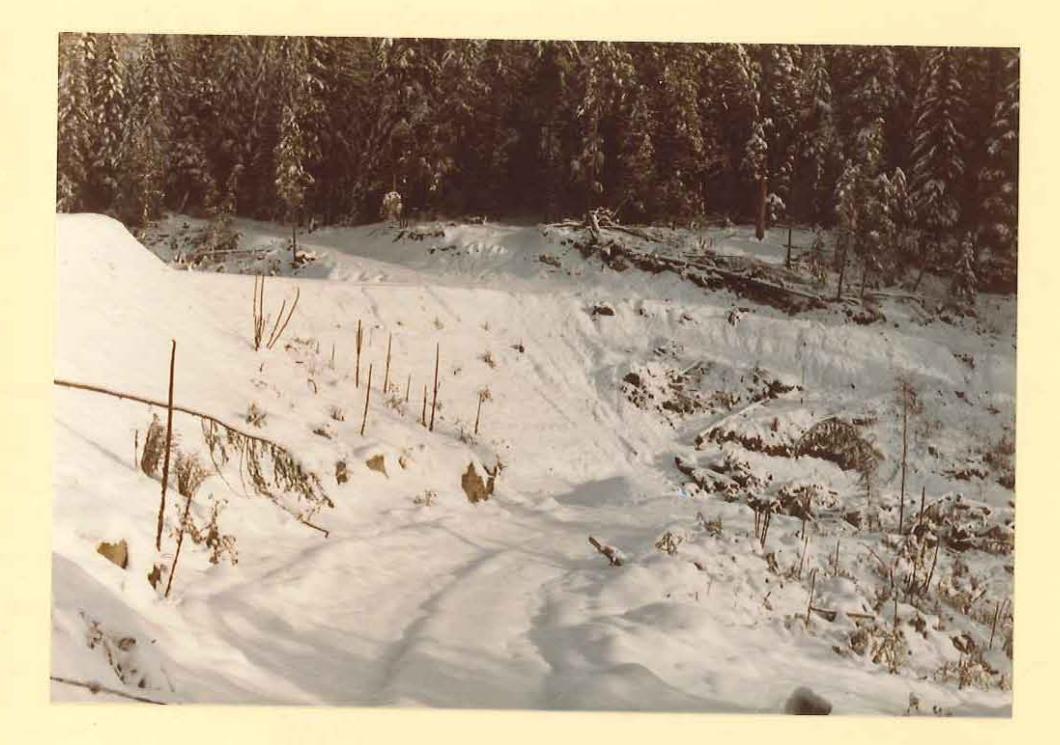
Left downstream abutment contact area.
