2012 INSPECTION COMPLIANCE FORM FOR OWNERS OF HIGH, VERY HIGH & EXTREME CONSEQUENCE DAMS

By Fax at: By email at:	250-952-6792 dam.safety@gov.bc.ca)52-6792 safety@gov.bc.ca		N, NL, WL, PG
MCCUDDY CREE	KRESERVOIR #2 SADDLE DAM	Is Contact N	ame and Address corr	ect?
KEVIN TULAK MCKINNEY RD W	ATER USERS COMMUNITY	YESNO_	Piease correct belo	w:
s.22		· .

Small earthfill saddle dam at north end of reservoir.

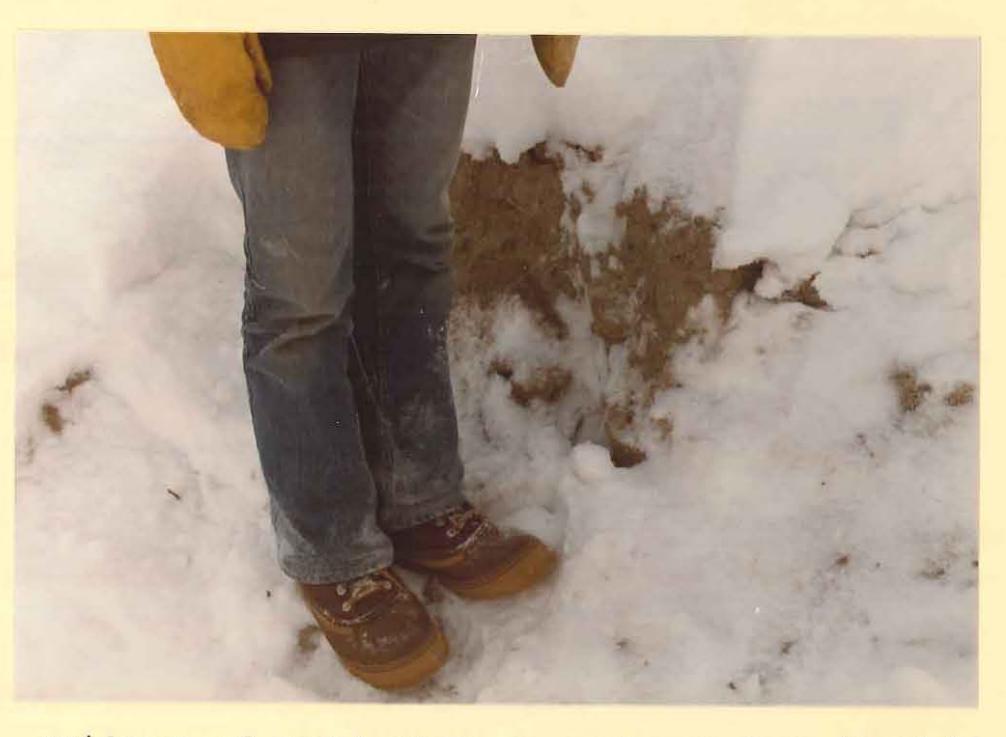
Evidence of small slump on upstream face in right abutment area probably occurring during drawdown.

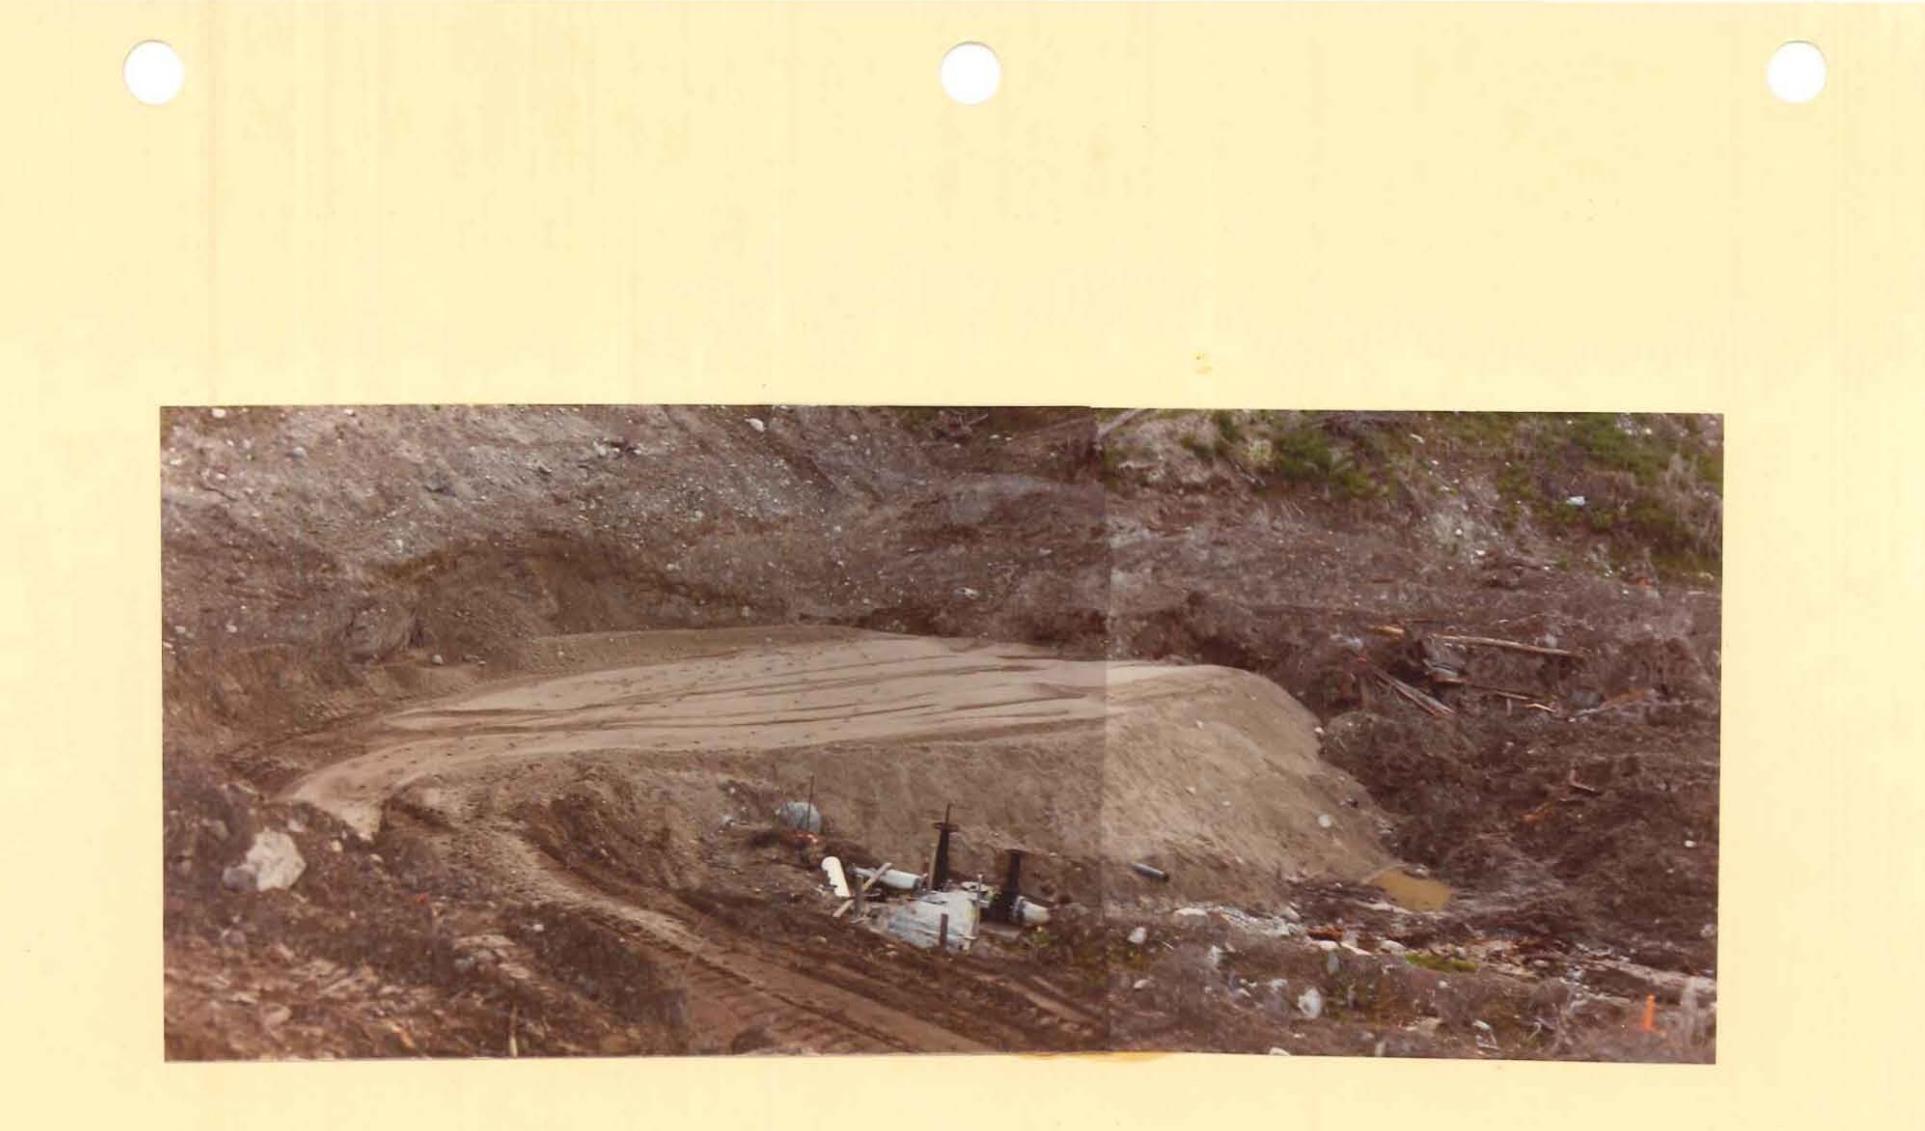
More deleterious materials exposed while stripping downstream toe area.

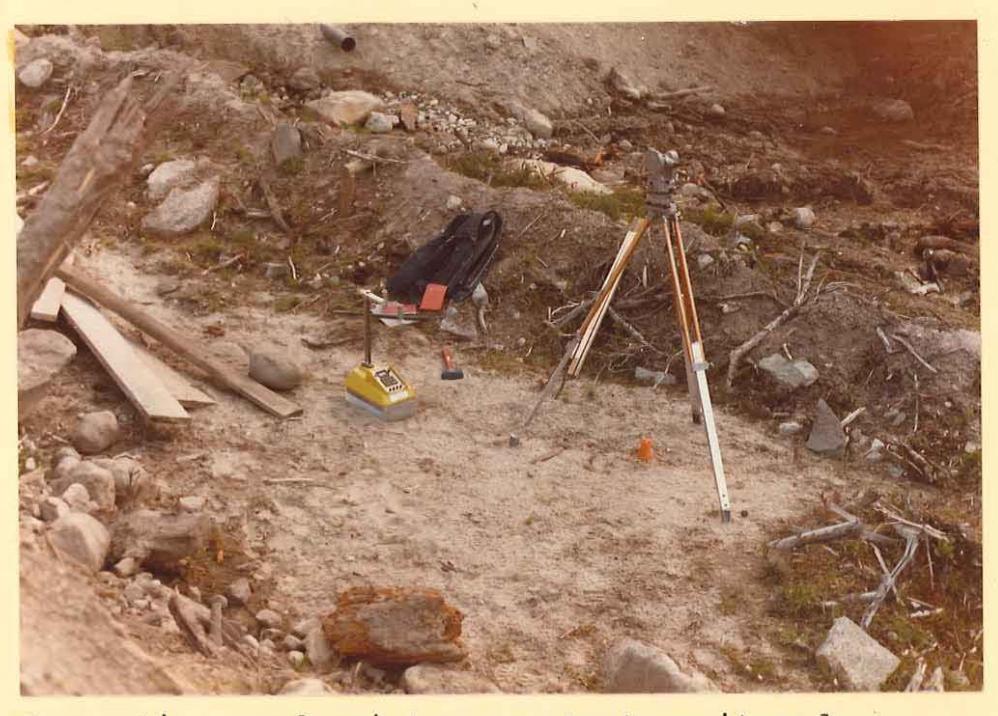
Heavy moisture content is reduced as drains function.

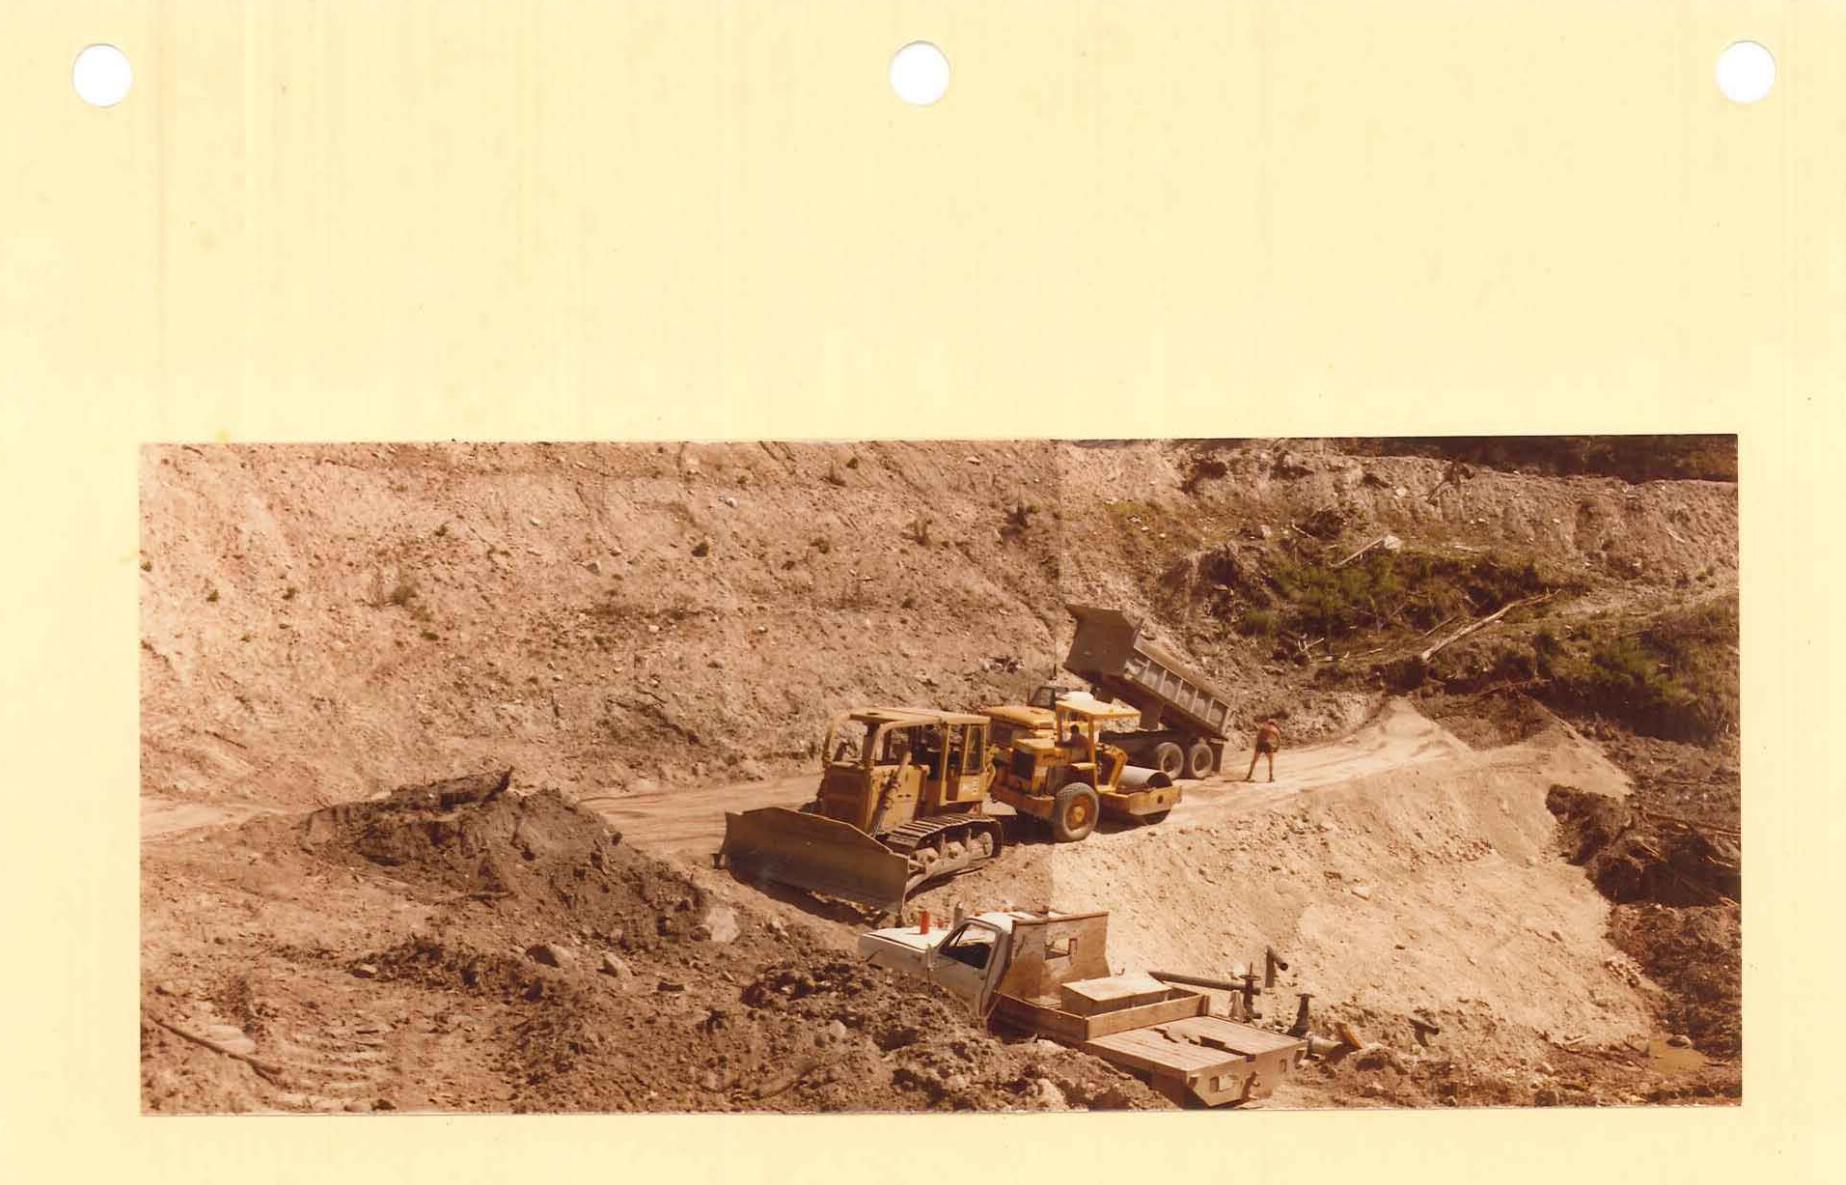
McCUDDY CREEK #2 Checking berm width. May, 1983

Compaction and moisture content monitored regularly.

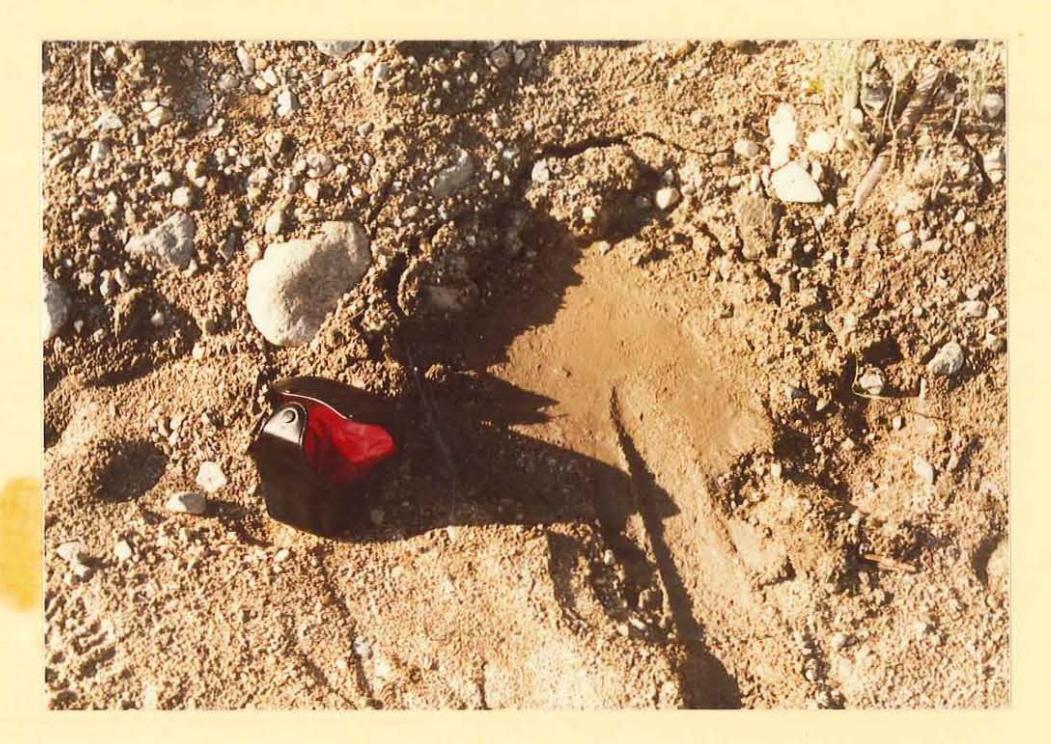
Soft spot located where top of berm meets downstream dam face.

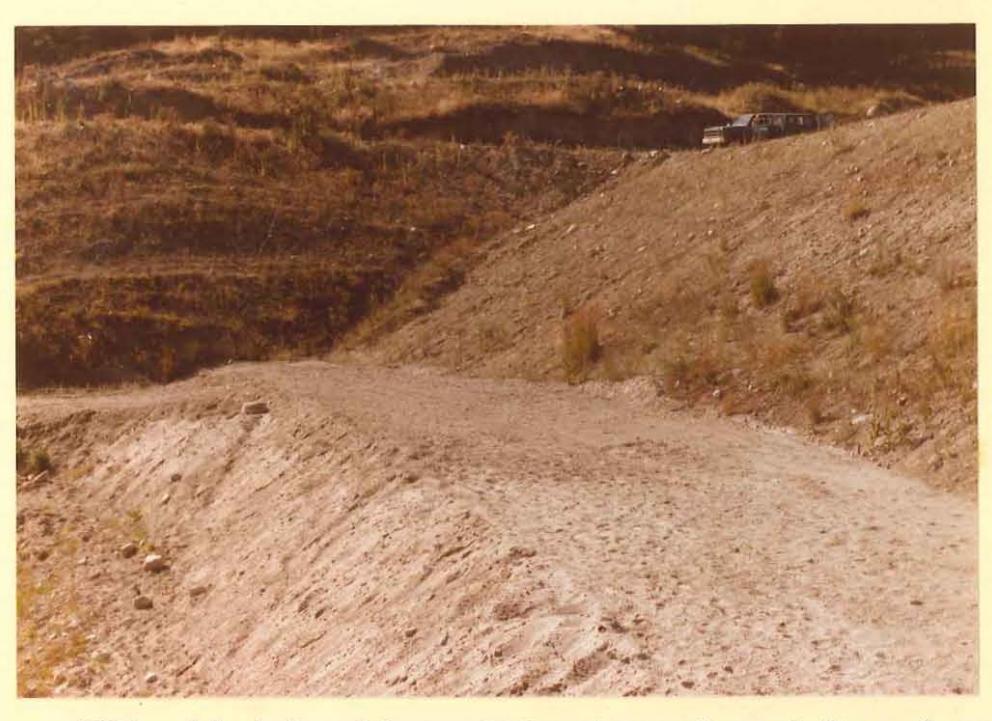
Filter blanket and berm at downstream dry and free of growth.

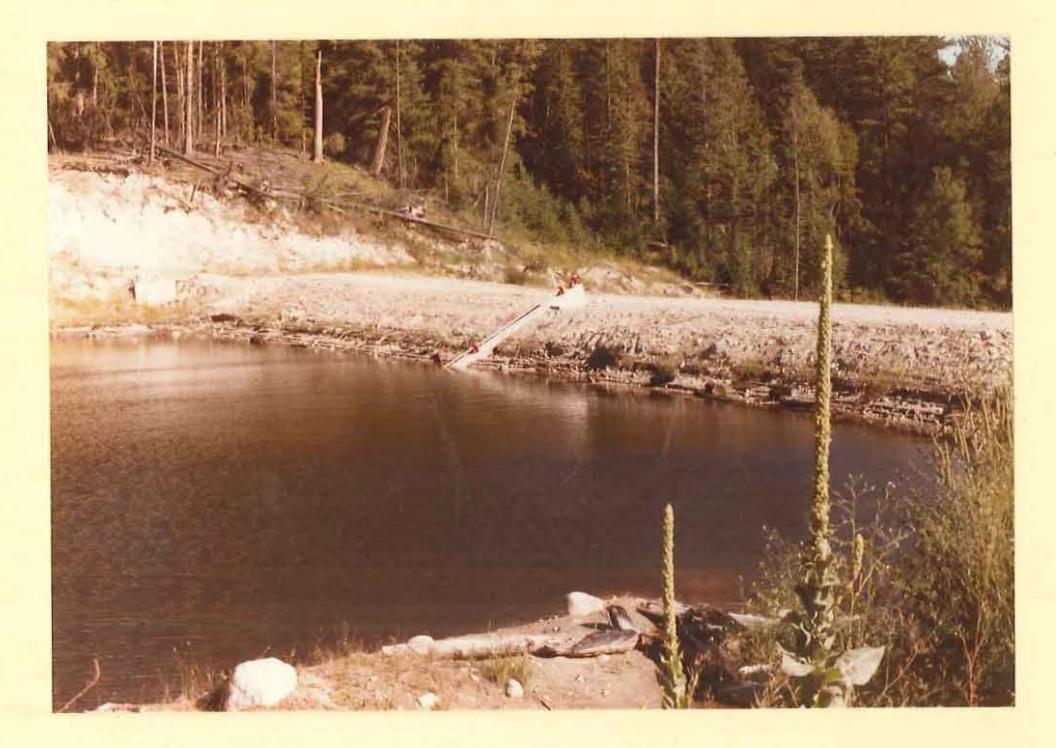
Minor ravelling on upstream face.

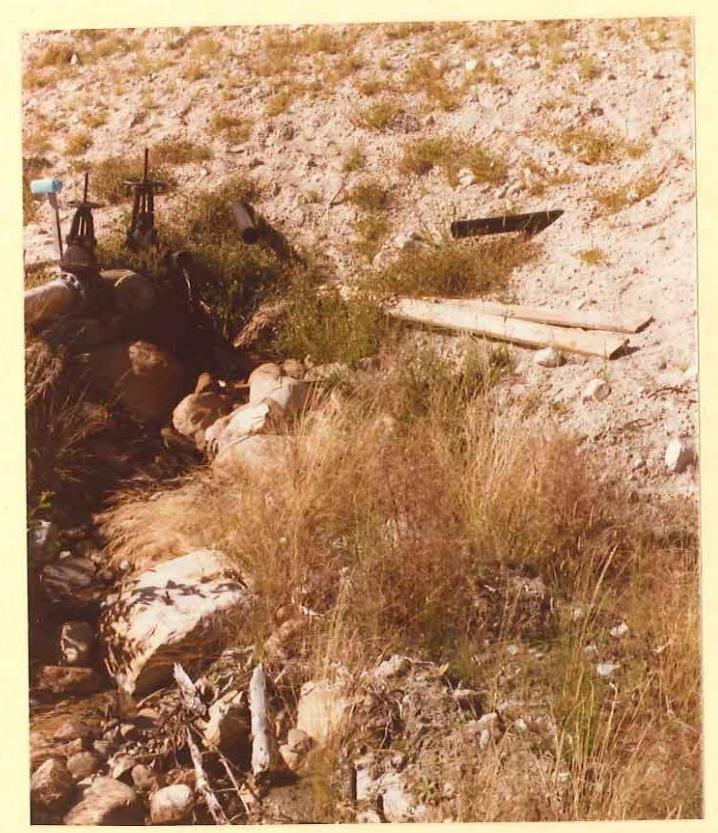
Pipe drains at downstream toe indicating minor flows.

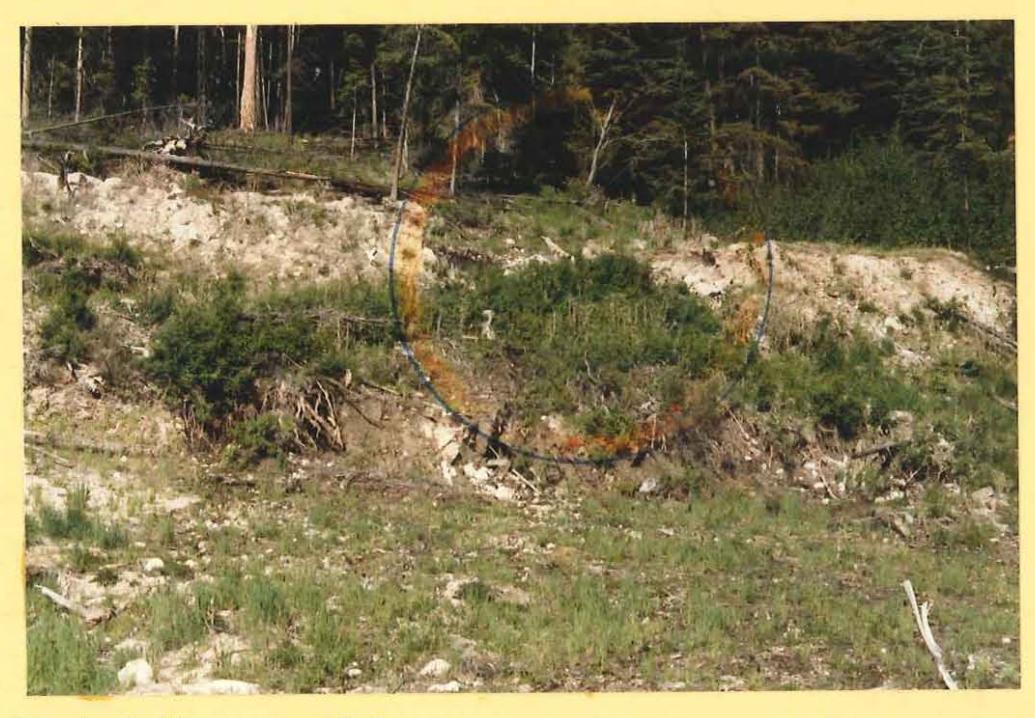
Spillway exit heavily eroded downstream of box culvert.

Circle indicates eroded area.

Spillway washout occurred last spring. Remedial repairs should be completed prior to next spring's freshet.

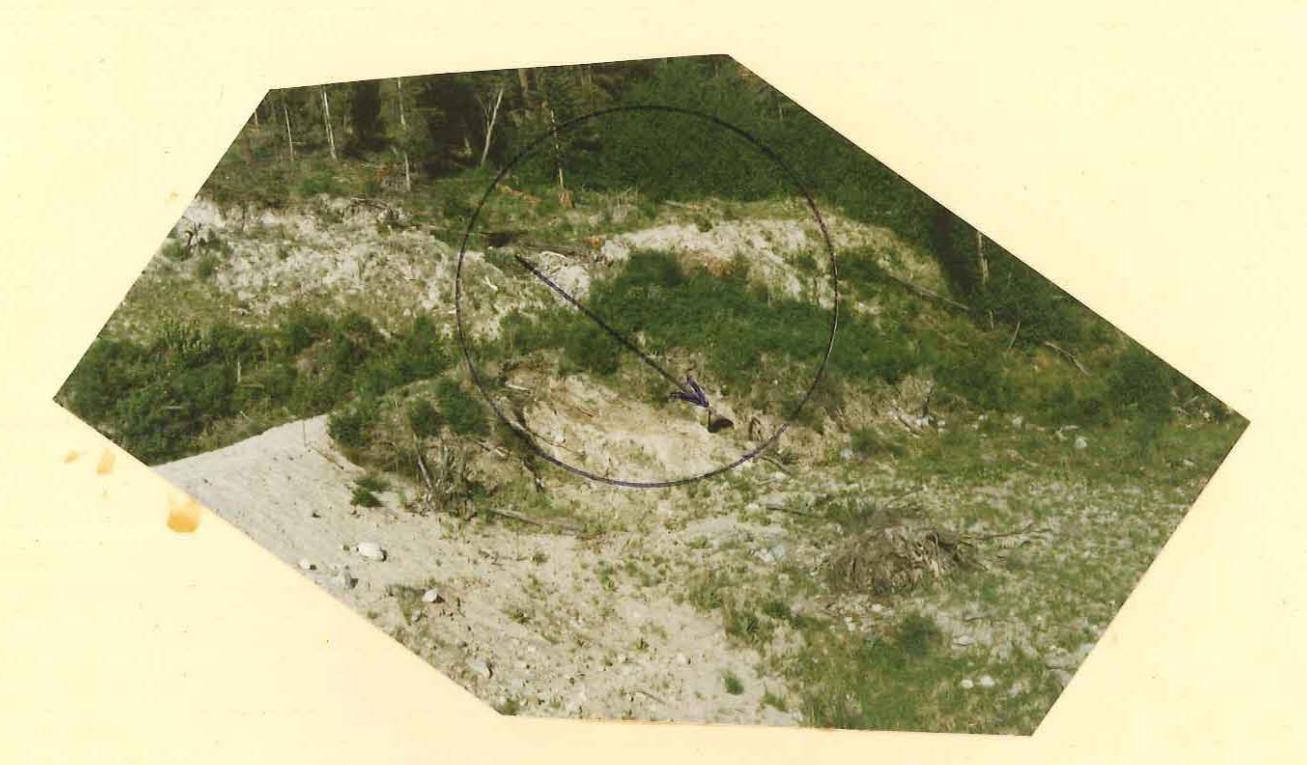
Spillway embankment still overtopped since 1985 season. Arrow indicates overcut channel route.

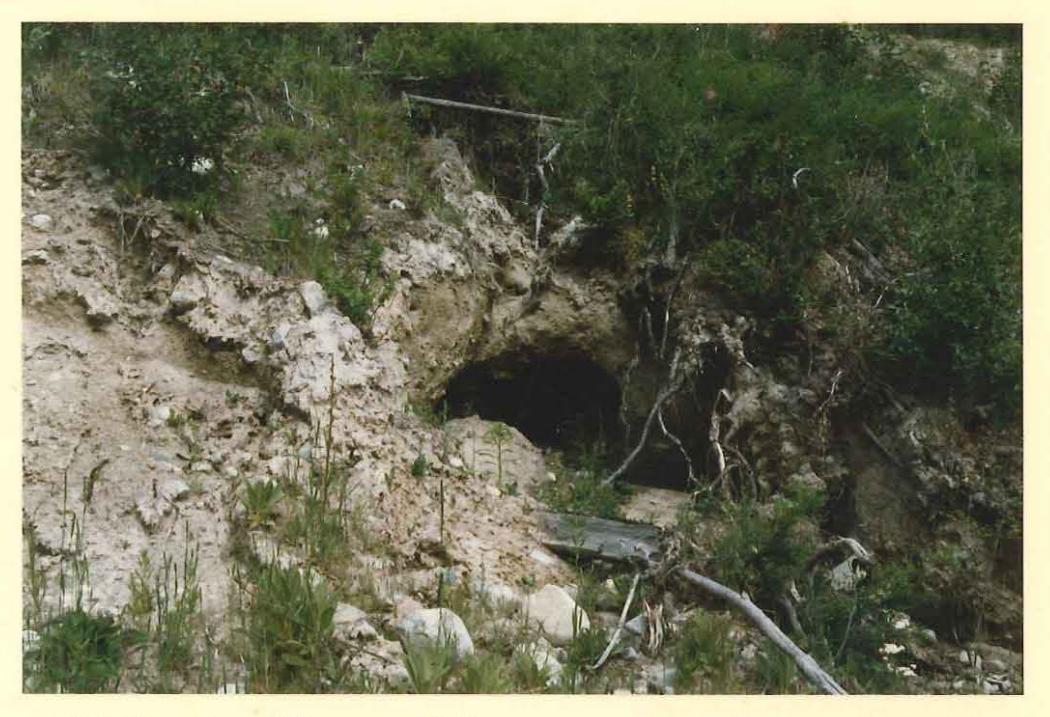
Erosion at spillway outlet.

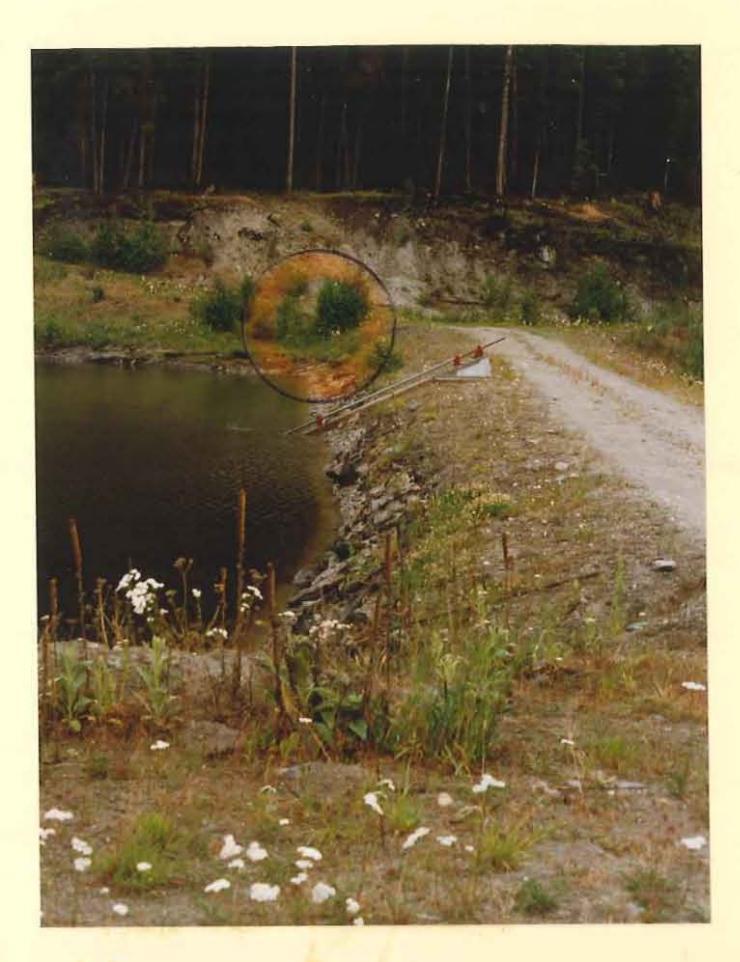
Growth in spillway entrance located on left abutment. Upstream gate open for irrigation.

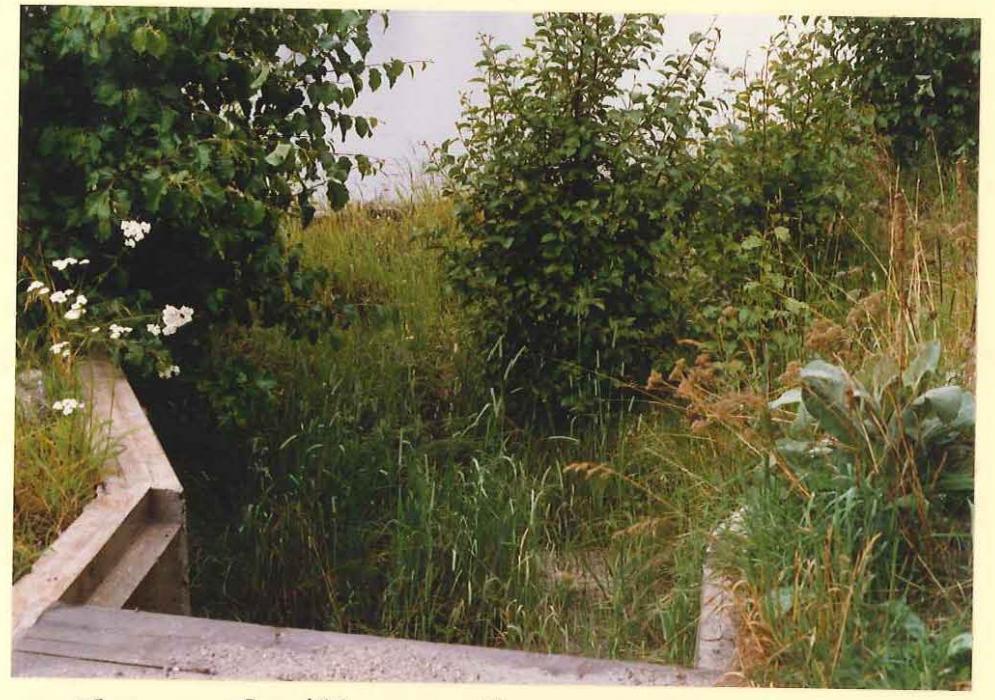
Close-up of spillway growth.

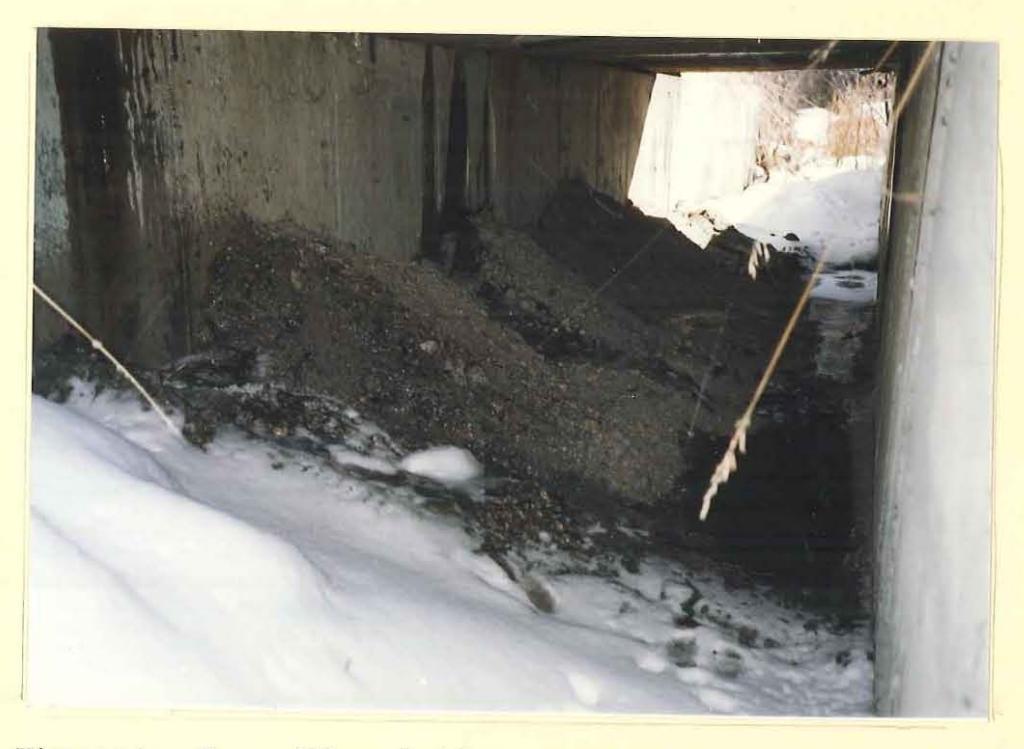
View under the spillway bridge. Note the large amount of sand and gravel that has accumulated in the spillway channel.

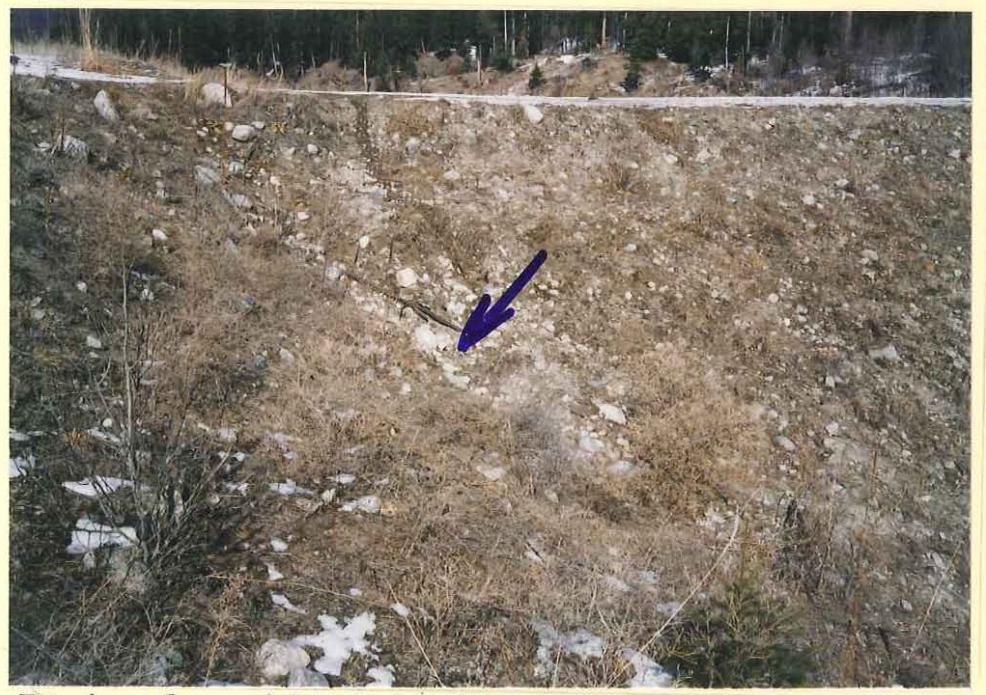
Erosion along right abutment groin area.

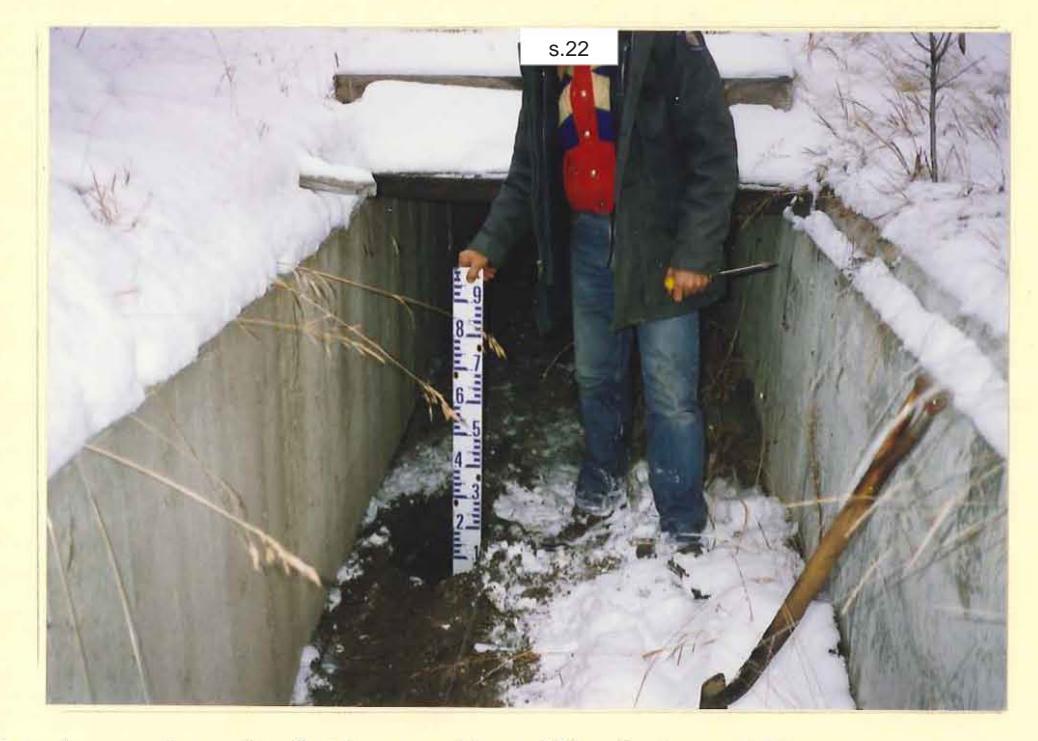
Sand and gravel accumulation on the sill of the spillway at the downstream end of the bridge is 0.15 m deep.

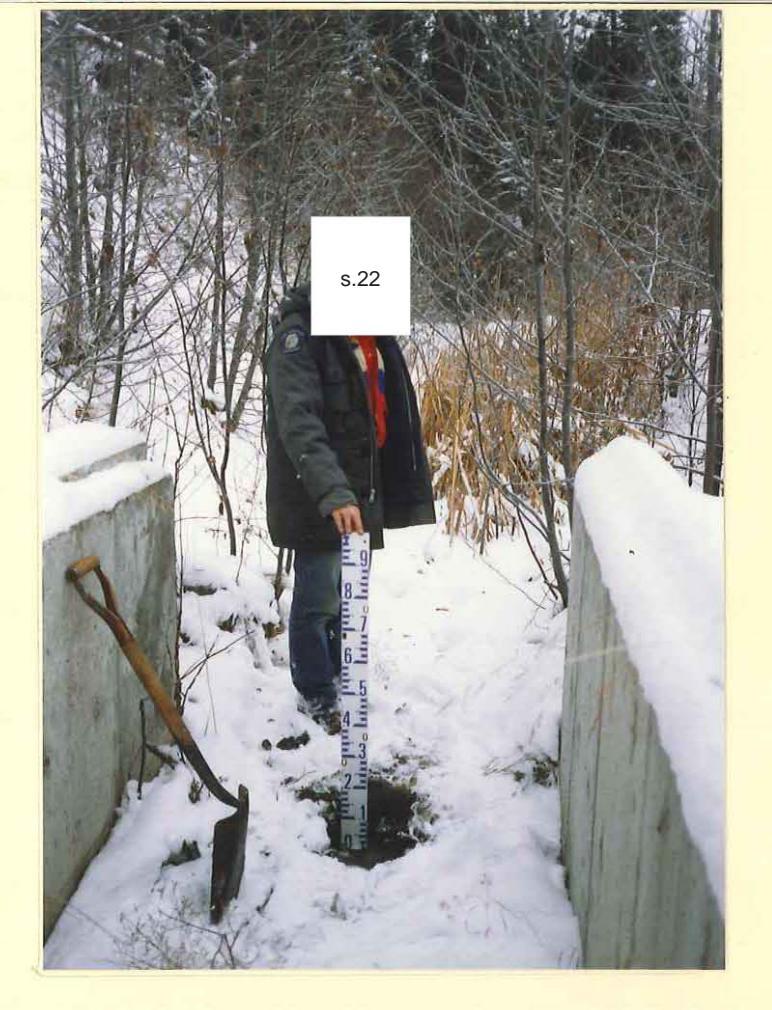
Sand and gravel accumulation on the sill of the spillway at the upstream end of the bridge is 0.20 m deep. The accumulation is about twice as deep on the left side.

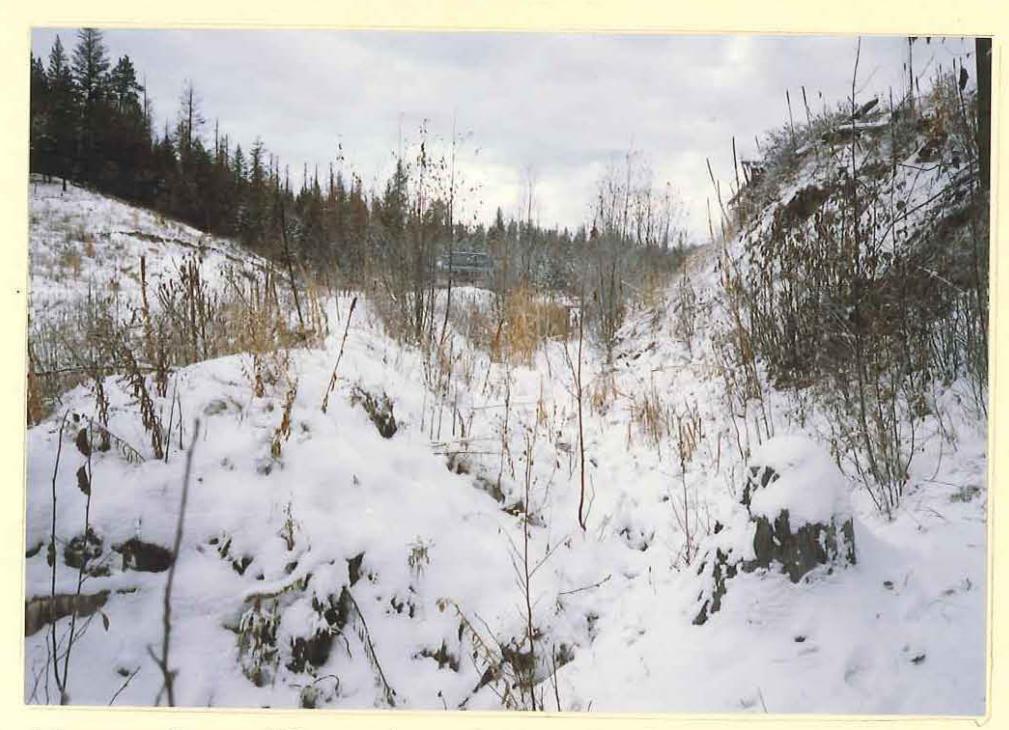
Sand and gravel accumulation on the downstream end of the sill of the spillway is 0.10 m deep.

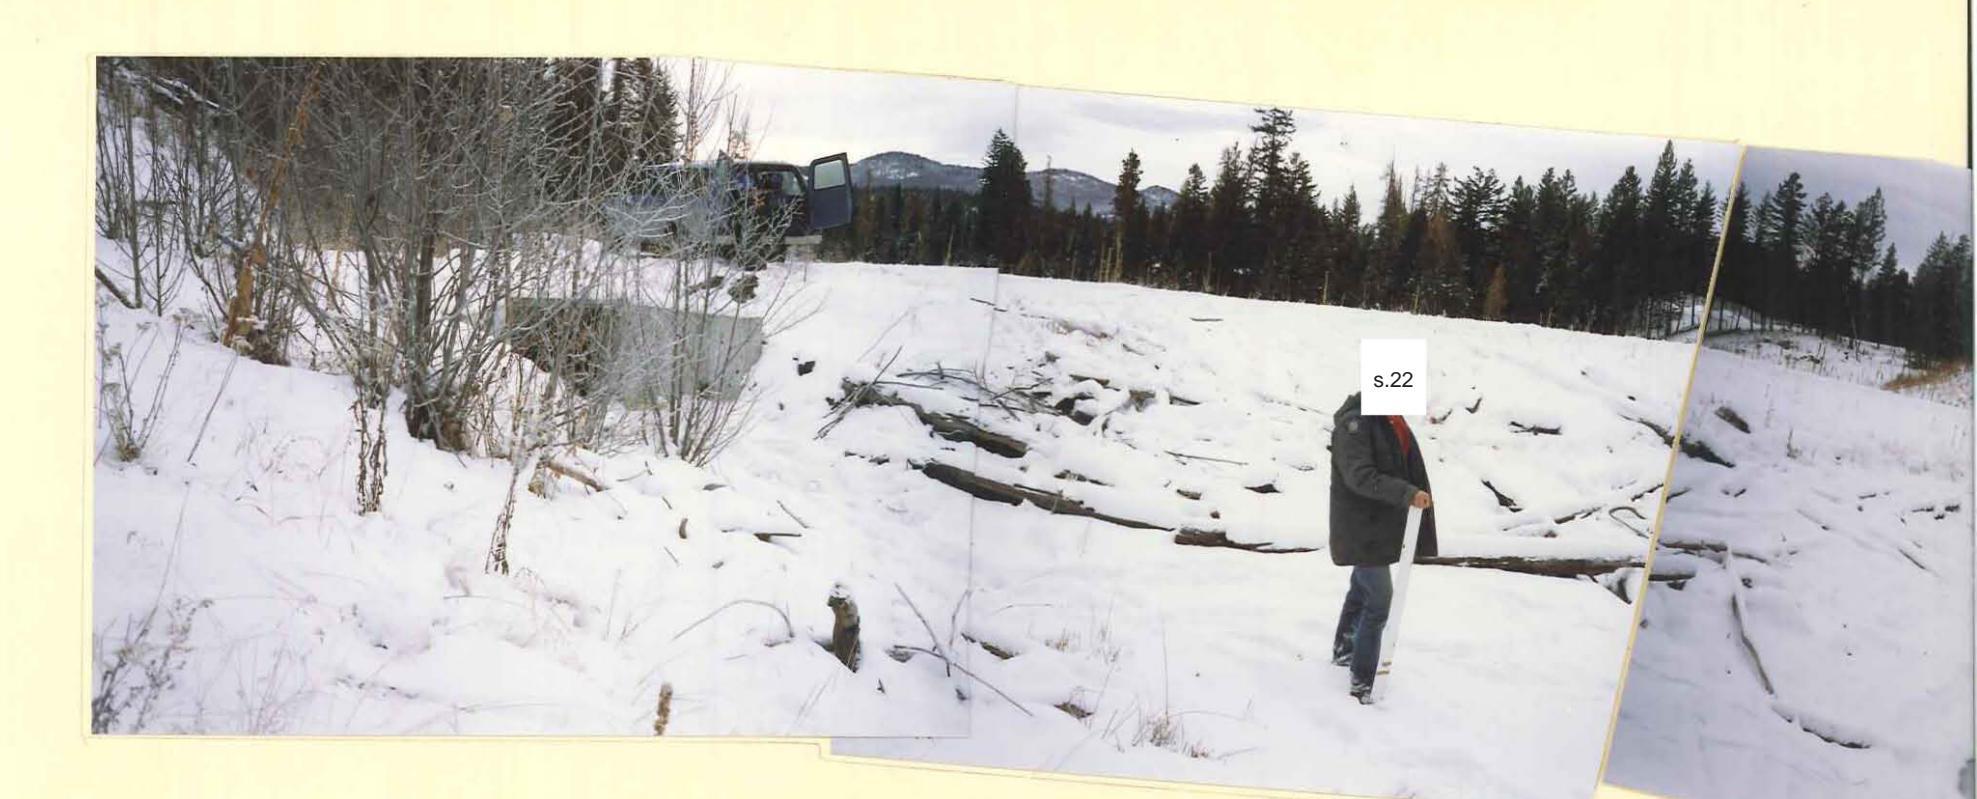
View looking up the spillway channel towards the reservoir. The bushes in the channel should be removed to allow unrestricted spillway flow. Mc Cuddy Creek Dam #2

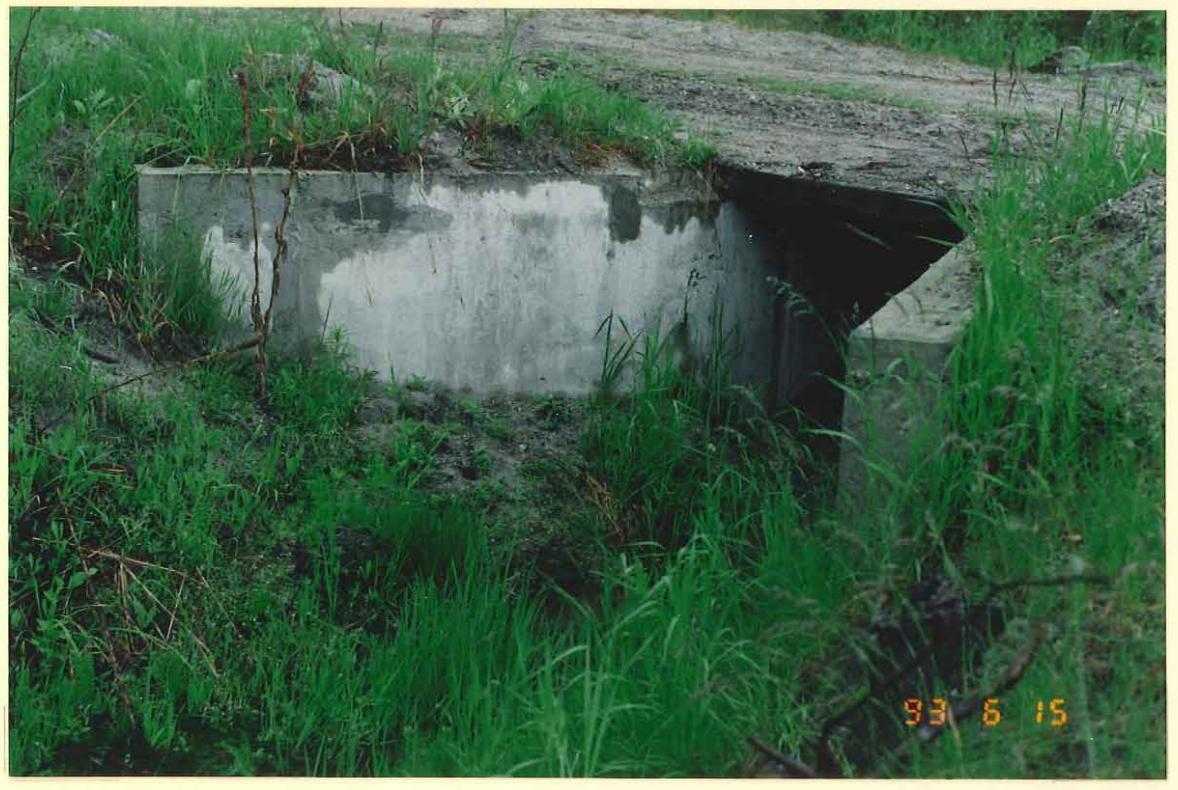
View of partially blaked spillway channel entrance.

There is a large amount of floating debris at the high water level near the spillway entrance. This debris should be removed from the reservoir so that it won't block the spillway during high flow conditions. A log boom should be constructed across the entrance to keep debris away from the spillway.

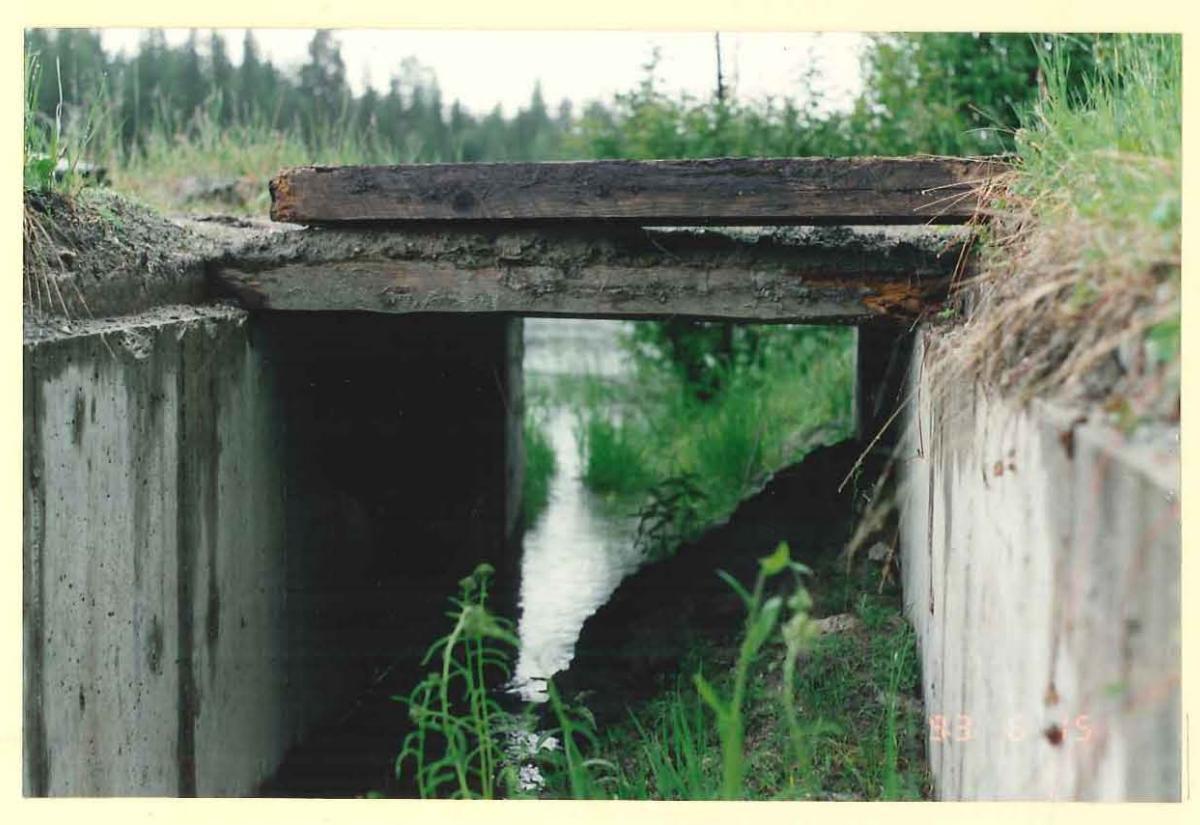
View upstream of partially blocked spillway channel.

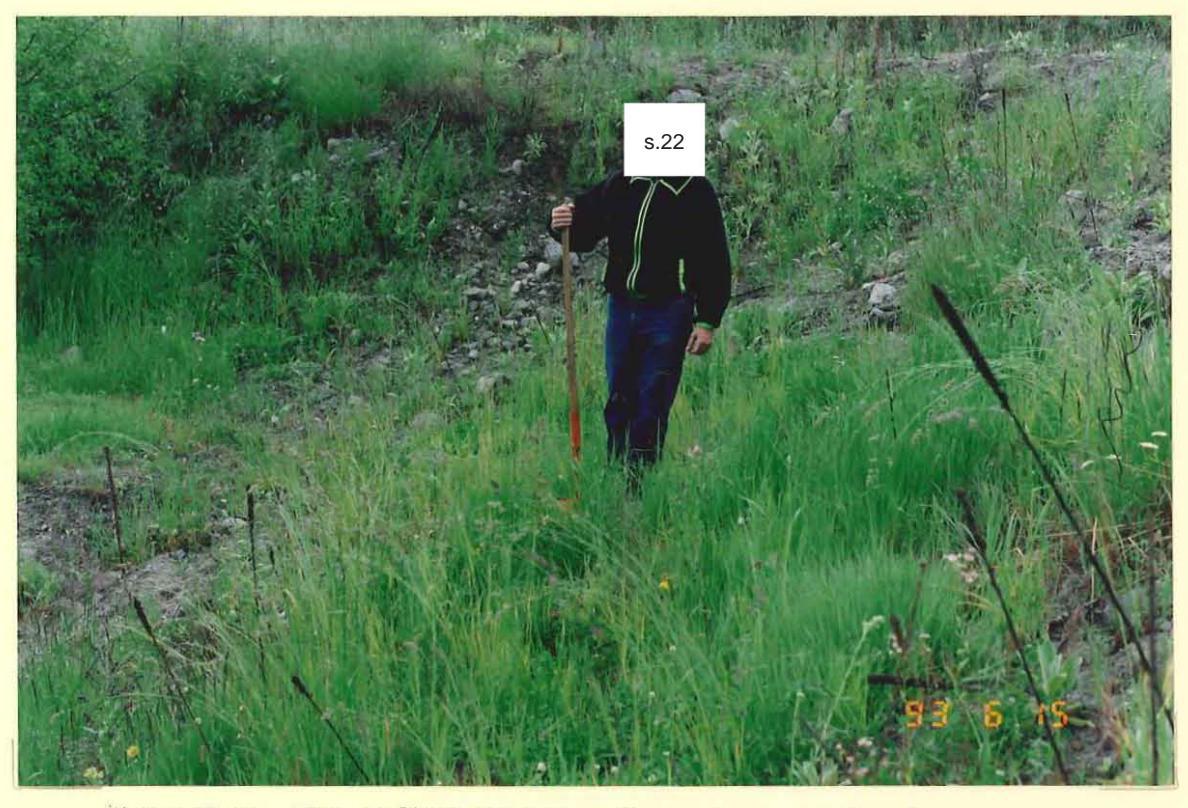
Steve Rowe, Dam Safety Officer, Penticton, indicating location of wet area on downstream slope of toe berm.

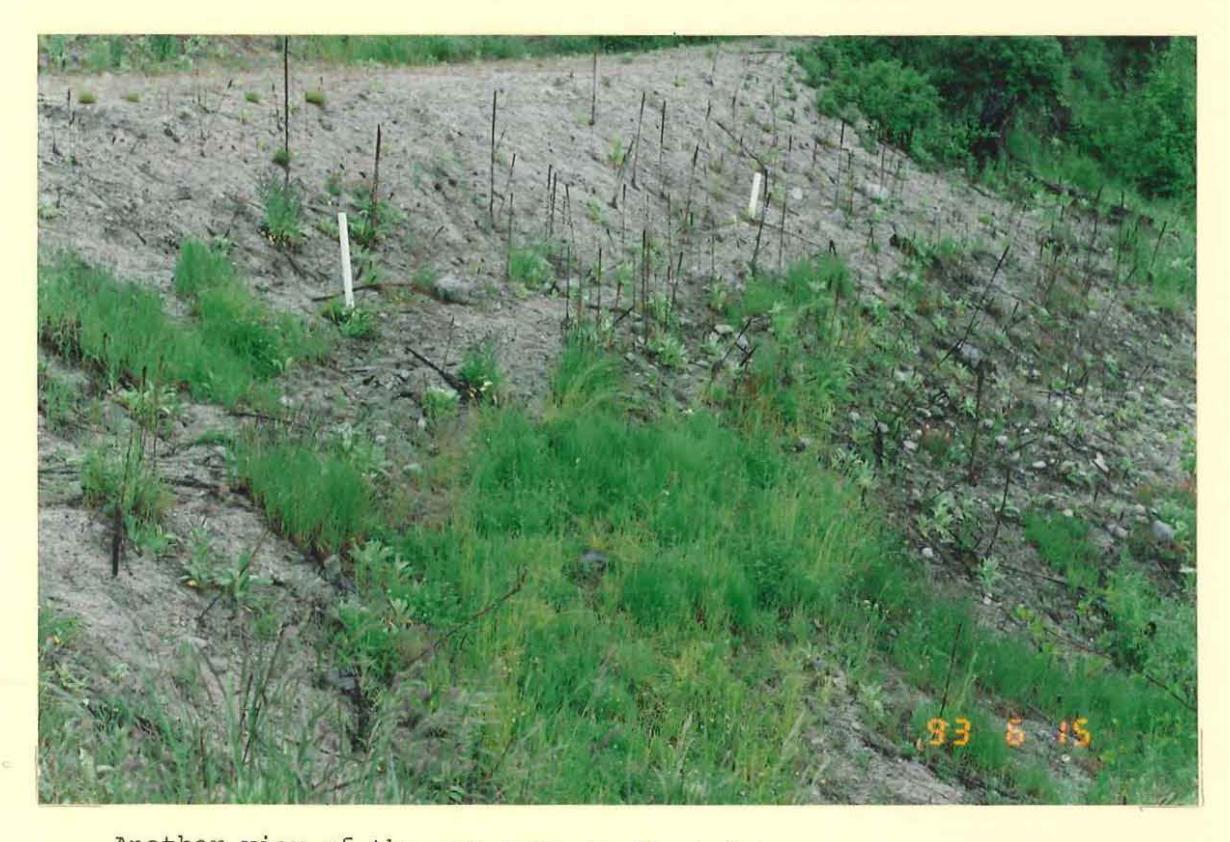
Another view of the wet area (indicated by the vegetation) on the downstream slope of the toe berm. Page 18
