2012 INSPECTION COMPLIANCE FORM FOR OWNERS OF HIGH, VERY HIGH & EXTREME CONSEQUENCE DAMS

By Fax at: By email at:	250-952-6792 dam.safety@gov.bc.ca)52-6792 safety@gov.bc.ca		N, NL, WL, PG
MCCUDDY CREE	KRESERVOIR #2 SADDLE DAM	Is Contact N	ame and Address corr	ect?
KEVIN TULAK MCKINNEY RD W	ATER USERS COMMUNITY	YESNO_	Piease correct belo	w:
s.22		· .

Small earthfill saddle dam at north end of reservoir.

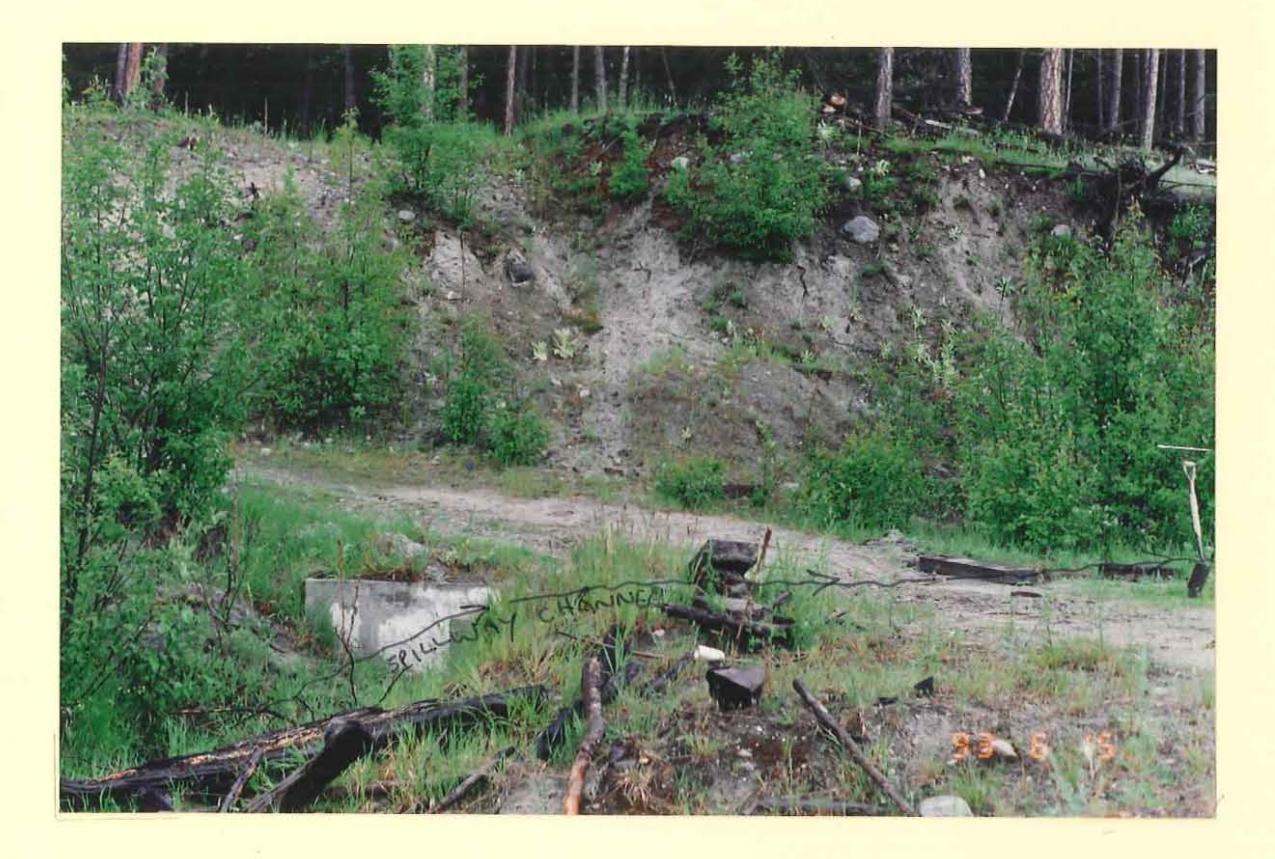
View of sloughing side hill above the spillway channel (along left abutment)

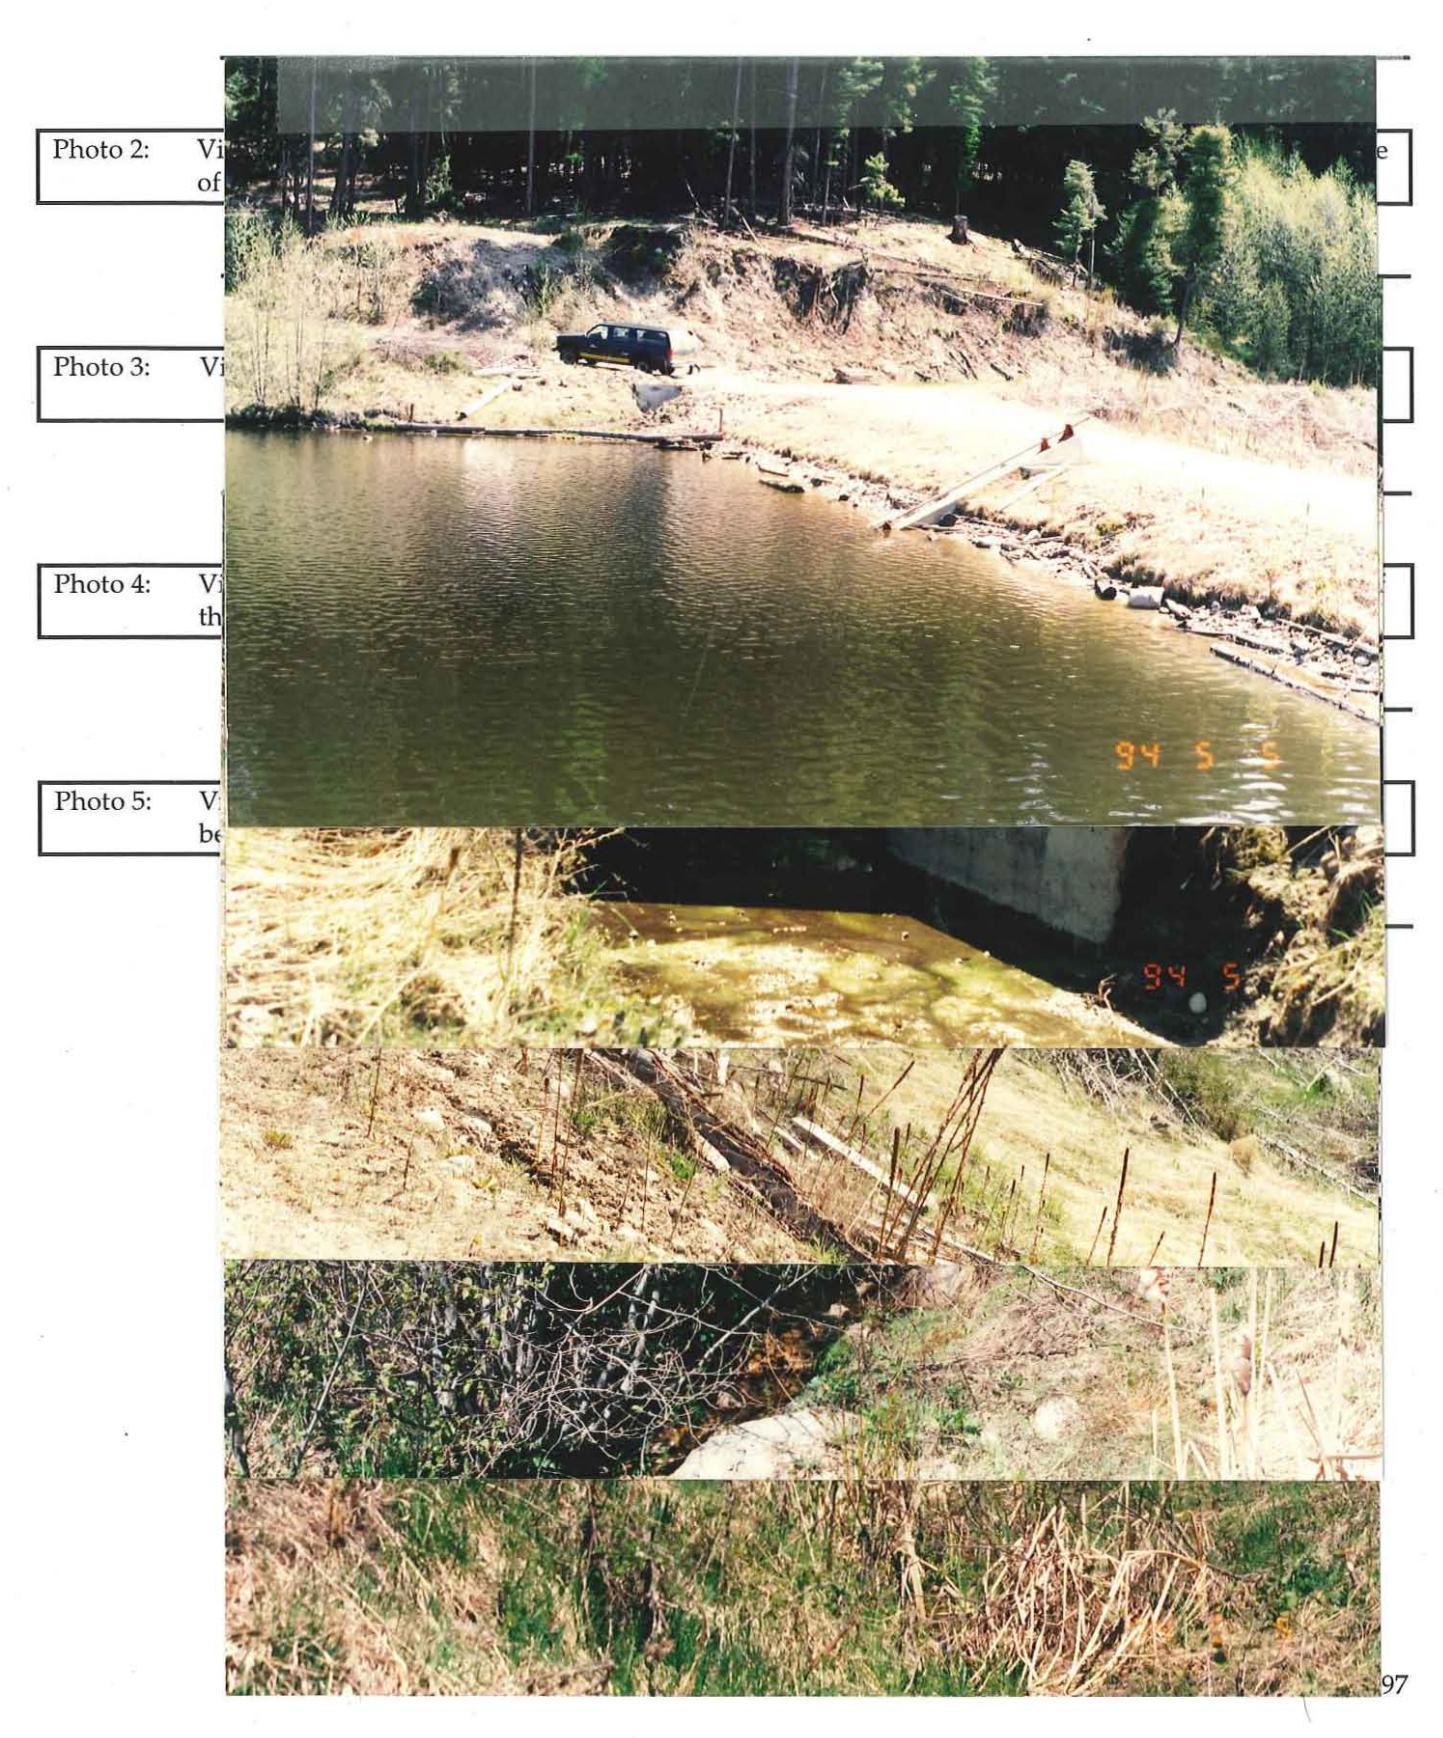
Photo 1: View of the crest and the upstream face looking towards the spillway entrance.

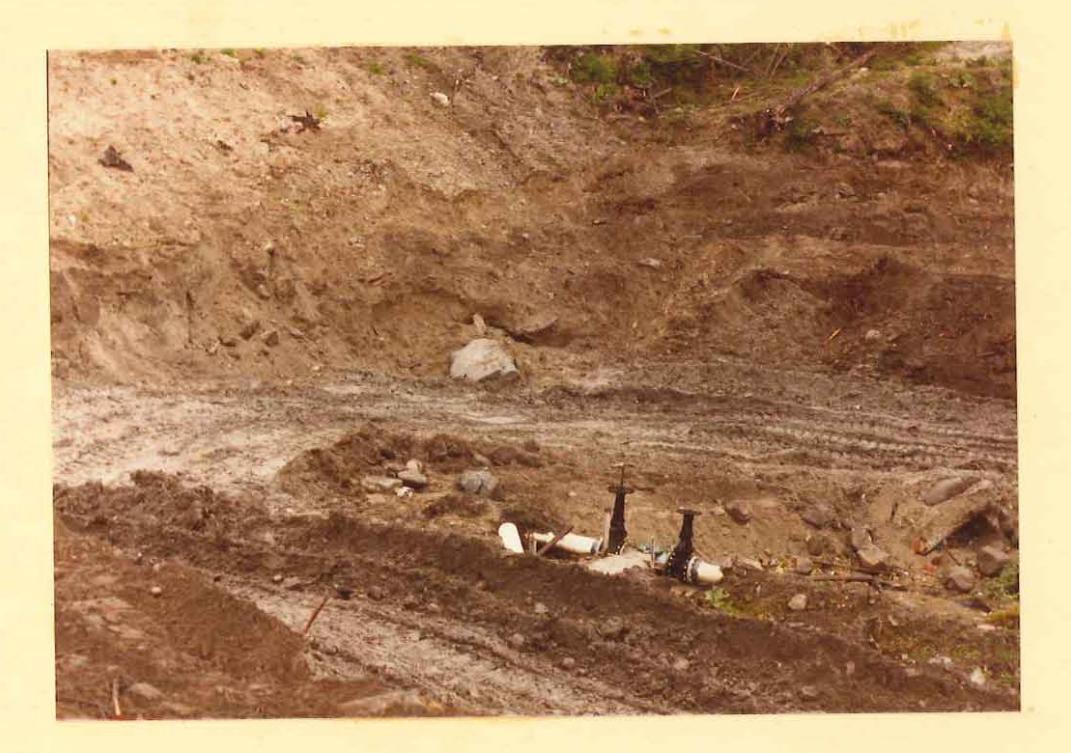
Initial stripping of saturated downstream toe area.

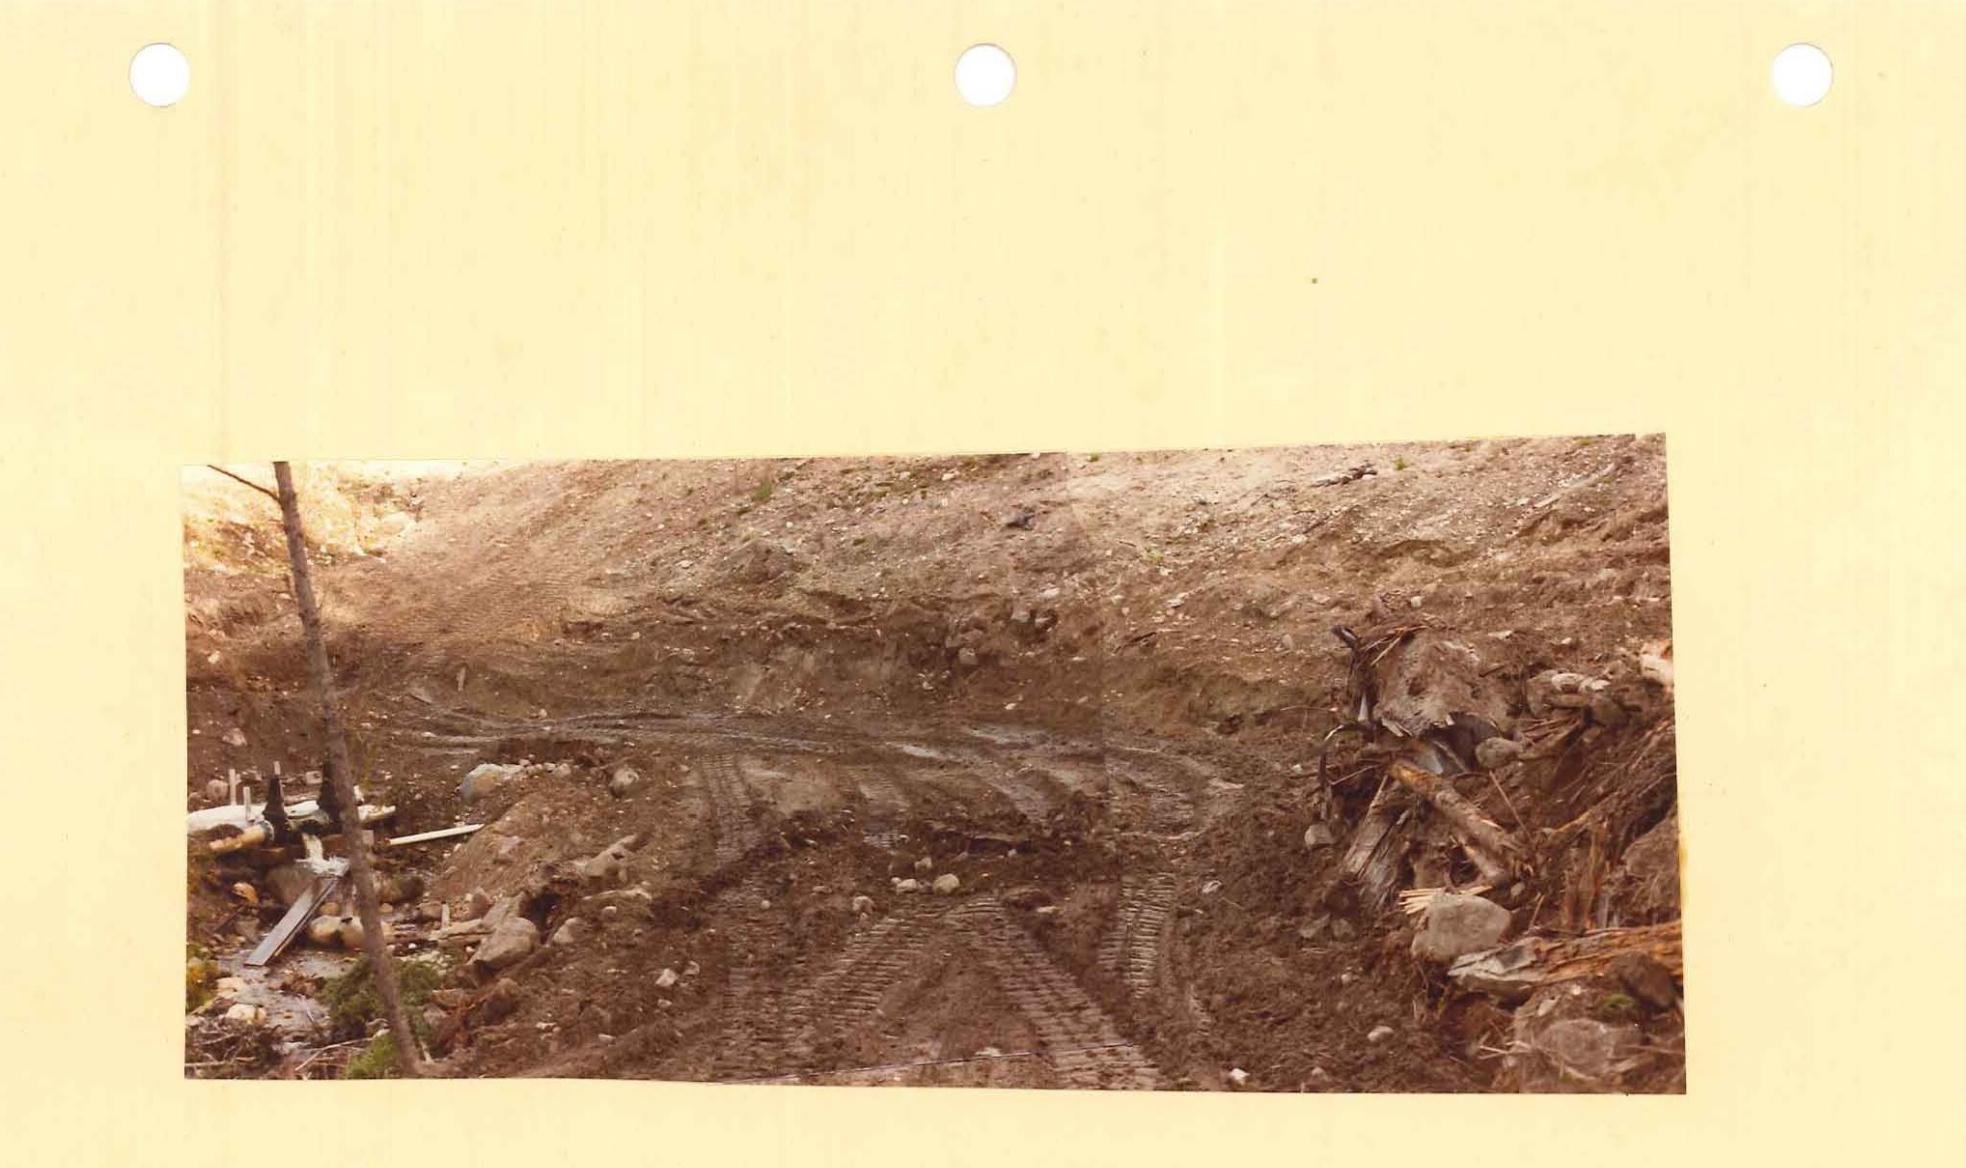
Totally saturated with exception of right abutment contact.

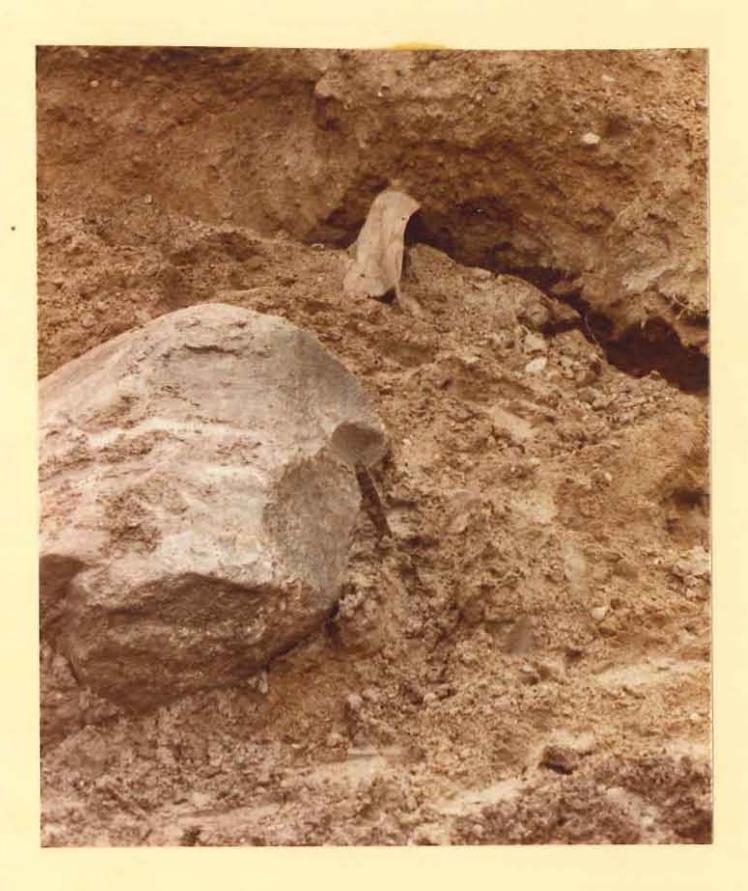
Large boulder in fill on left abutment. Also, filter cloth is located above the seepage path.

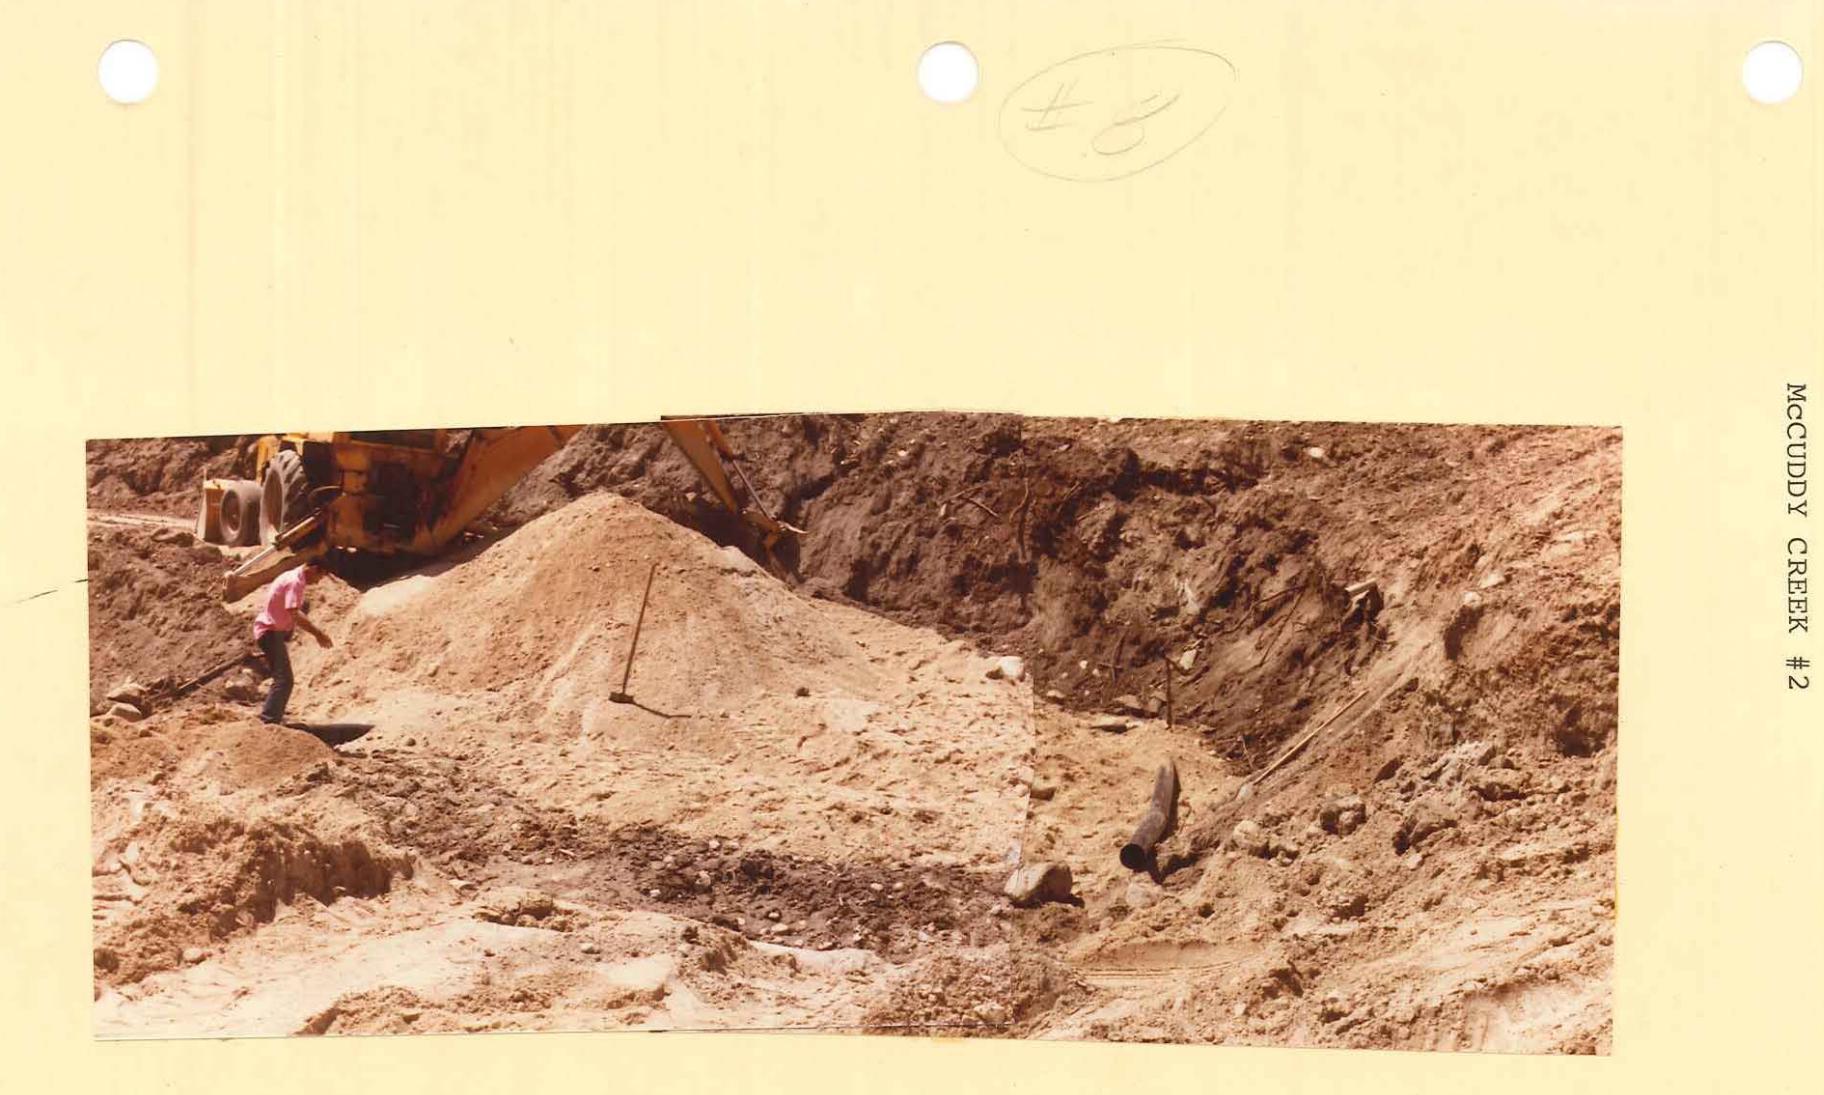
Stabilizing saturated base with coarse granular filter material.

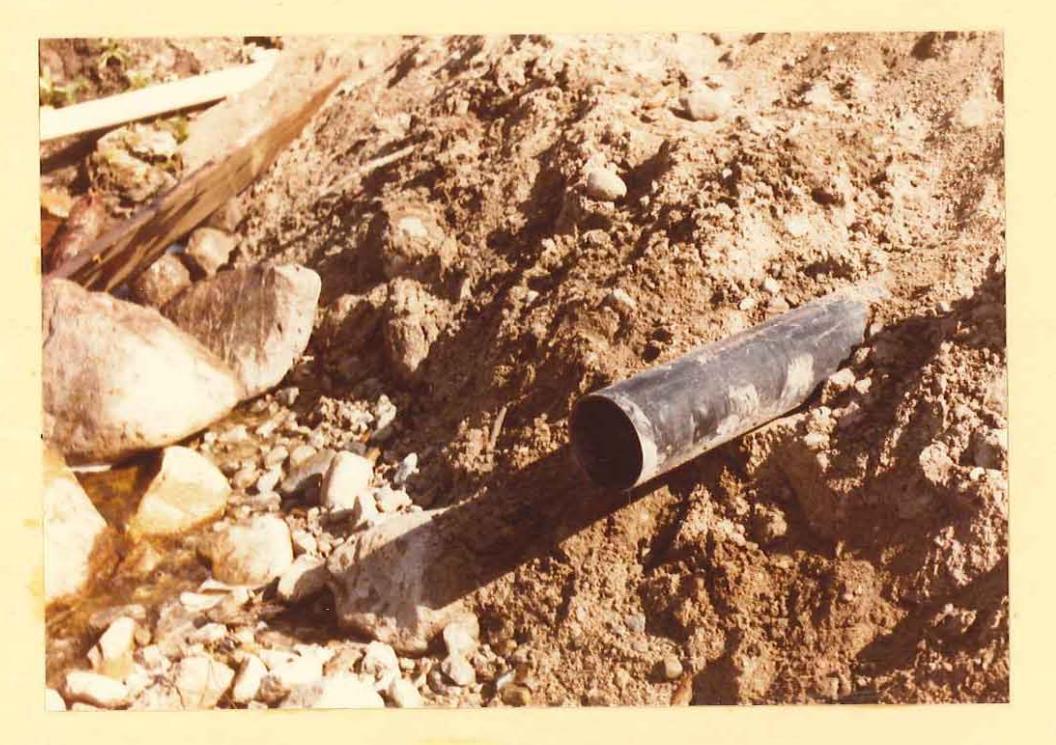
Center drain functioning with a minimal flow.

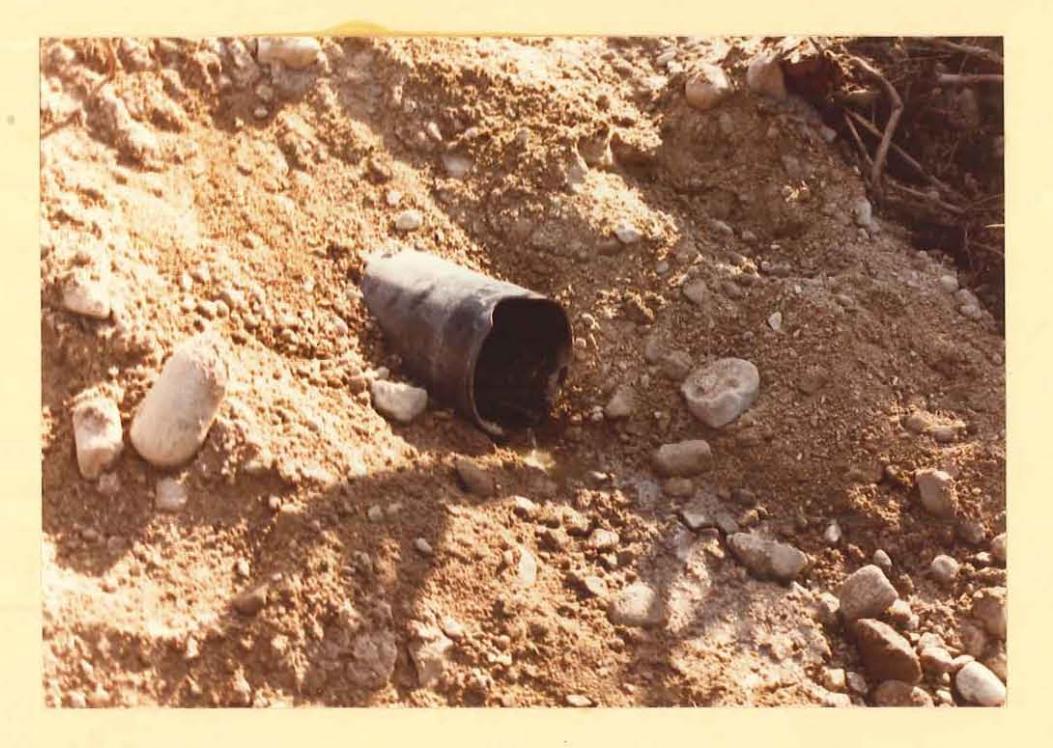
Left toe drain functioning on completion.

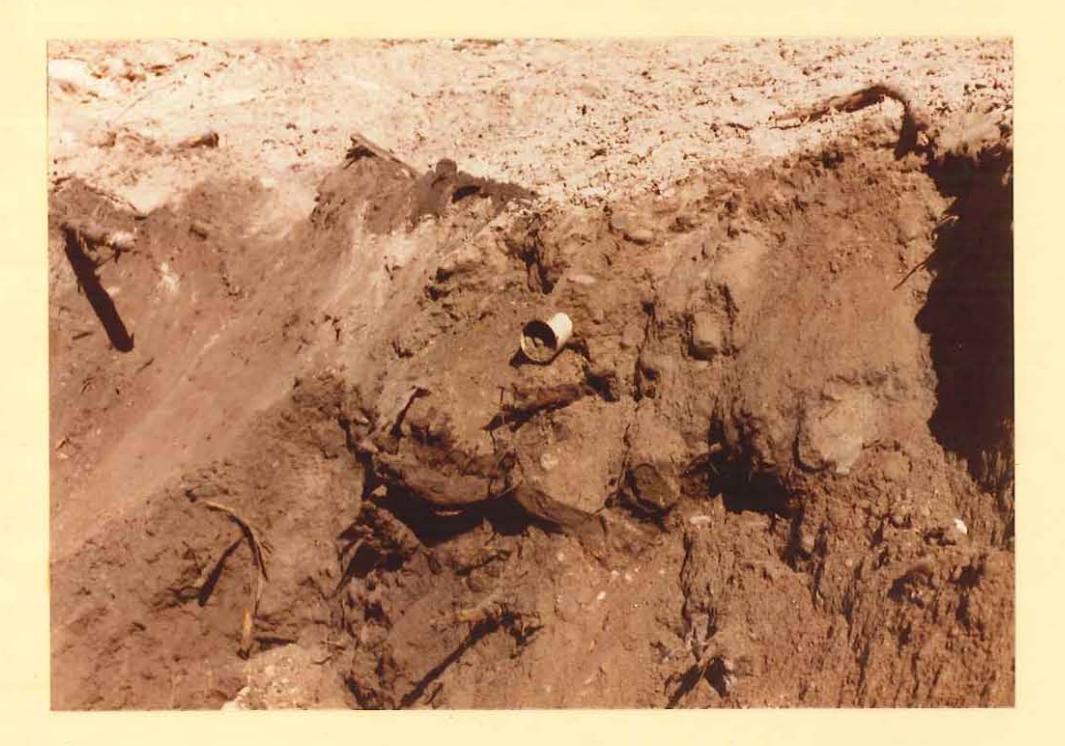
Existing perforated toe drain in place with rocks and roots exposed beneath.

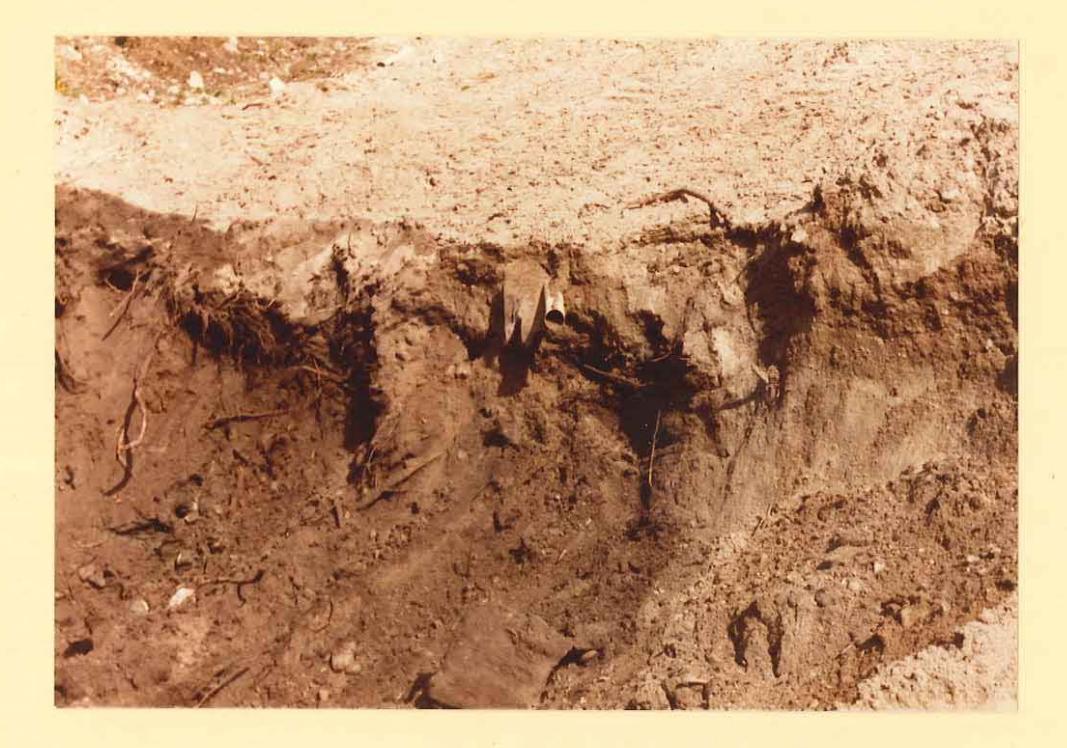
Existing groin area drain with filter clothe exposed (right side).

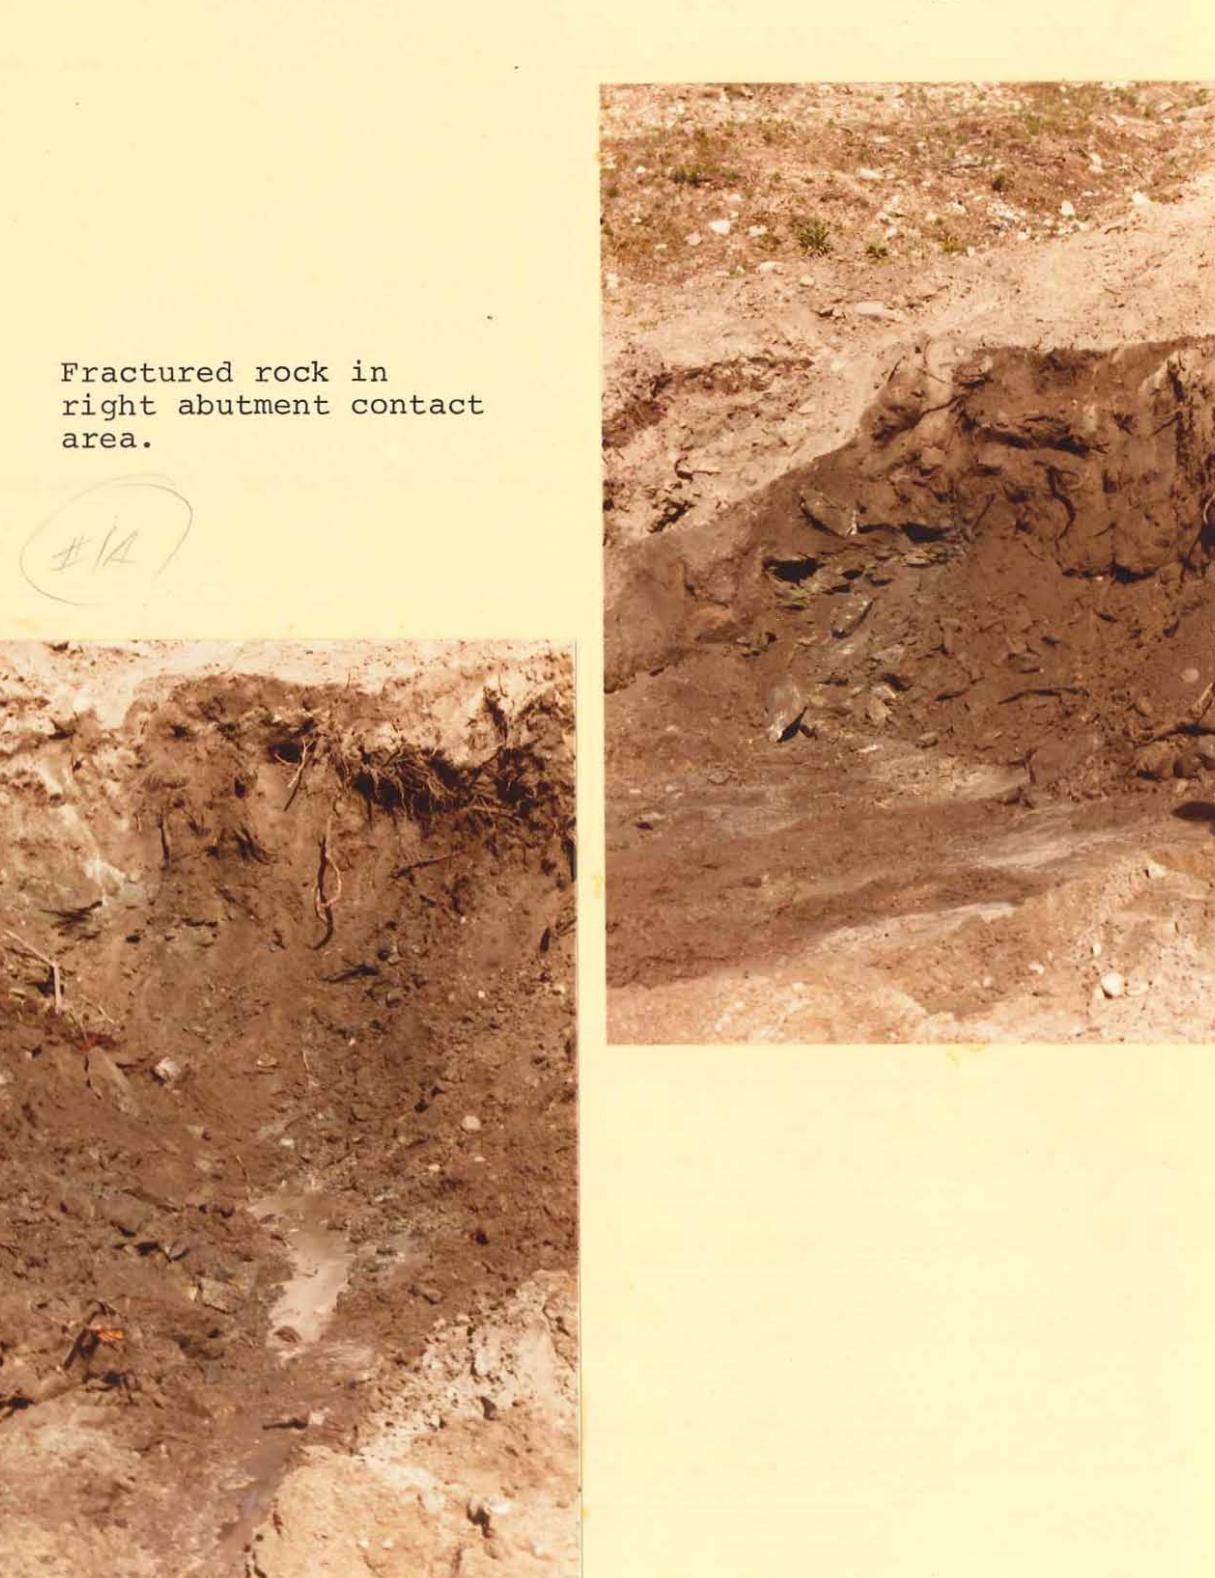
Embankment seepage evident after a few scoops.

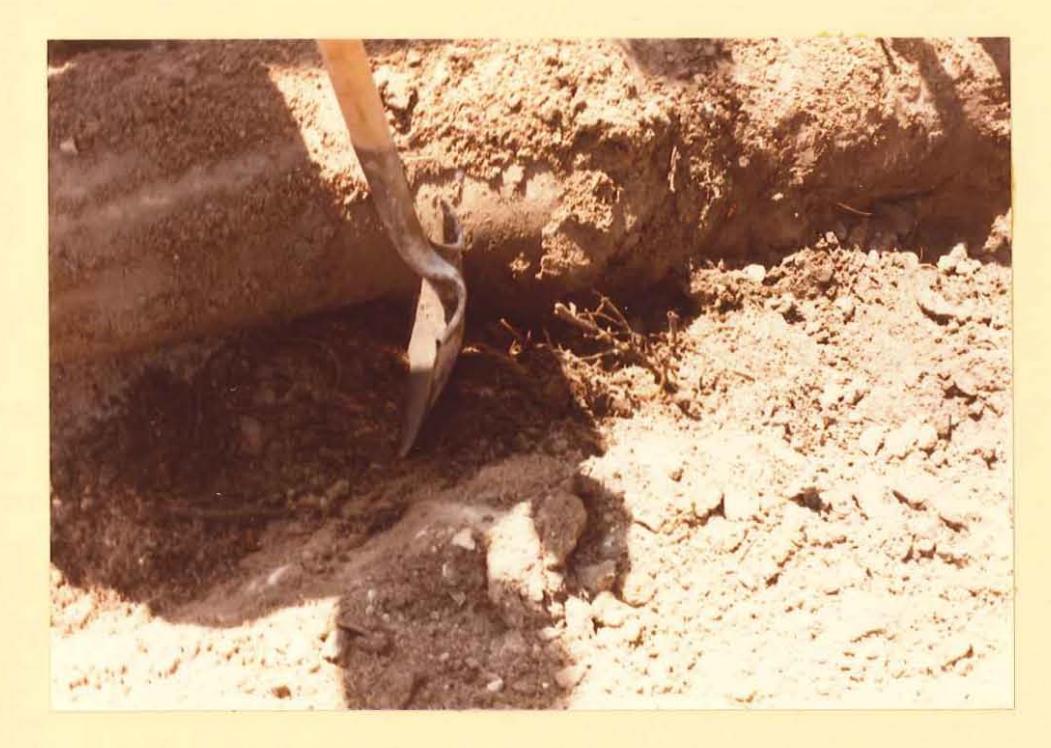
Branches and sticks in bedding.

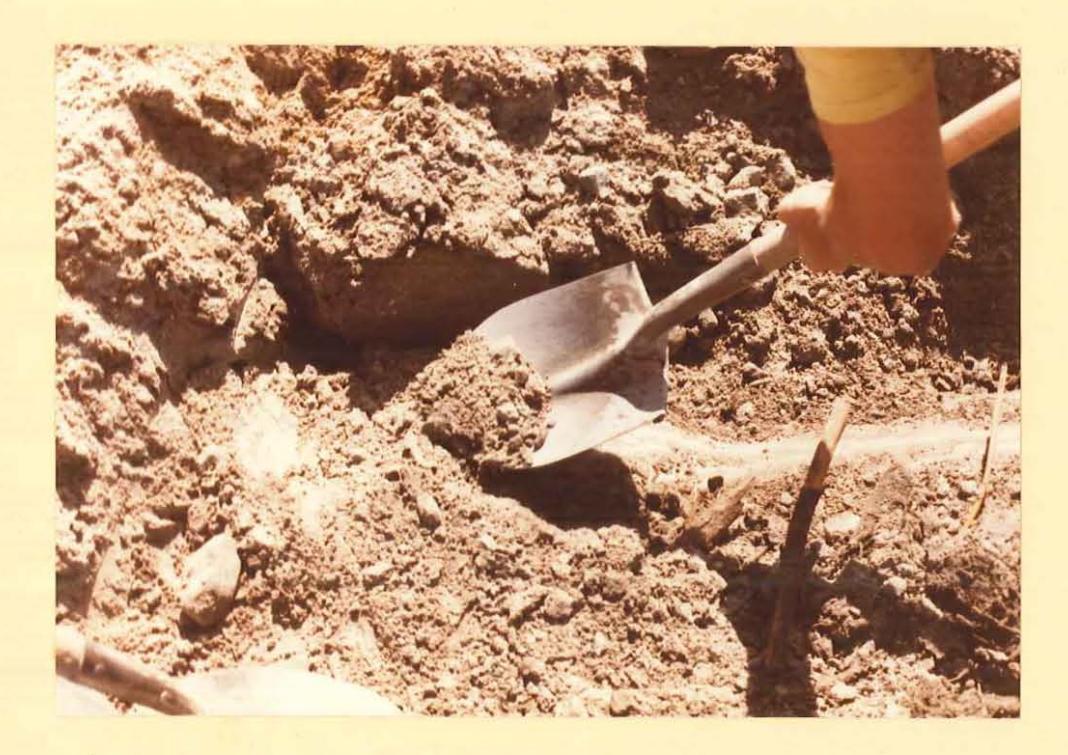
Boulder on top of concrete pipe.

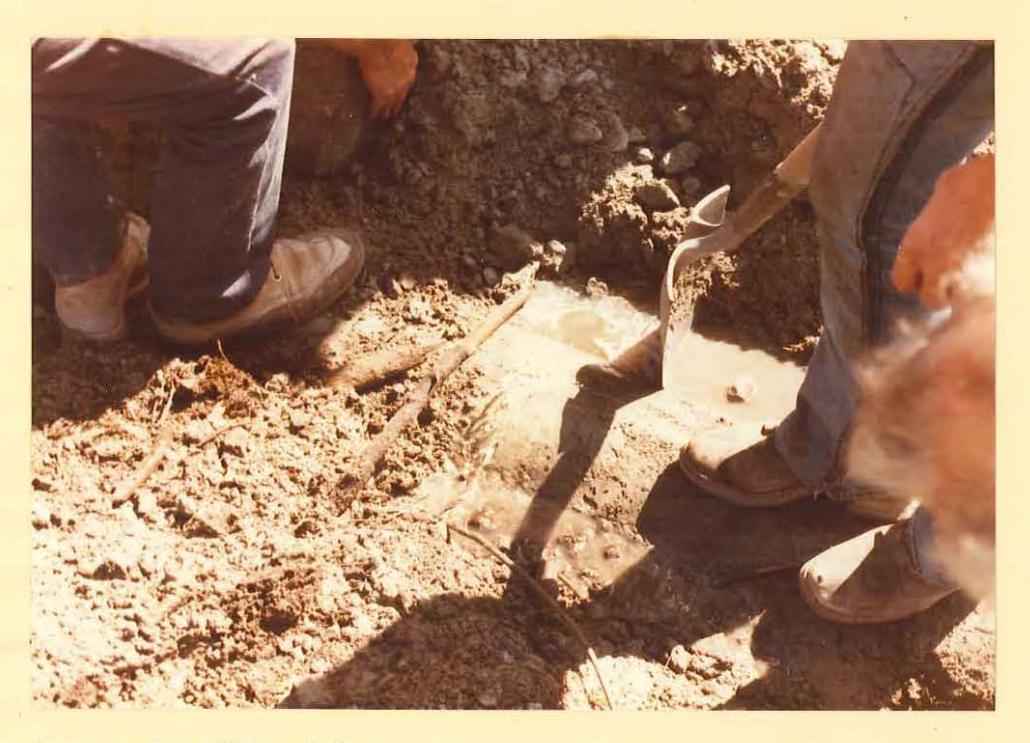
Boulder and sticks on leaking concrete pipe.

Removal of boulder.

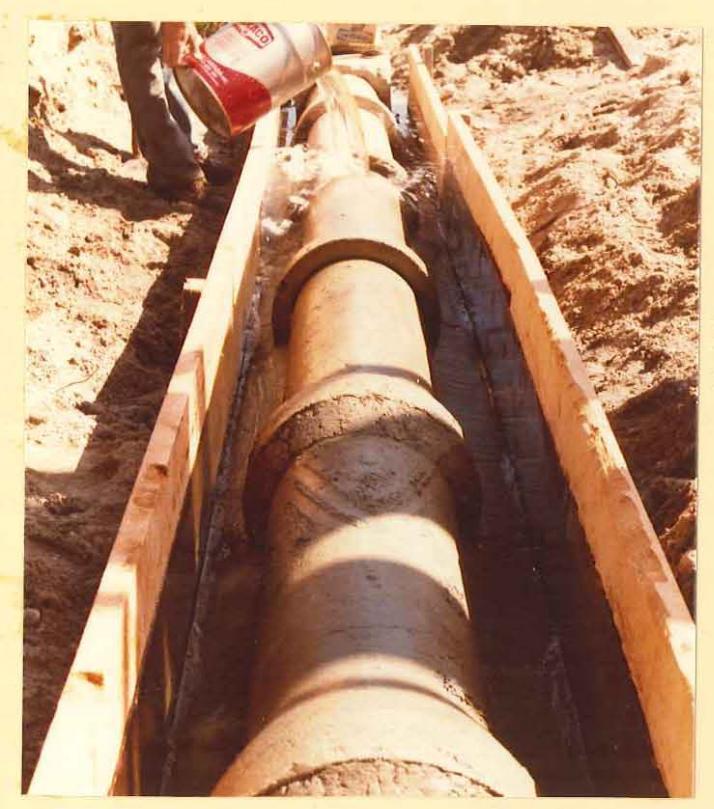
Some joints round packed with concrete, others with none.

All joints hand cleaned.

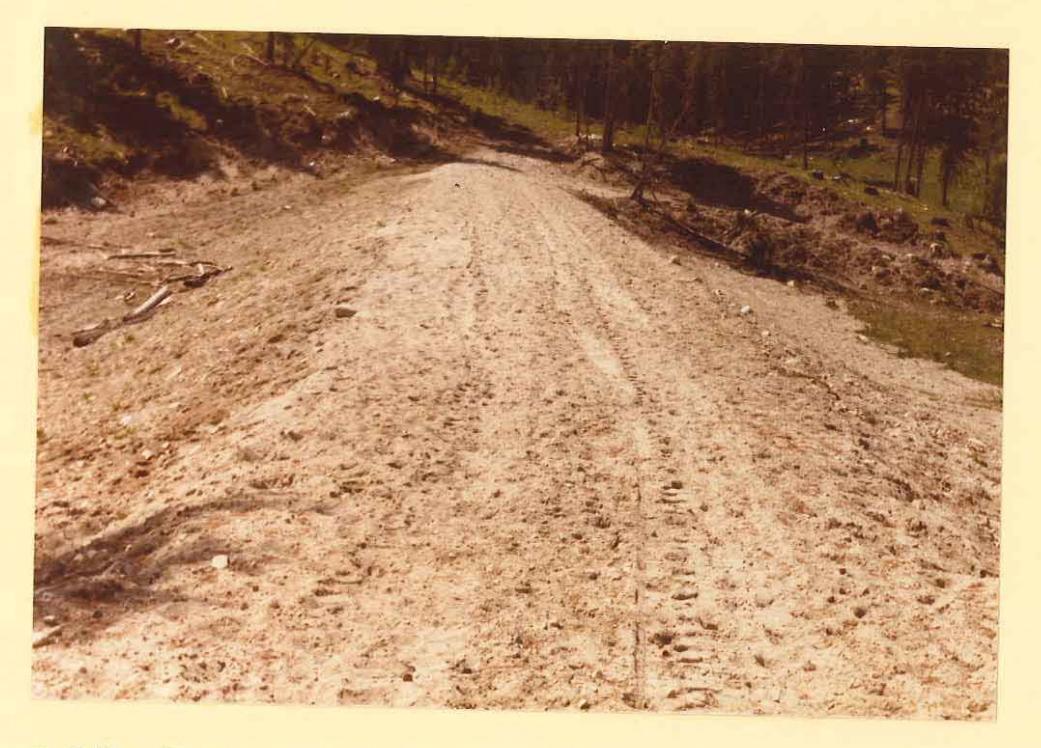
The saddle dam located at the north end of the reservoir appears in satisfactory condition. The area downstream of the toe is saturated but poses no threat to the dams integrity.

Saddle Dam.

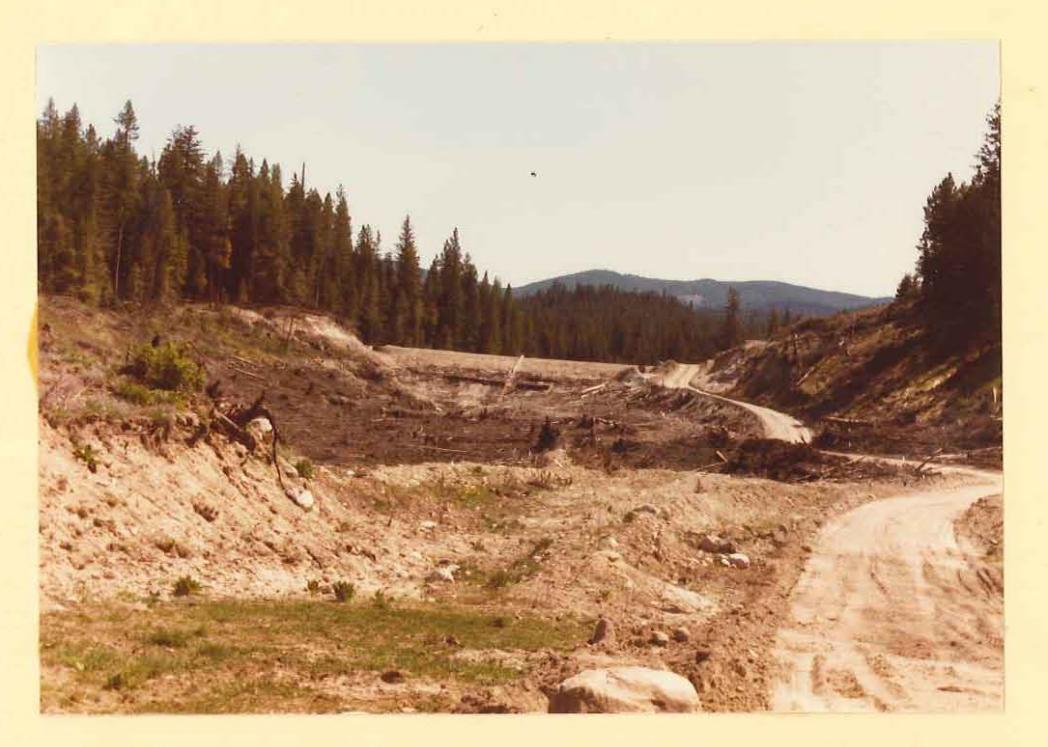
Access road through reservoir. (Note debris)

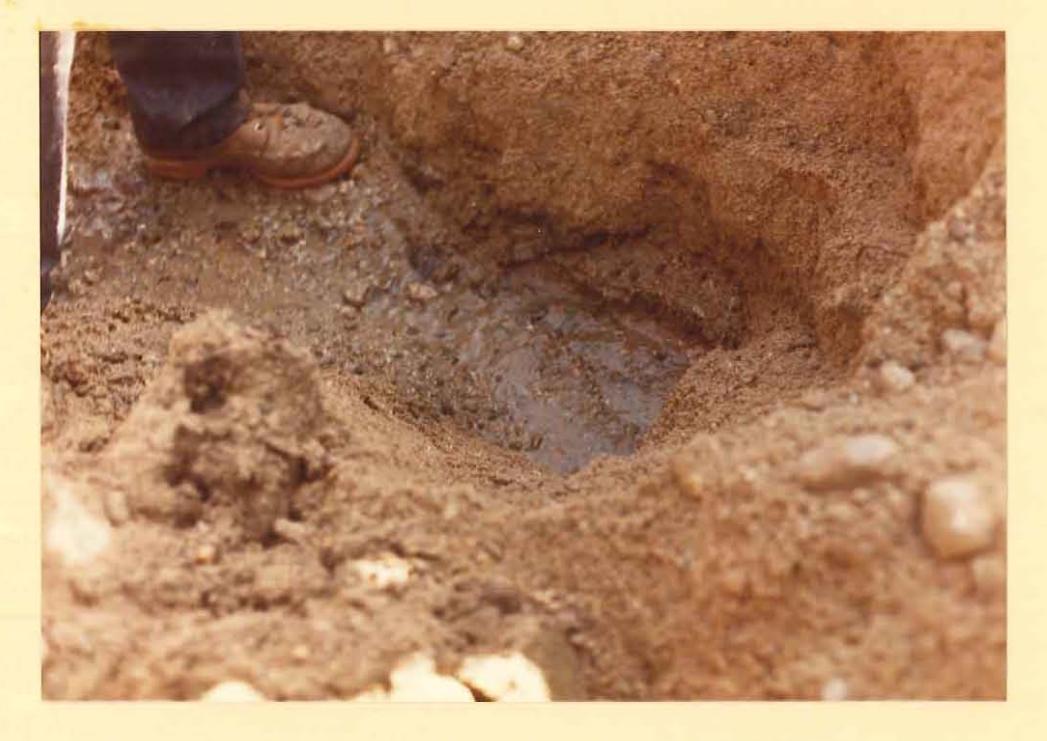
Contained seepage in right abutment area.

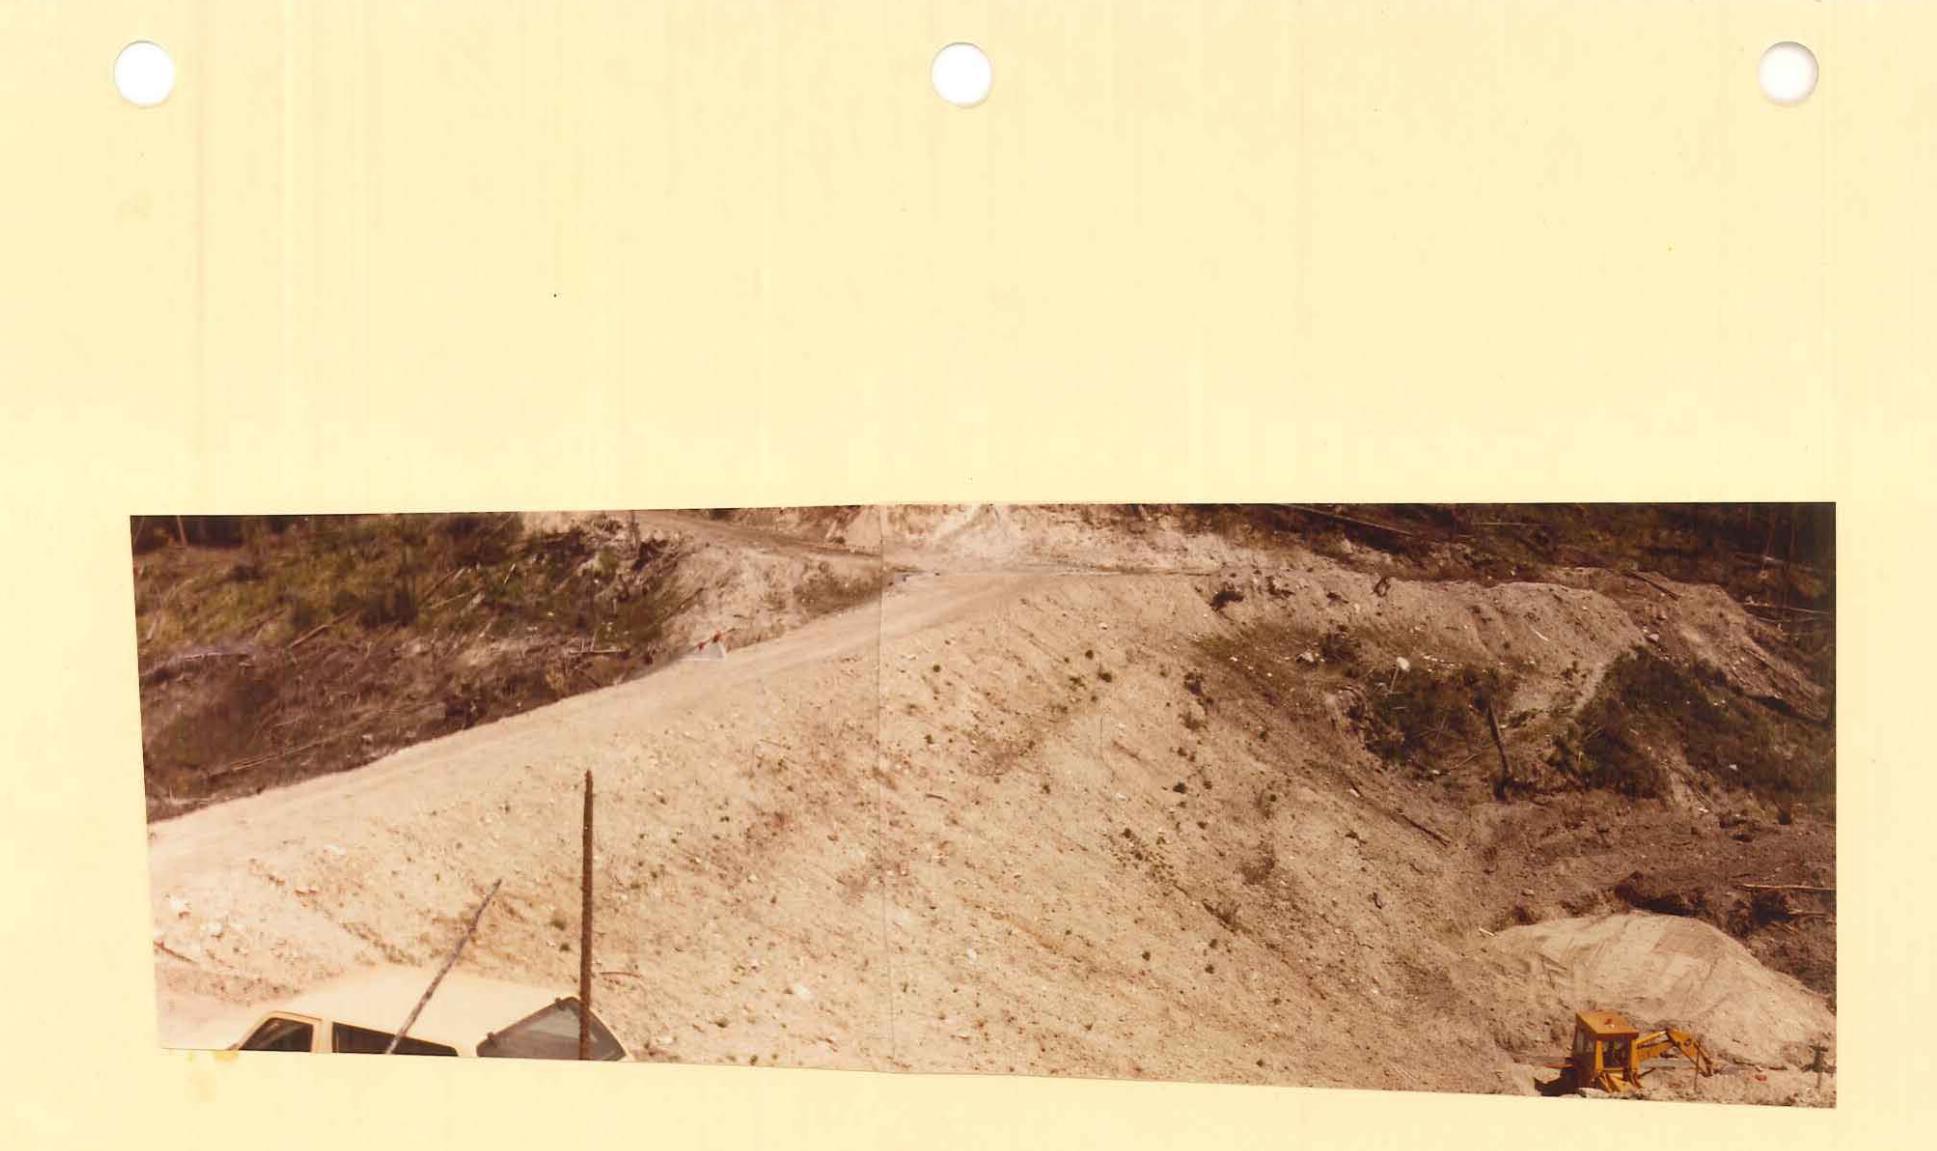
Some debris and logs were found on the upstream face and will require removal.

Sloping gate stem and considerable debris on upstream face.

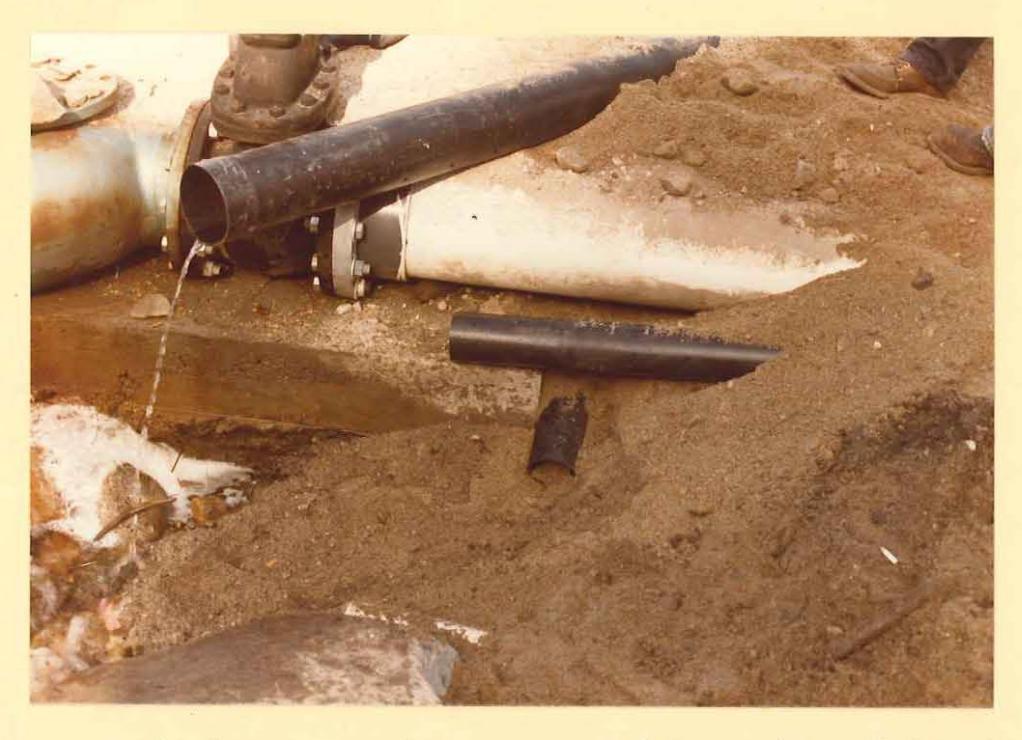
Two 4" lines are pick-ups on either side of low level outlet.
