2012 INSPECTION COMPLIANCE FORM FOR OWNERS OF HIGH, VERY HIGH & EXTREME CONSEQUENCE DAMS

By Fax at: By email at:	250-952-6792 dam.safety@gov.bc.ca)52-6792 safety@gov.bc.ca		N, NL, WL, PG
MCCUDDY CREE	KRESERVOIR #2 SADDLE DAM	Is Contact N	ame and Address corr	ect?
KEVIN TULAK MCKINNEY RD W	ATER USERS COMMUNITY	YESNO_	Piease correct belo	w:
s.22		· .

Small earthfill saddle dam at north end of reservoir.

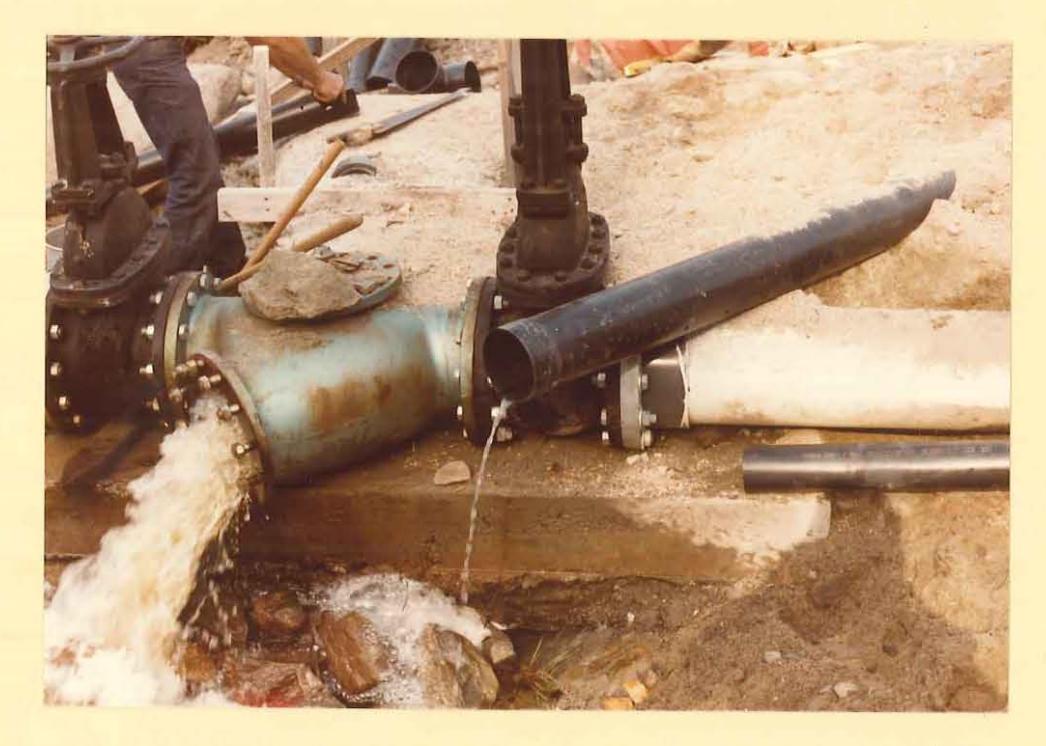
The flowing 6" line is carrying water from right abutment groin area.

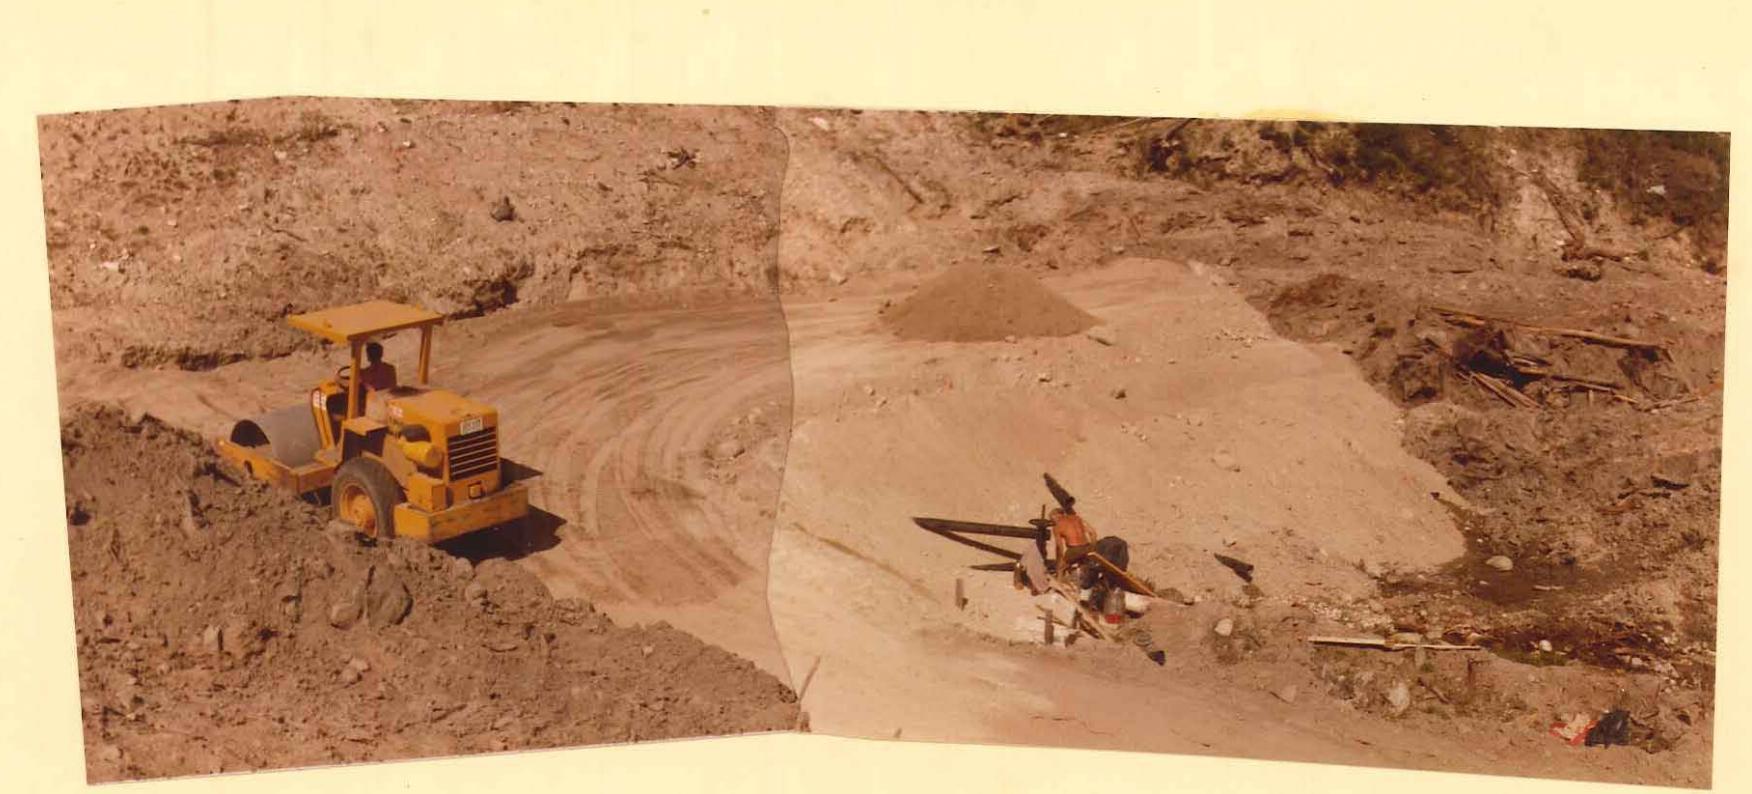
Replacement berm approaching original slope.

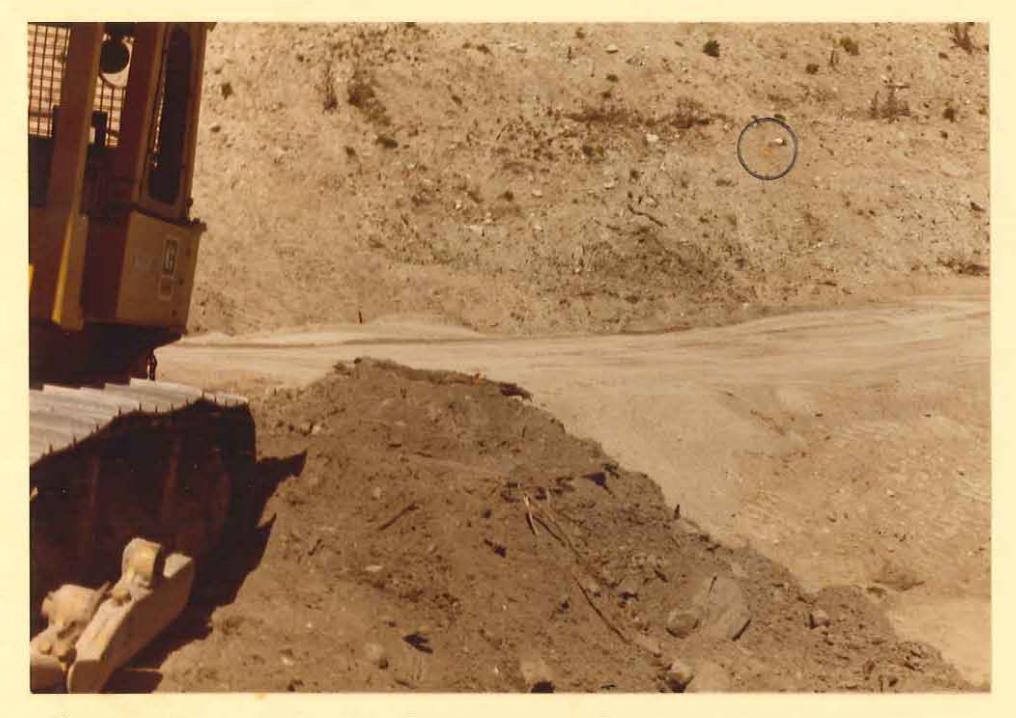
Circuled x-head indicates design elevation of berm when project was halted. (about 6' low).

Spillway outlet appears to be in fill.

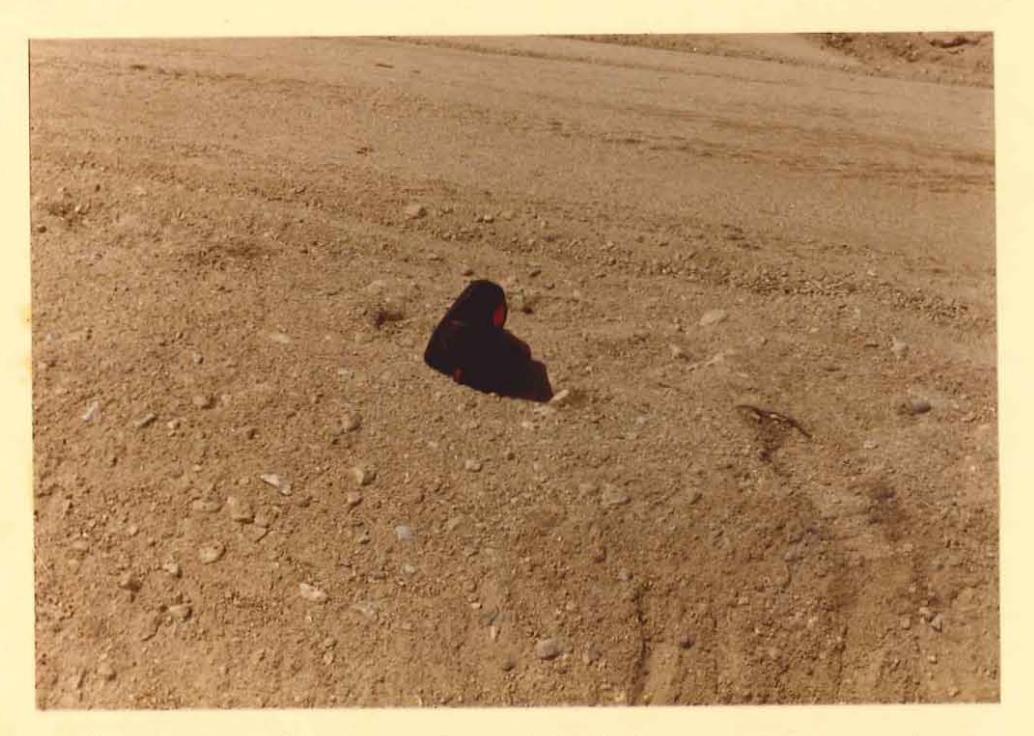
Coarse grained sand to l&l/2" gravel typical of placed berm material.

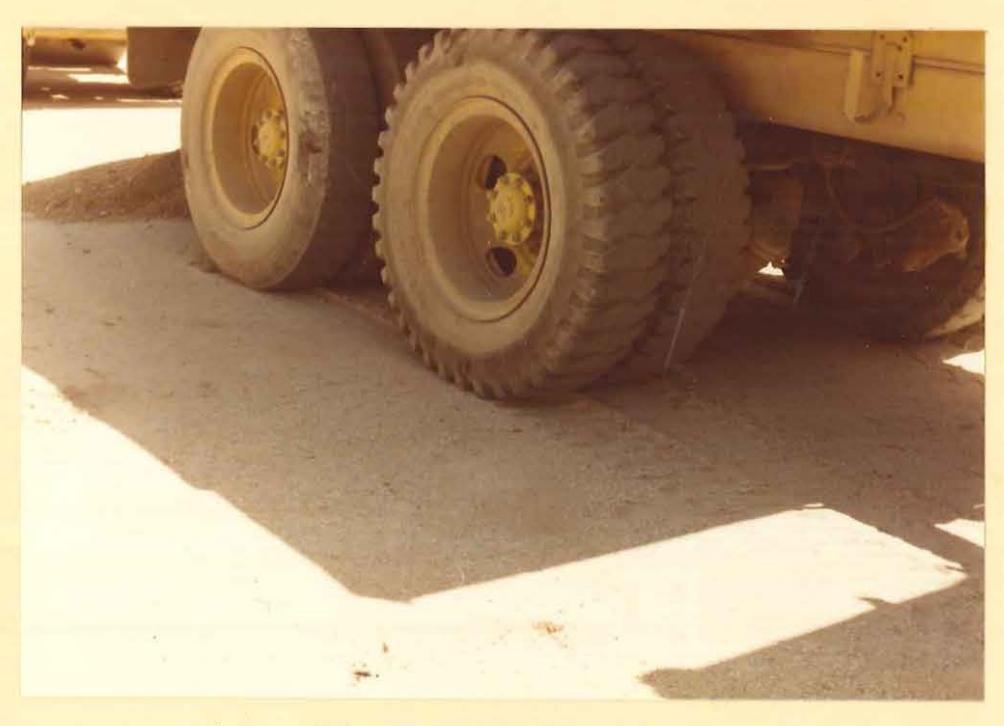
Compaction of berm material 95% proctor+.

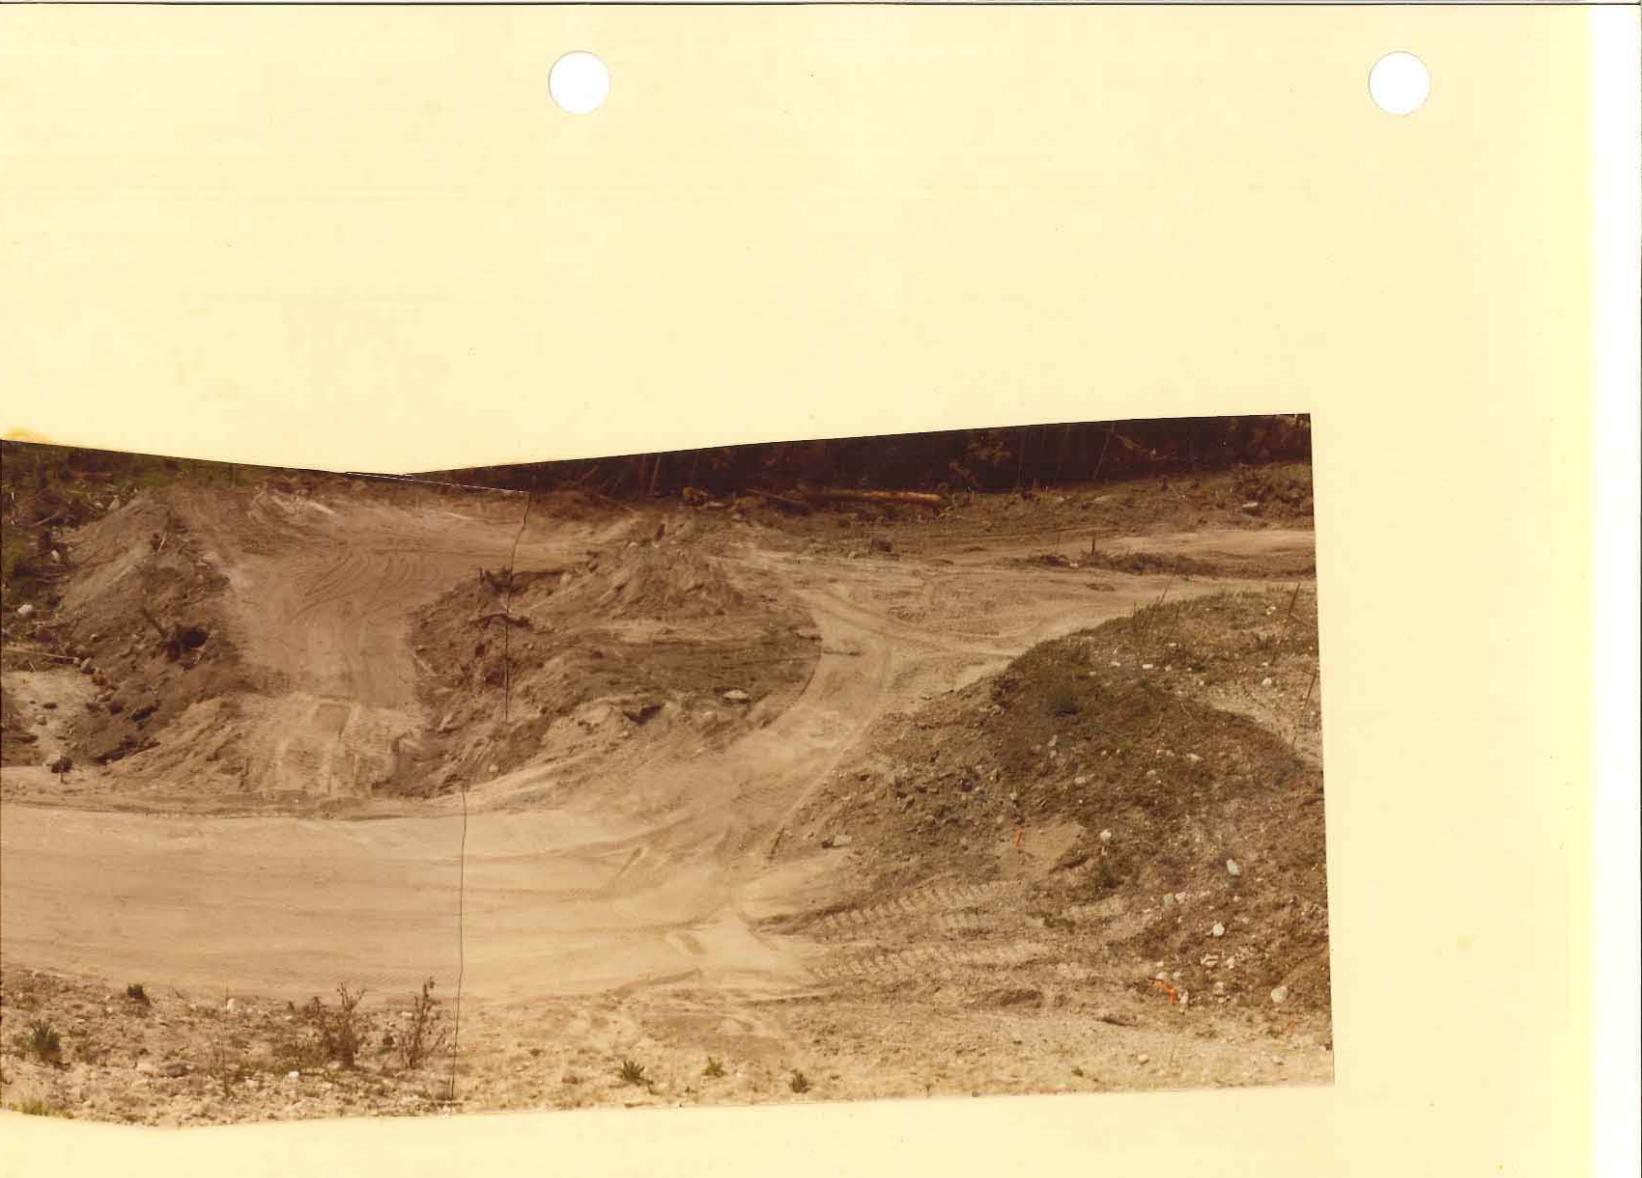
McCUDDY CREEK #2 May, 1983 Clean-up of surrounding area prior to equipment removal.

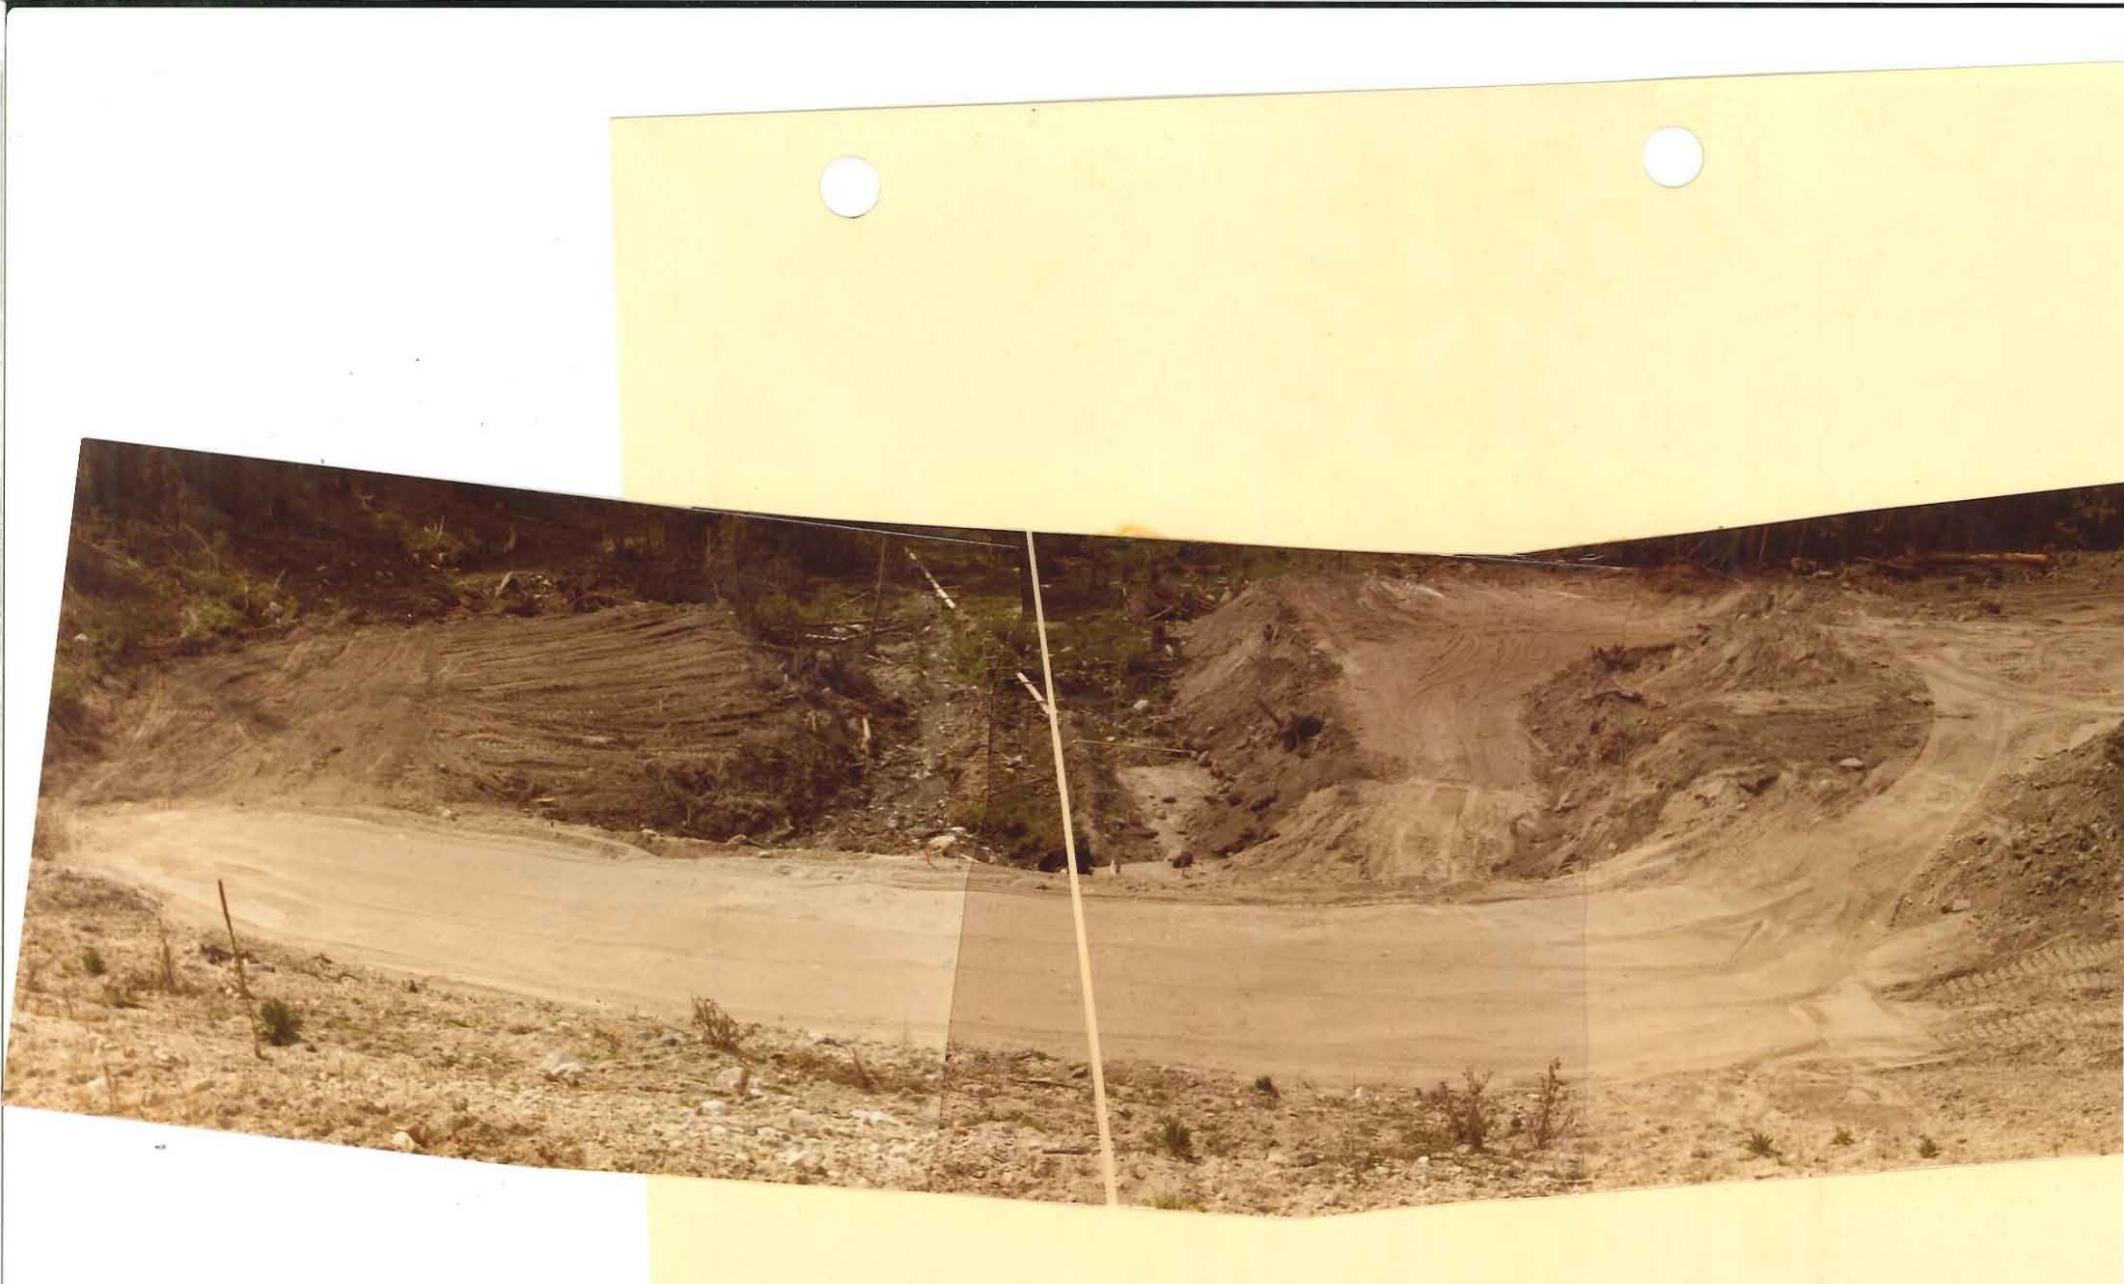
of project and downstream area.

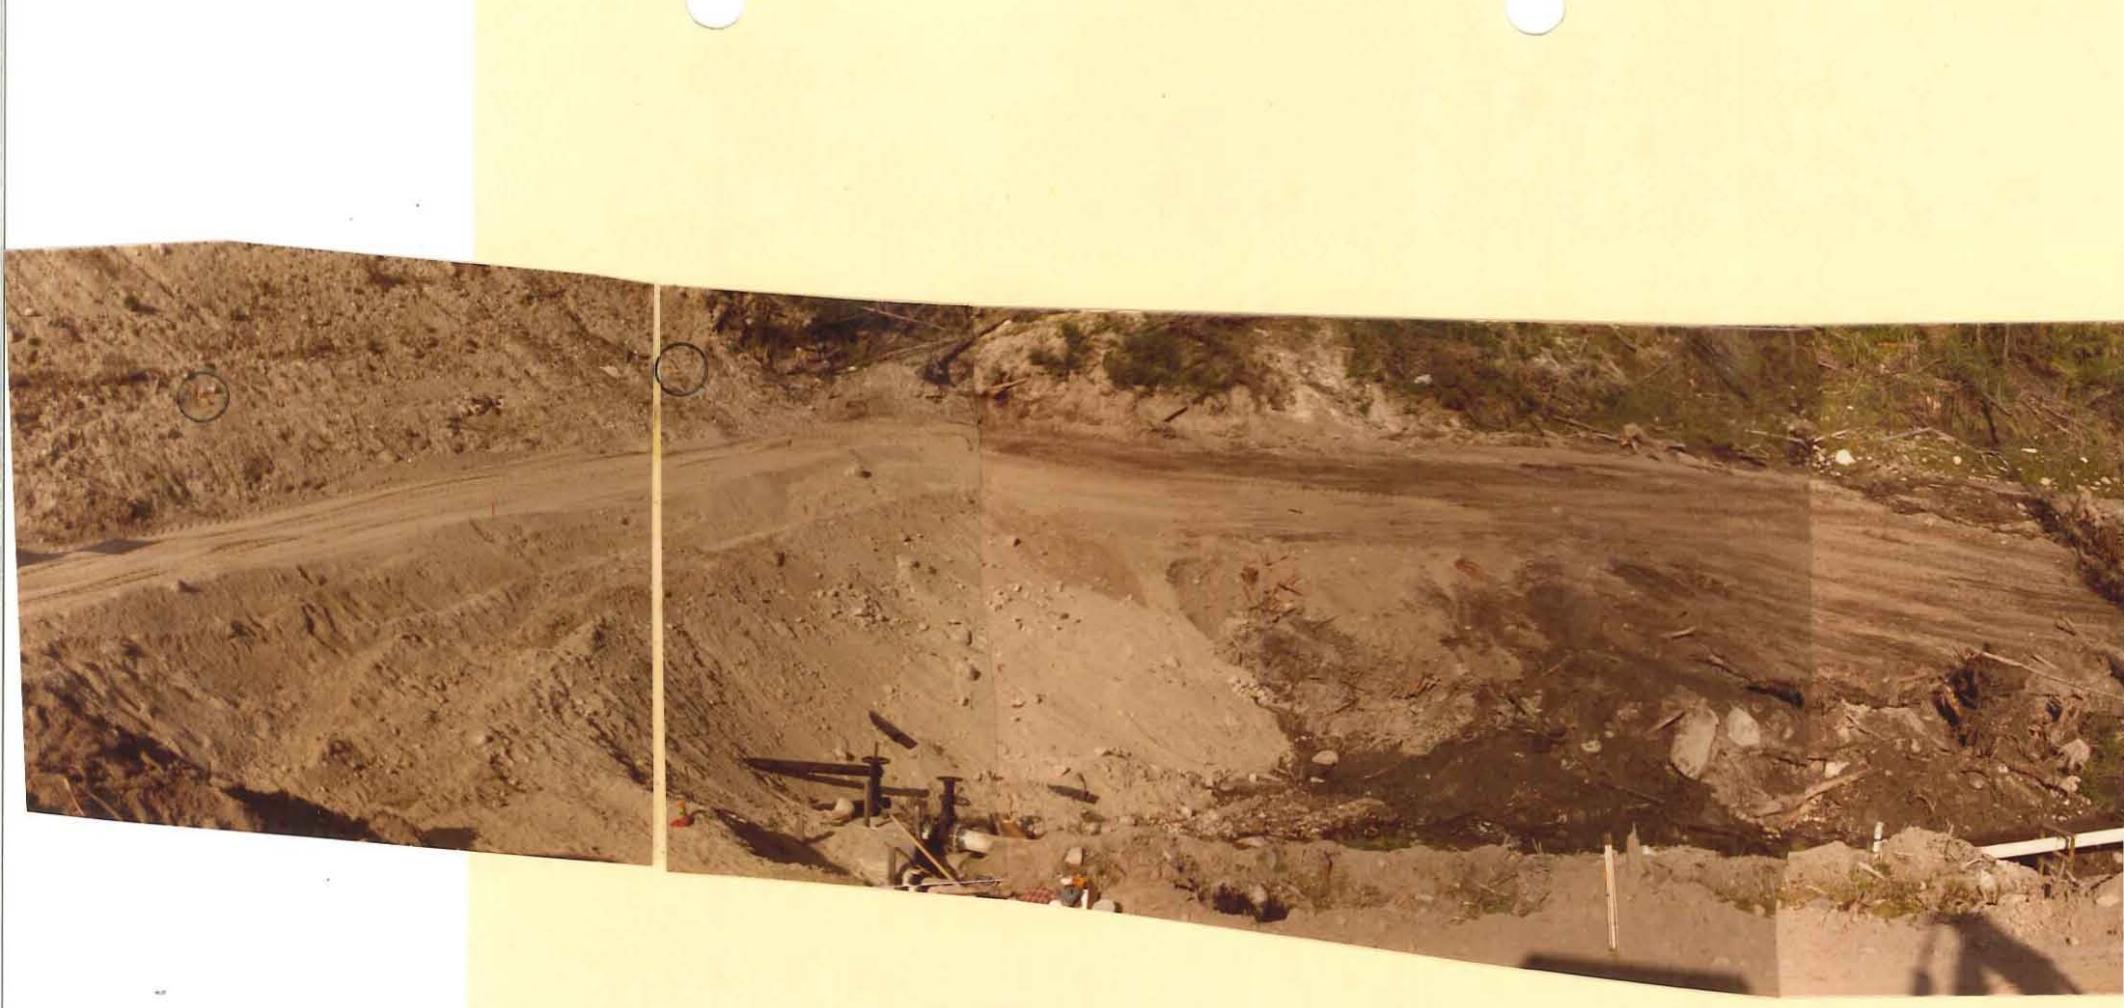
McCUDDY CREEK #2 Project incomplete.
