MOUNT POLLEY MINING CORPORATION		
MOUNT POLLEY MINE		
TAILINGS STORAGE FACILITY LONG TERM UPSTREAM TOE DRAIN FLOW ESTIMATES		
Knight Piésold CONSULTING	PROJECT / ASSIGNMENT NO. VA01-00001/14-A	REF NO. VA07-00362
	FIGURE 4	
		REV. 0

**MOUNT POLLEY MINING CORPORATION
MOUNT POLLEY MINE**

**TAILINGS STORAGE FACILITY
REPORT ON 2010 ANNUAL INSPECTION**

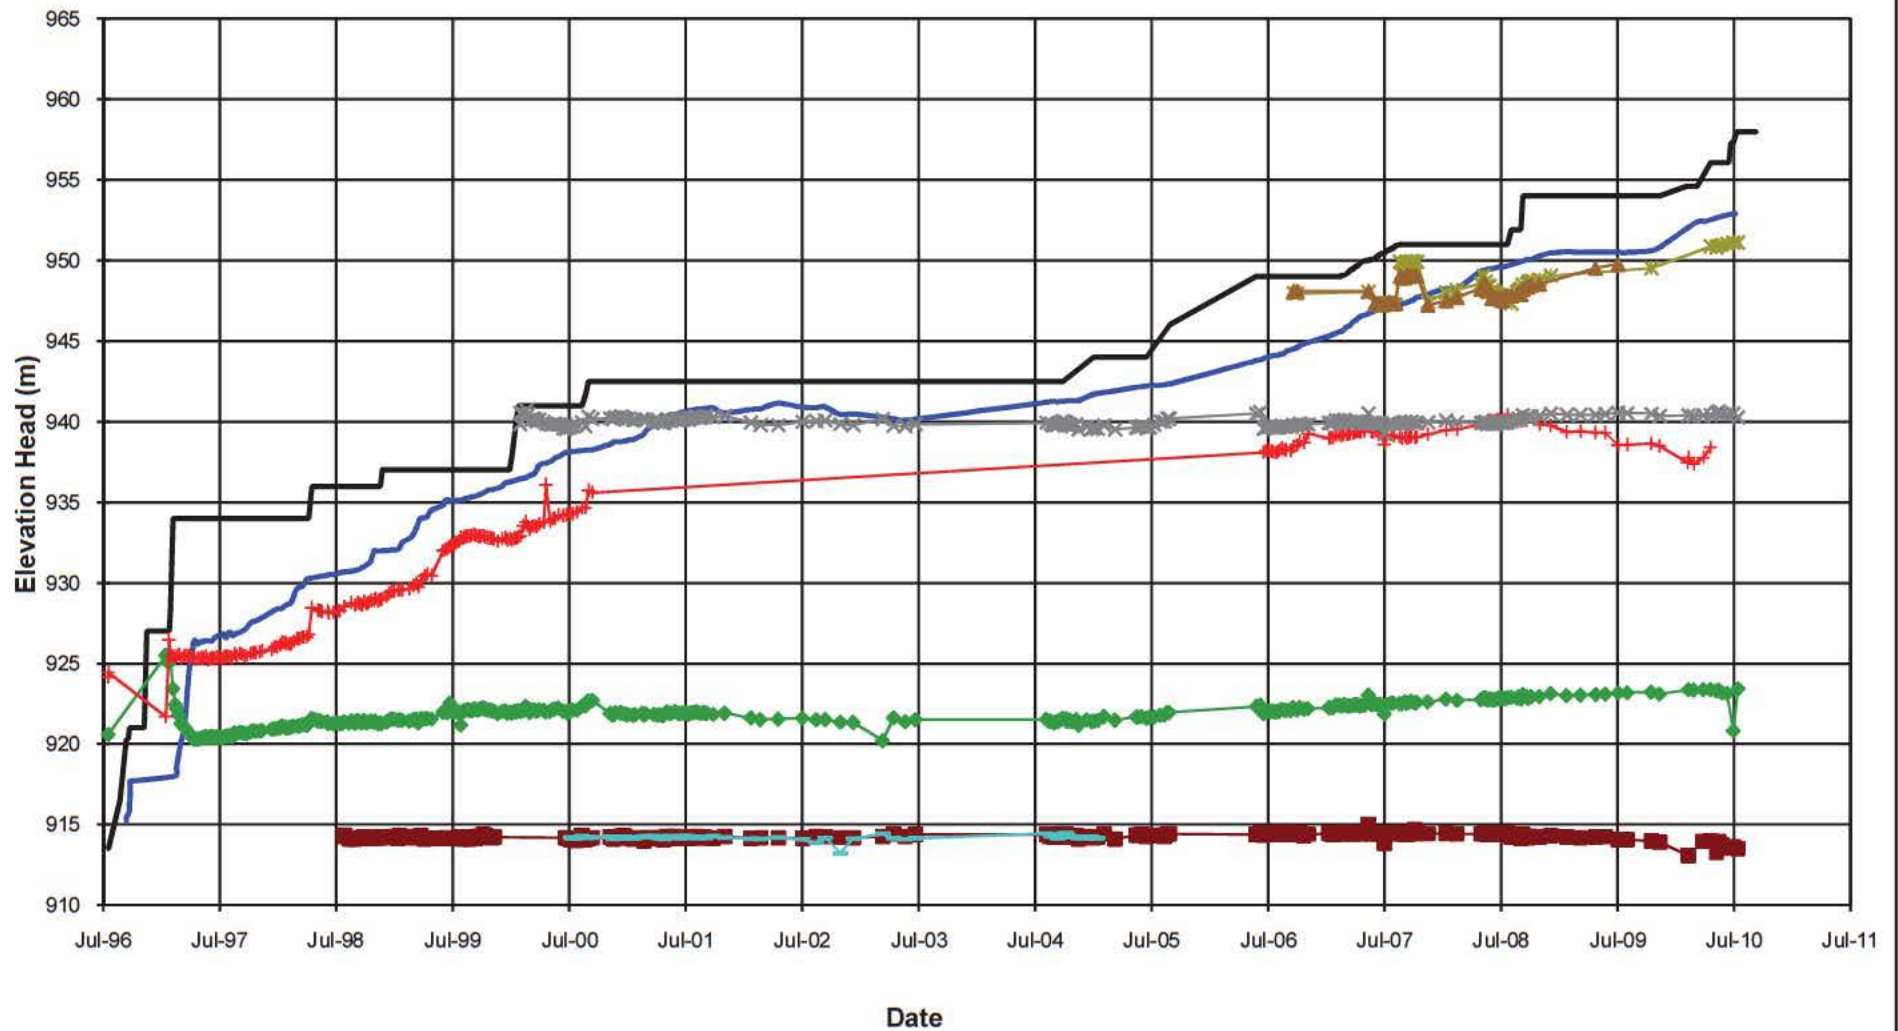
FIGURE A3.2

1. PIEZOMETERS IN PARENTHESES NO LONGER FUNCTIONING

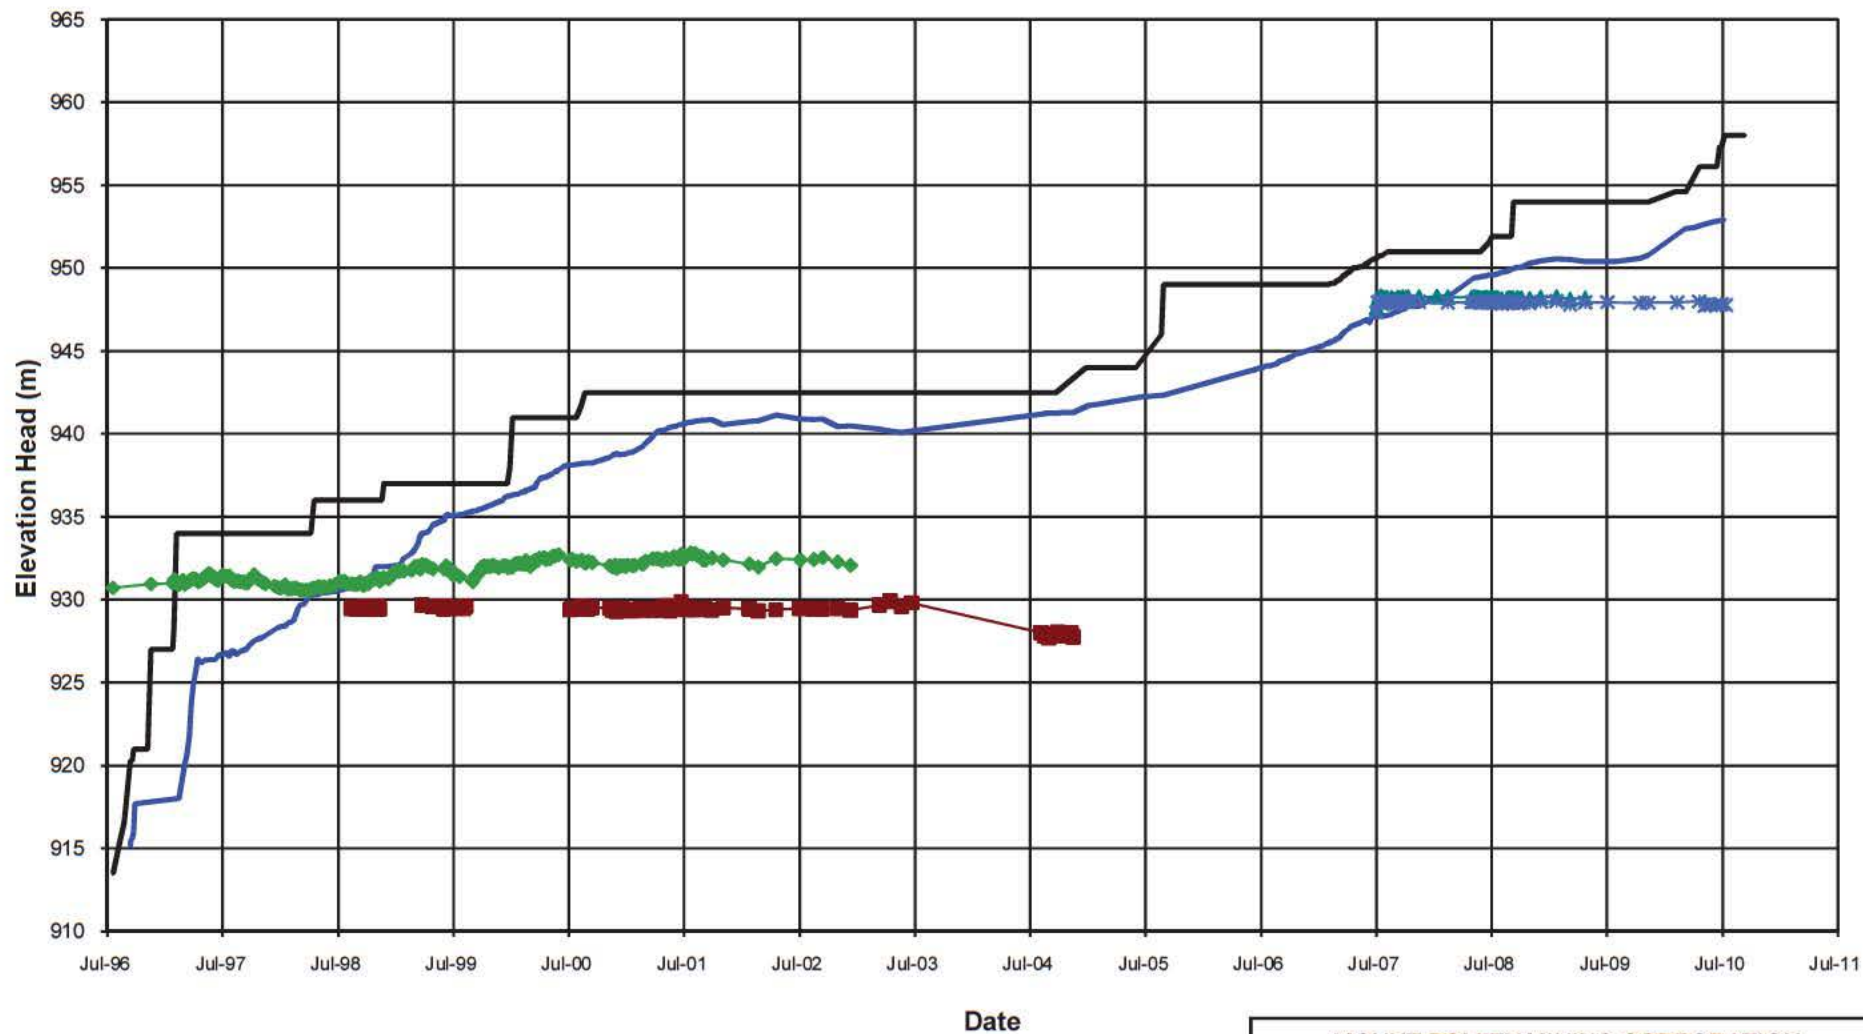
FIGURE A3.3

1. PIEZOMETERS IN PARENTHESES NO LONGER FUNCTIONING

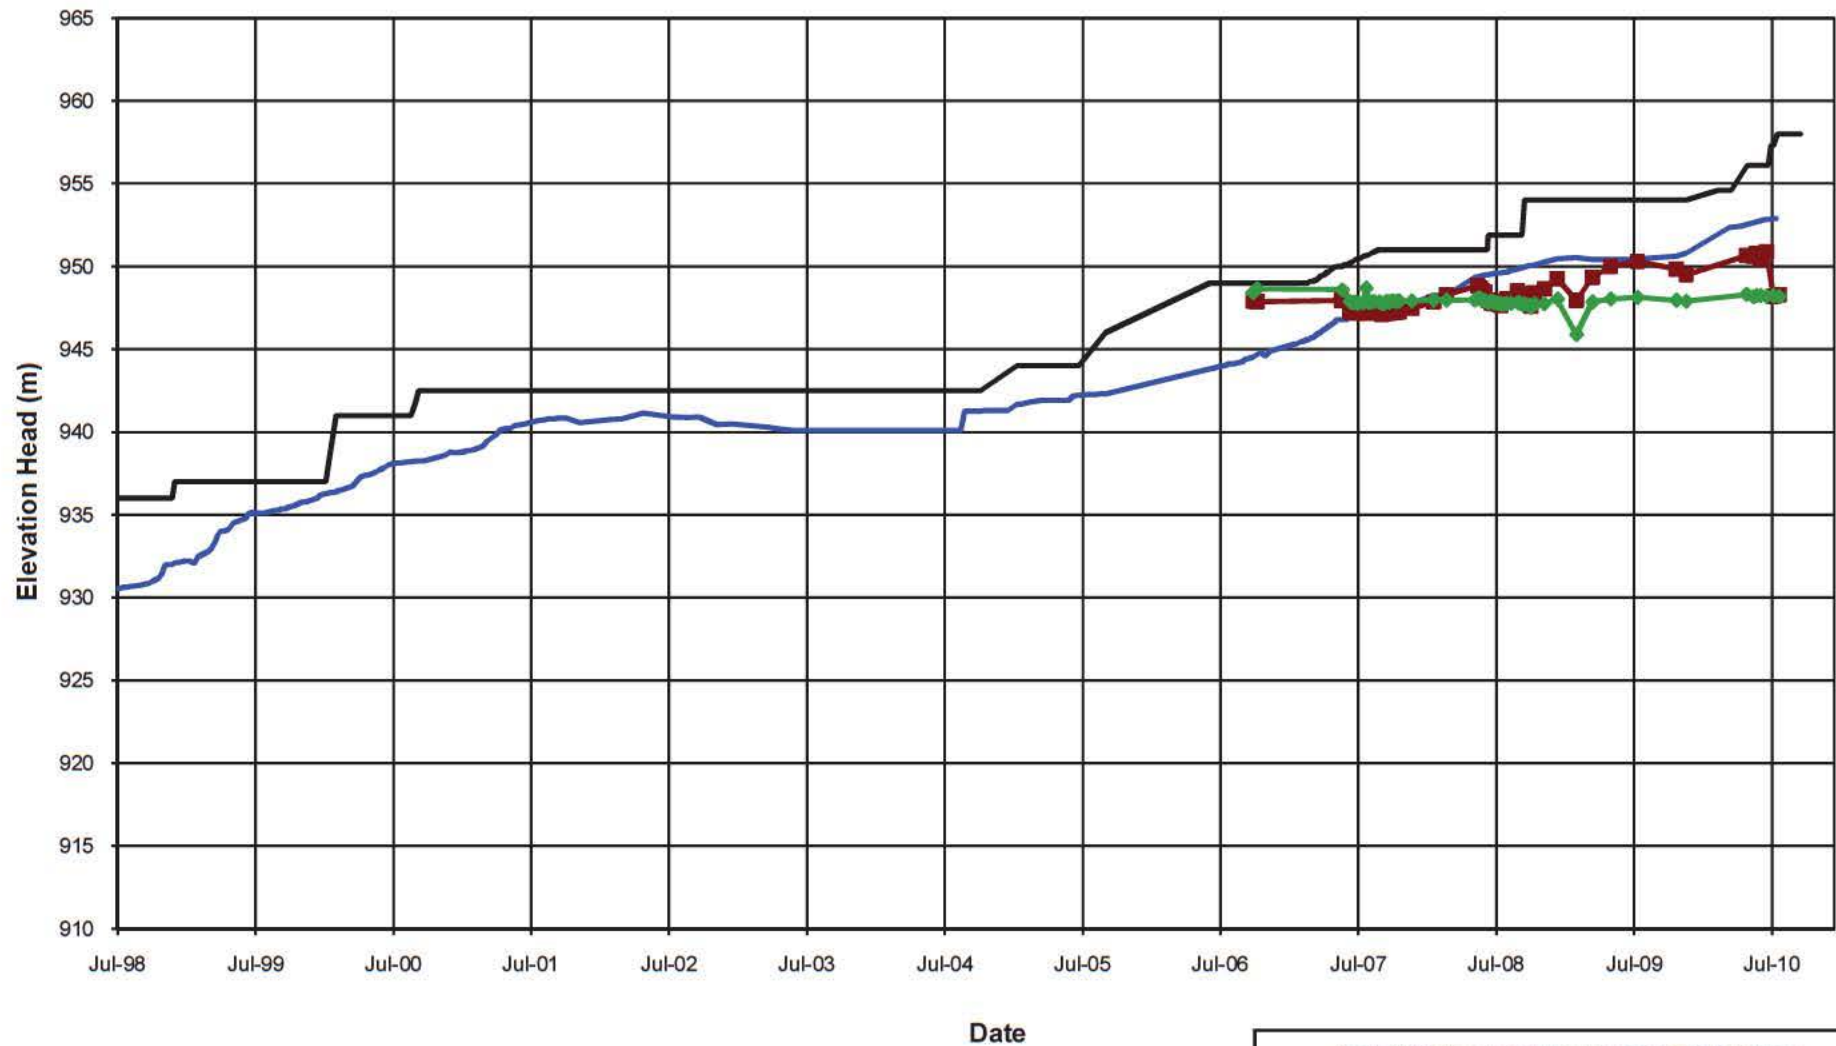
FIGURE A3.4

1. PIEZOMETERS IN PARENTHESES NO LONGER FUNCTIONING

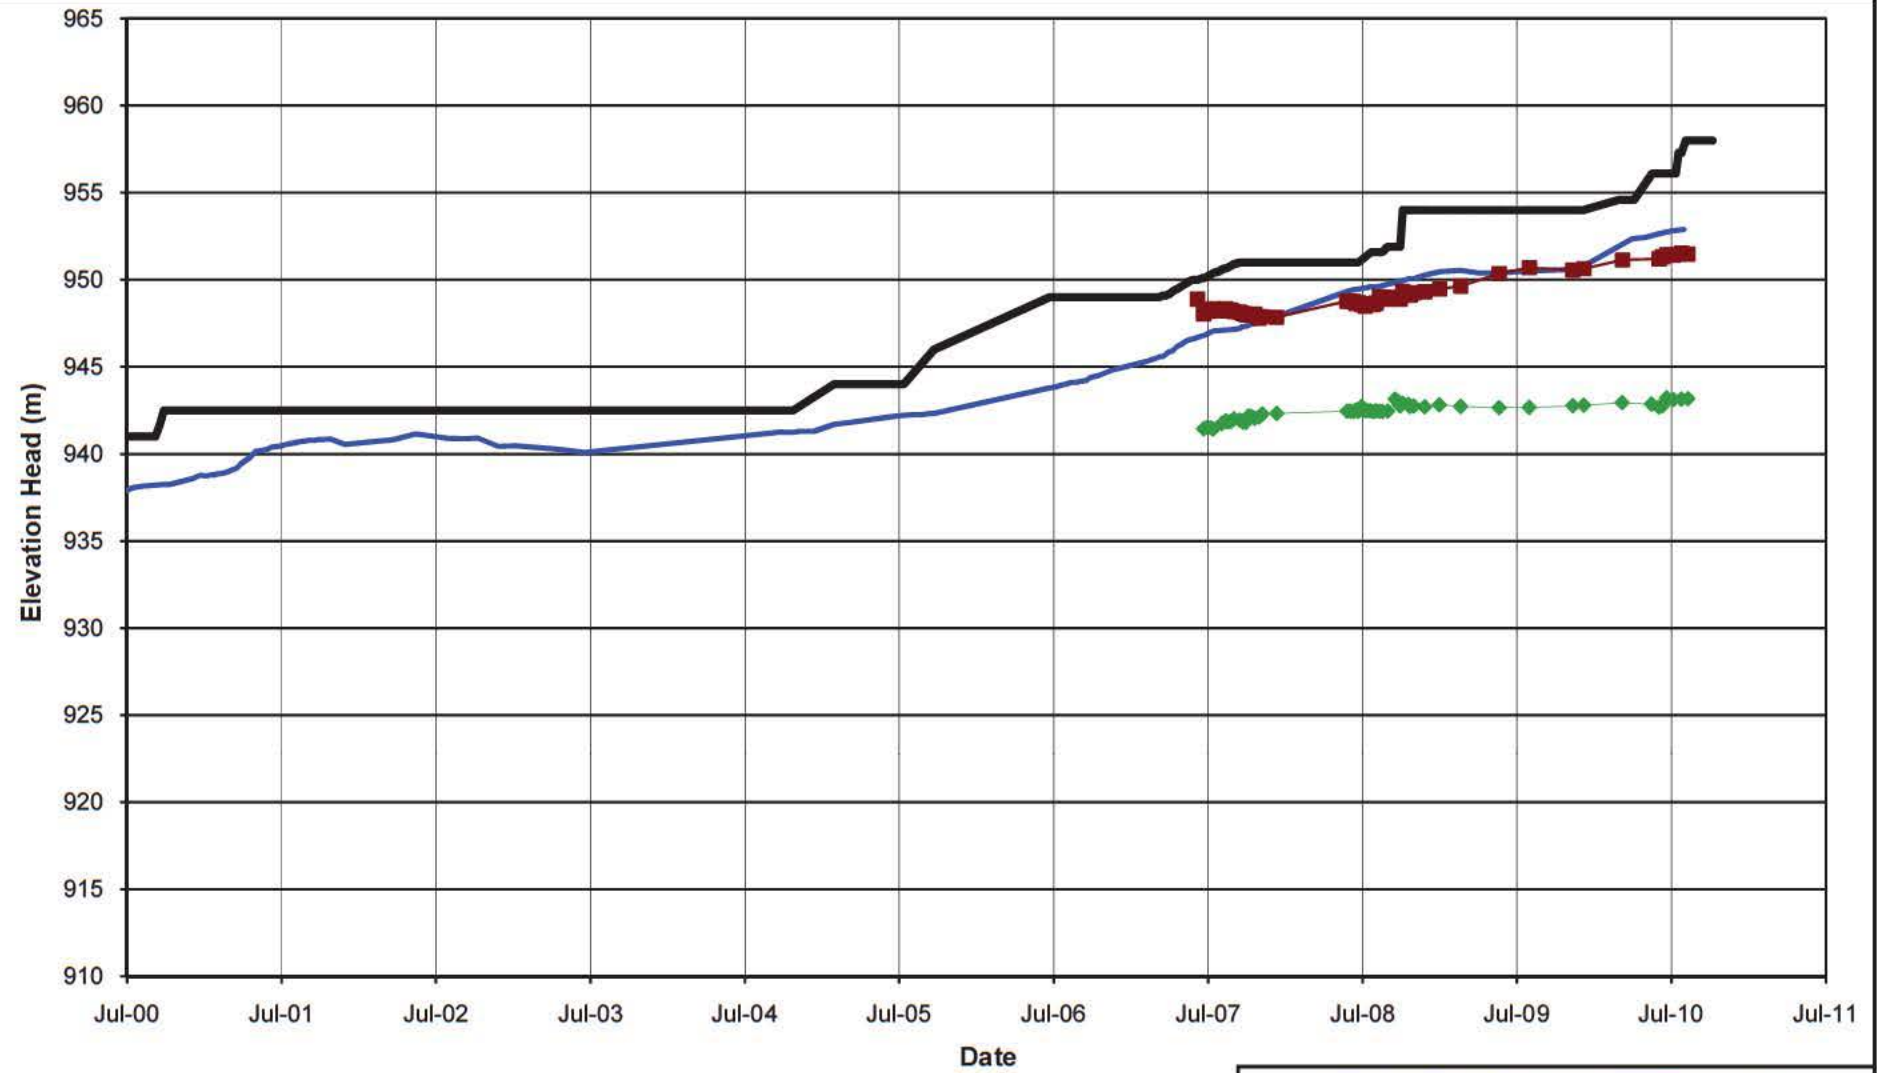
FIGURE A3.5

1. PIEZOMETERS IN PARENTHESES NO LONGER FUNCTIONING

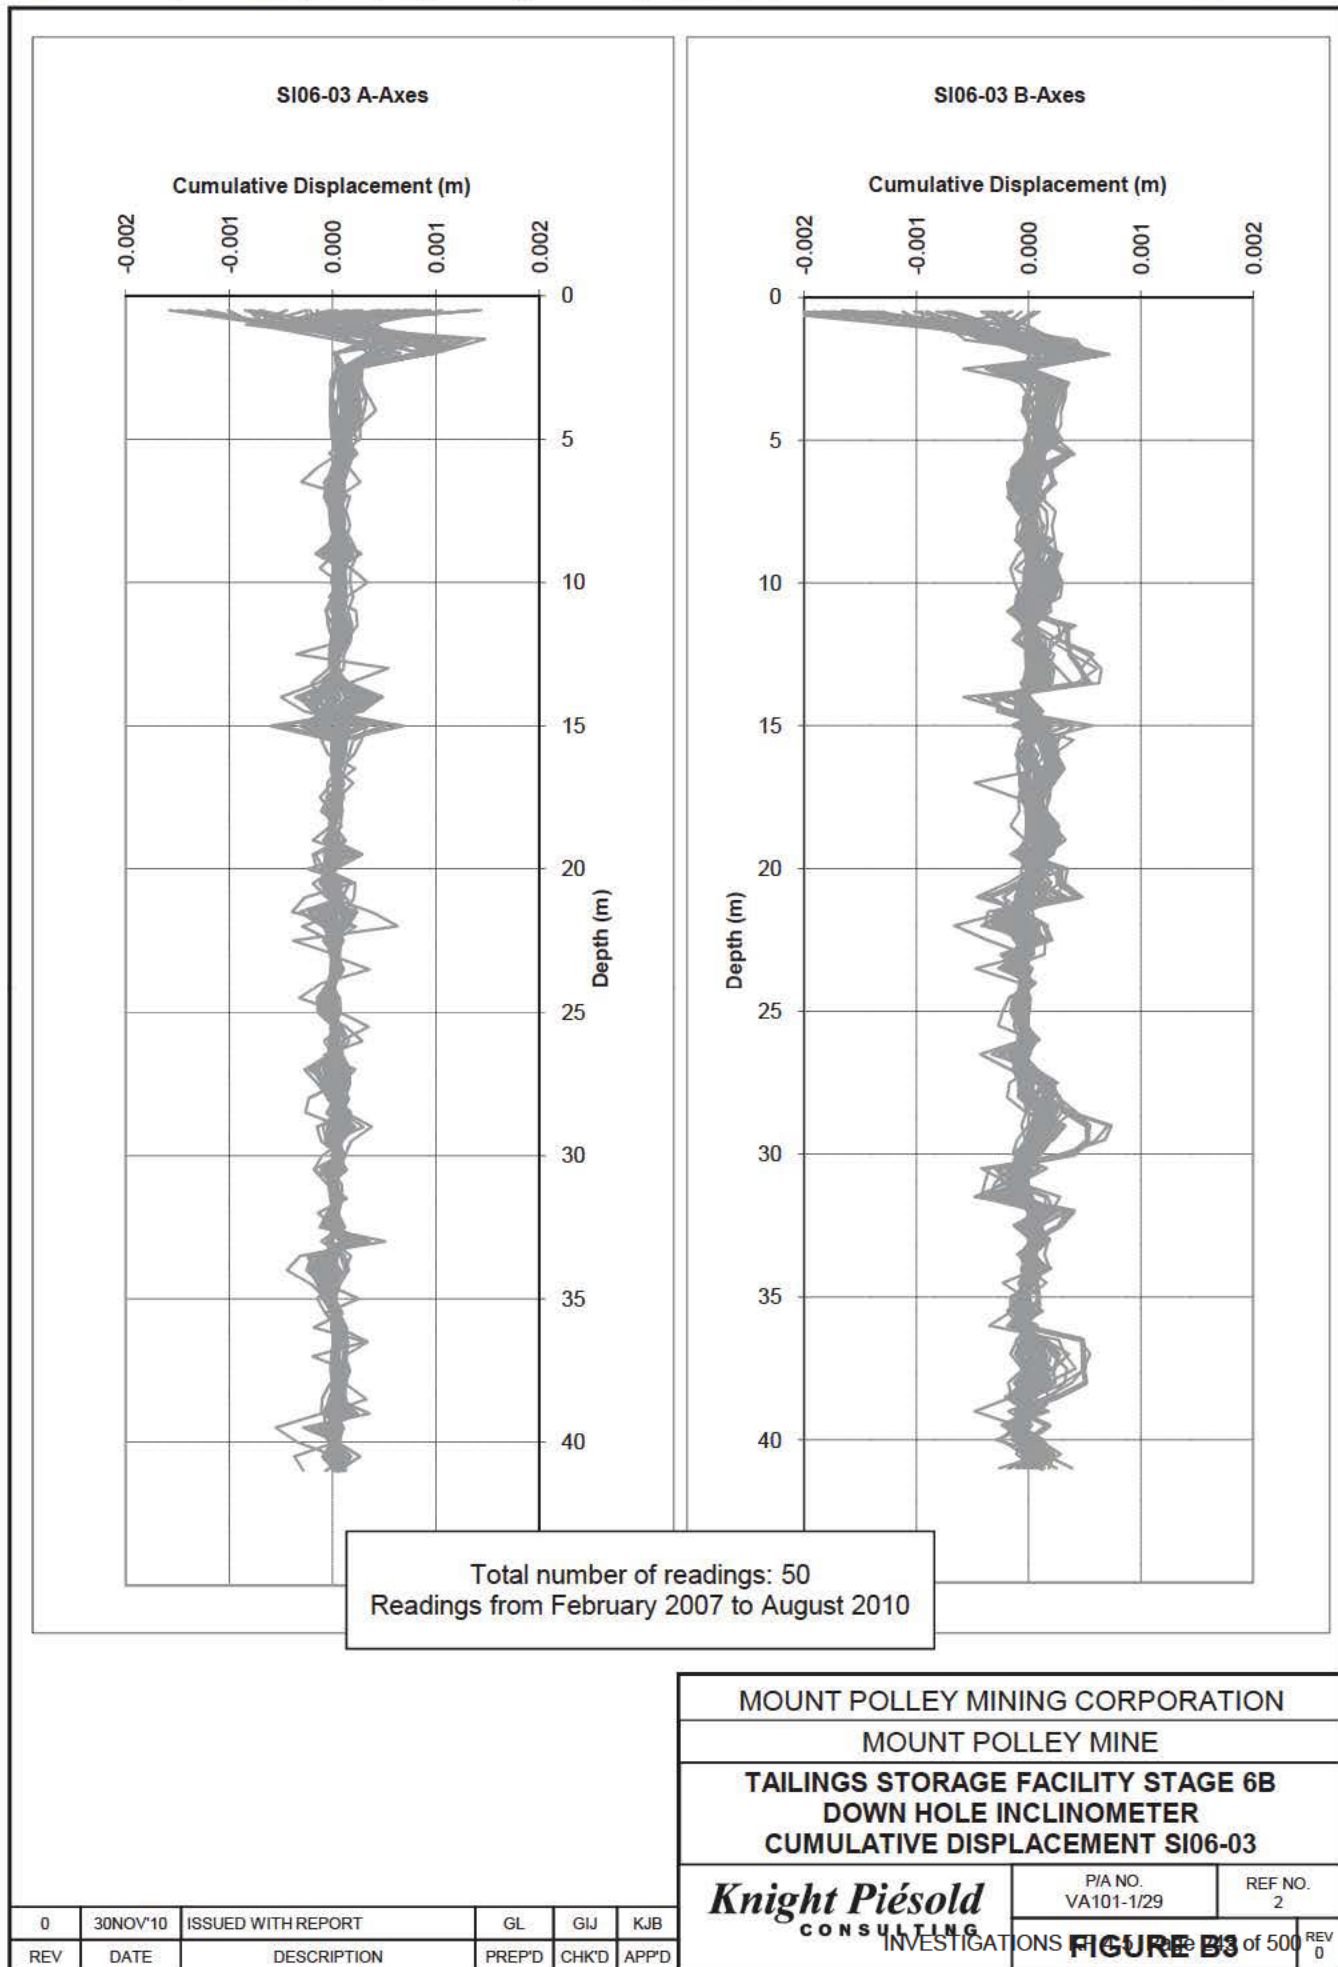
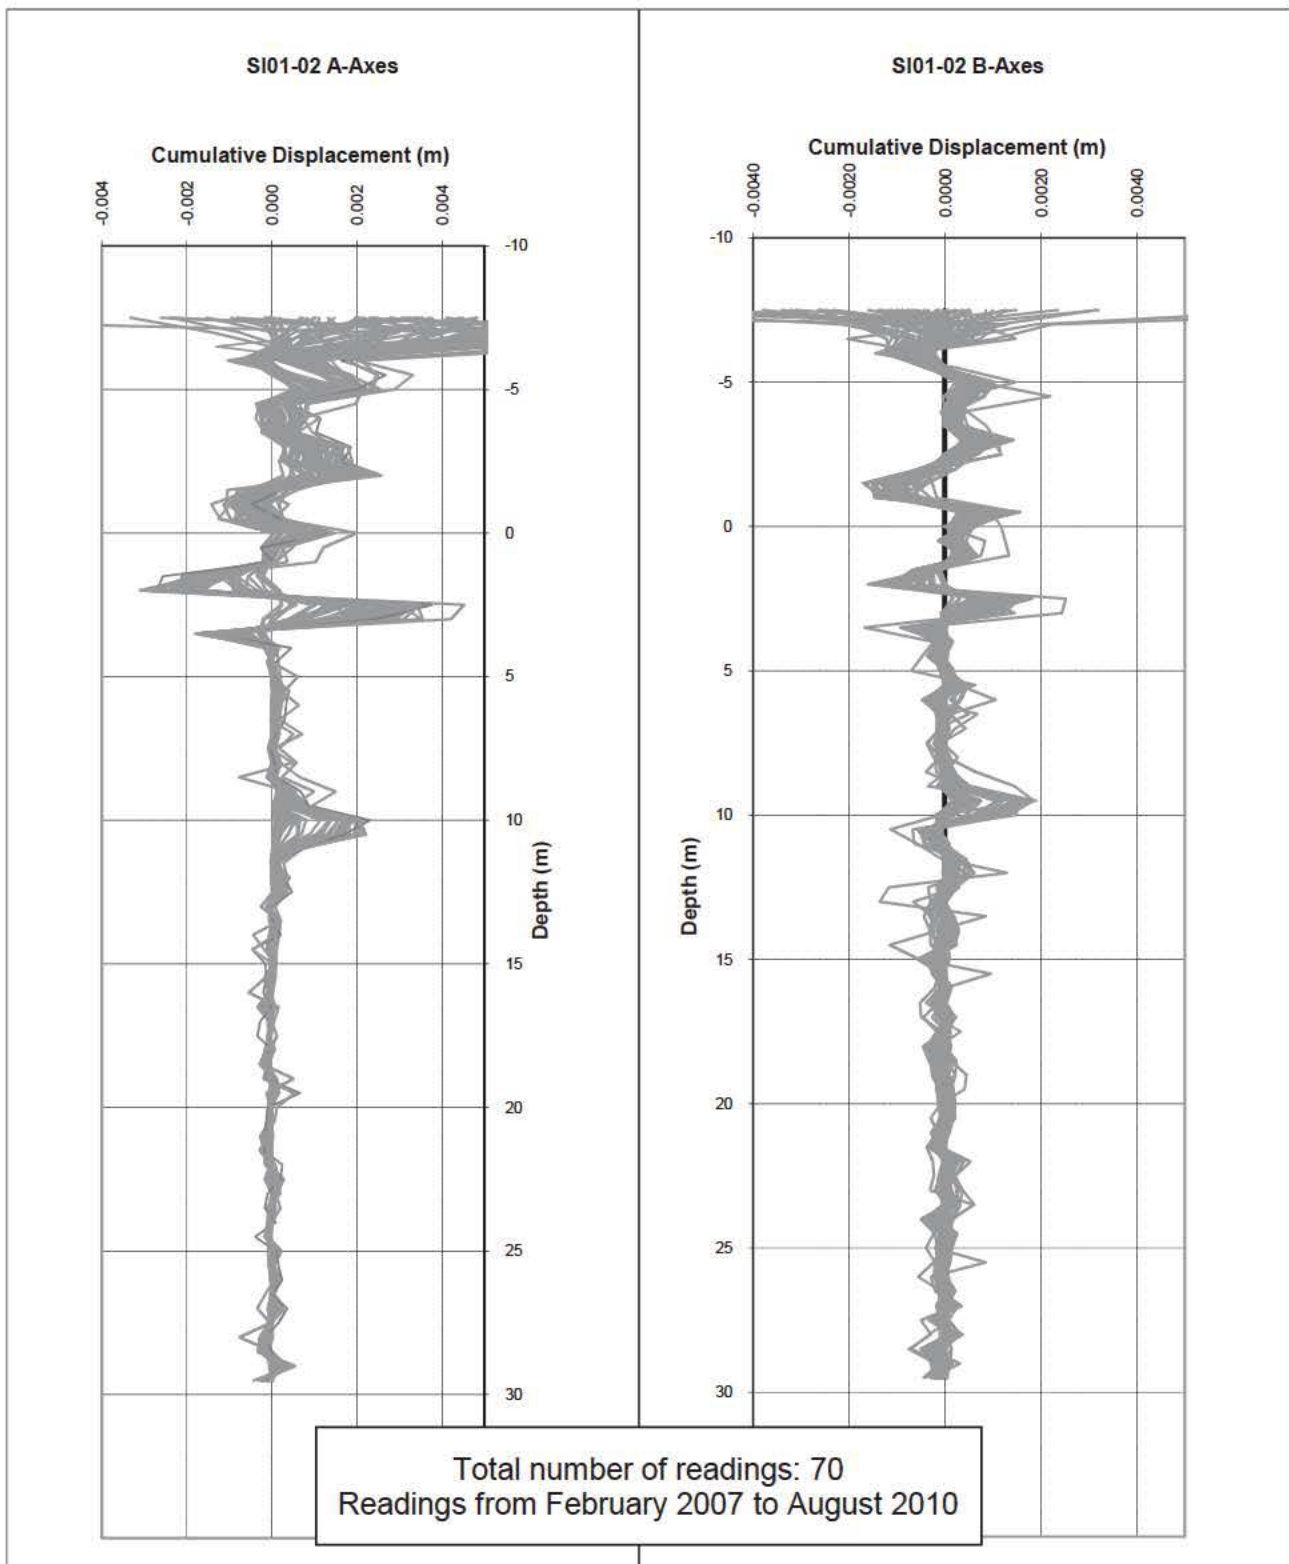
MOUNT POLLEY MINING CORPORATION		
MOUNT POLLEY MINE		
TAILINGS STORAGE FACILITY STAGE 6B		
DOWN HOLE INCLINOMETER		
CUMULATIVE DISPLACEMENT SI01-02		
Knight Piésold CONSULTING	P/A NO. VA101-1/29	REF NO. 2
	INVESTIGATIONS	FIGURE B4 of 500 REV 0

Slight deviations identified in Inclinator SI01-02 have resulted in the construction of a buttress at the Main Embankment. An initial buttress was constructed downstream of the affected inclinometer but was not constructed across the entire embankment as recommended.
