Report of Inspector of Mines

Geotechnical

Inspection No.: 099689
Mine No.: 0500770
Permit No.: M-226
Total Orders: 9

Mine Name: Max Molybdenum Mine
Location: Trout Lake, B.C.
Owner, Manager: Dan Omeniuk
Company: MX Gold Corp.
Address: 1300 Redonda Street,
Winnipeg, MB R2C 3T7
Workers Contacted: None
Type of Mining: Metal – Underground (MU)
Date of Inspection: 2018-08-29
Inspector: Jennifer Brash, M.Eng., P.Eng., Senior Geotechnical Inspector
Accompanying Inspectors: Paul Hughes, Andrew Craig
In Attendance: None
Copies to: Al Hoffman, Diane Howe, Lowell Constable, Jennifer McConnachie, Tania Demchuk, Alan Day, Kathie Wagar; Heather Narynski

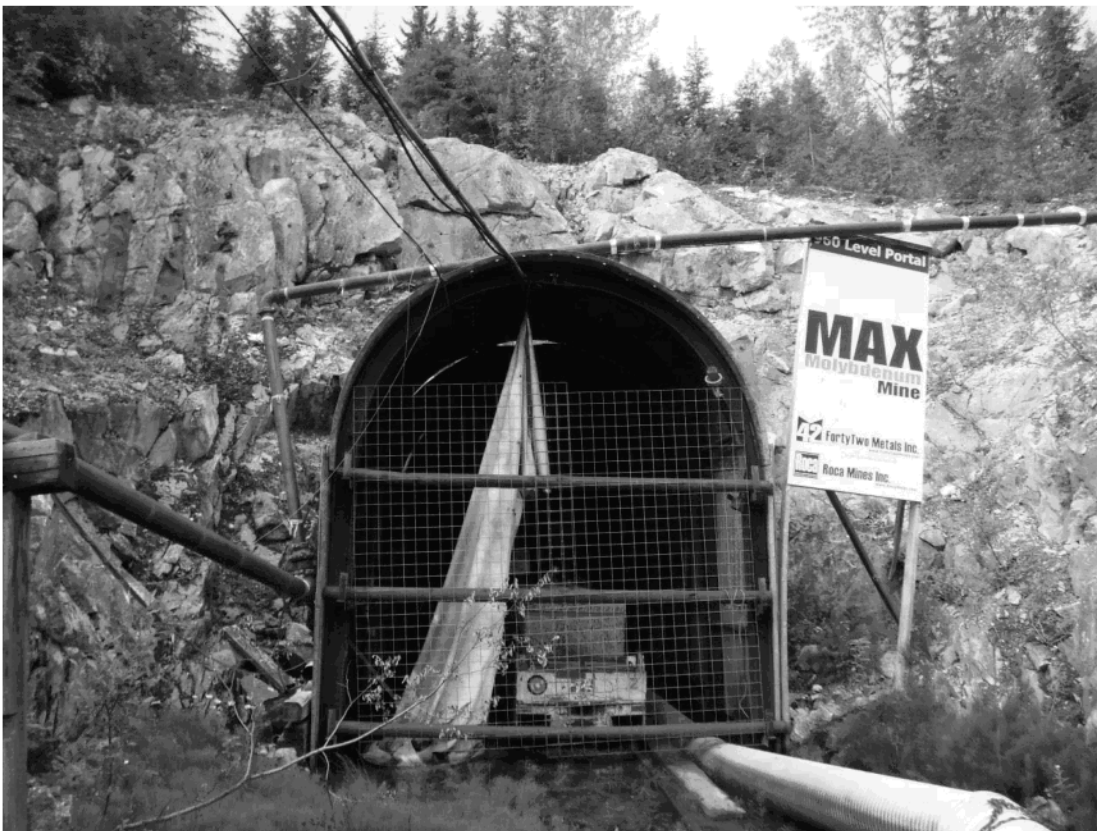
Photo 2: East Portal

The East and West Portals are located southwest of the Mill and were gated and fenced to prevent access, but were not adequately secured (Photo 1 and Photo 2). At the time of the inspection, water was actively flowing from the East Portal via a drainage channel and from the West Portal via a pipe into a settling pond. Iron staining was observed in the drainage channel and settling pond (Photo 2 and Photo 3). Subsequent drainage from the settling pond was piped approximately 1 km to a series of secondary settling ponds.

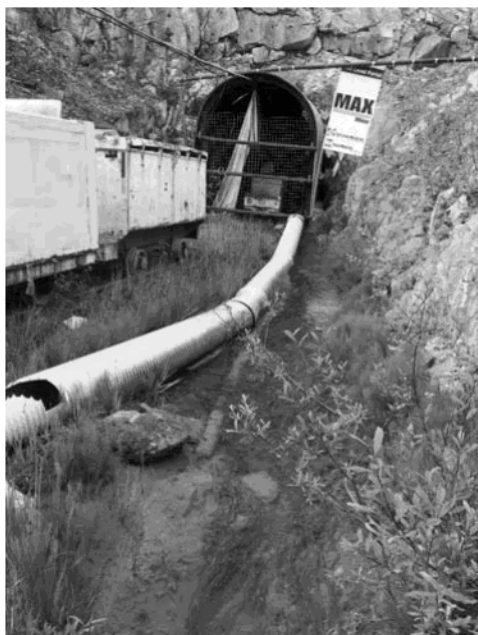
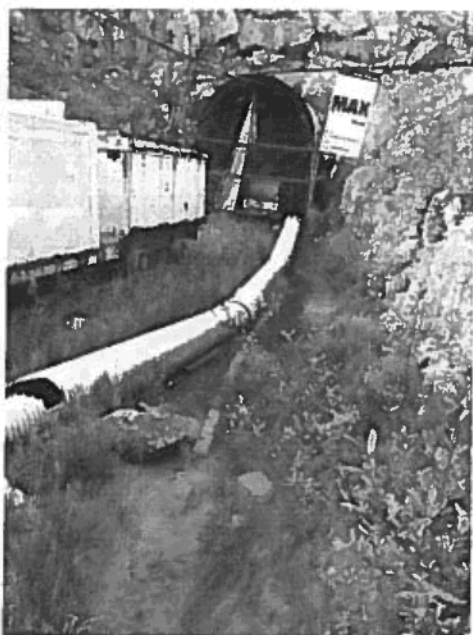
Photo 2. East Portal.

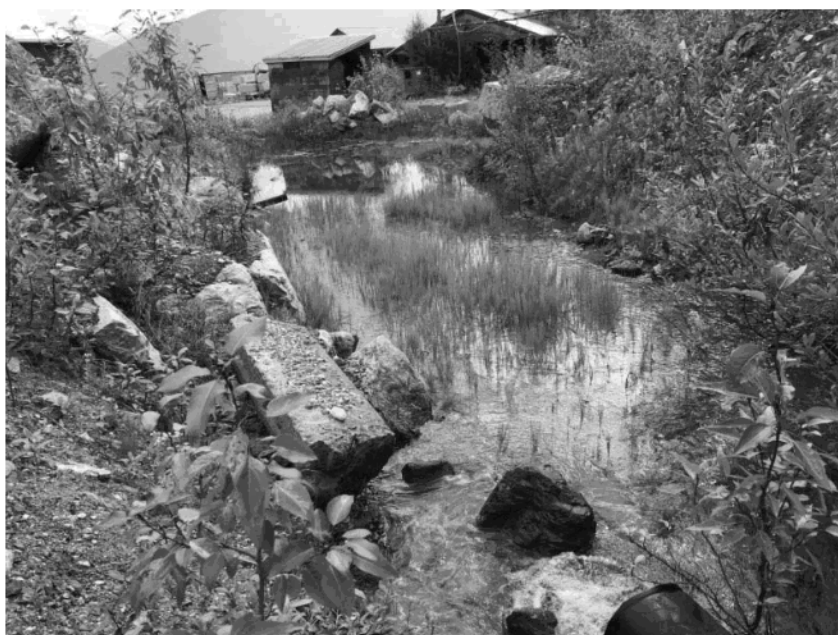
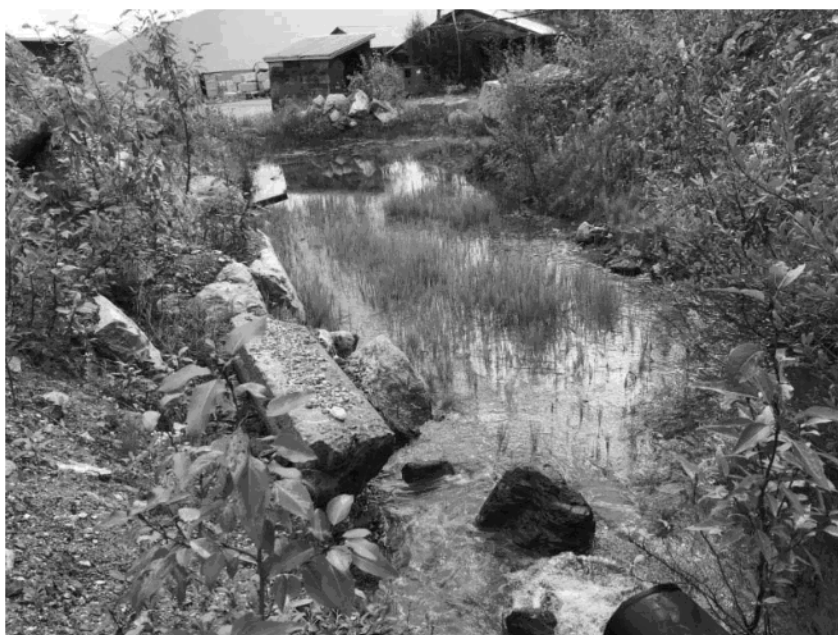
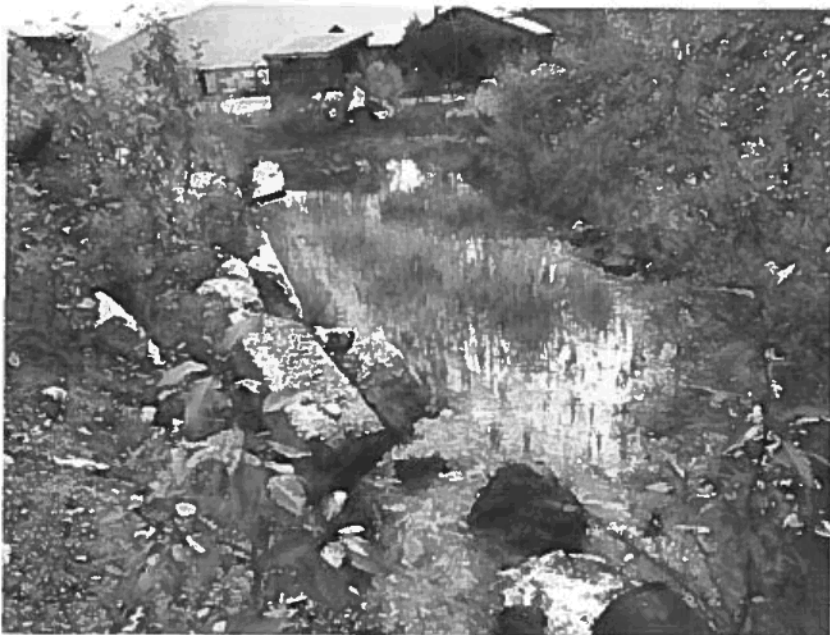
Photo 3. East and West Portal settling pond.

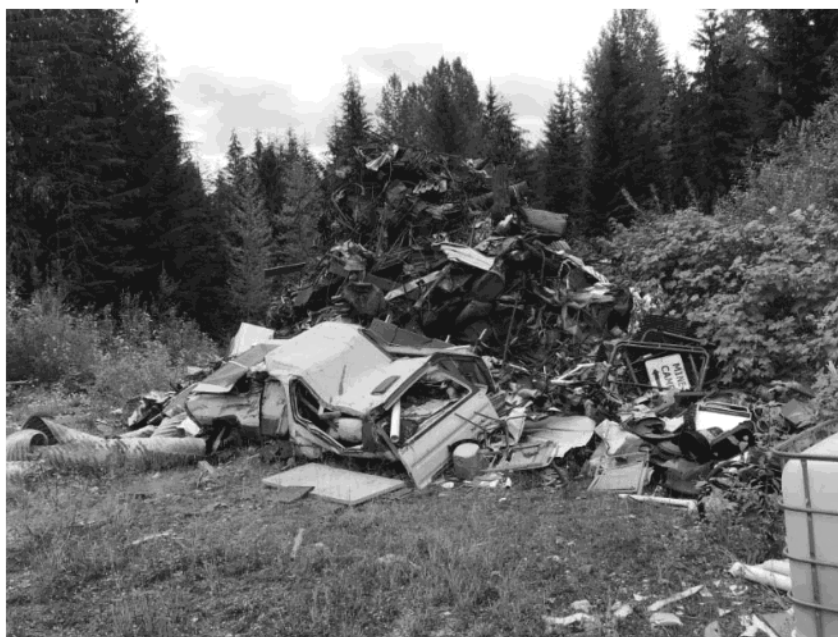
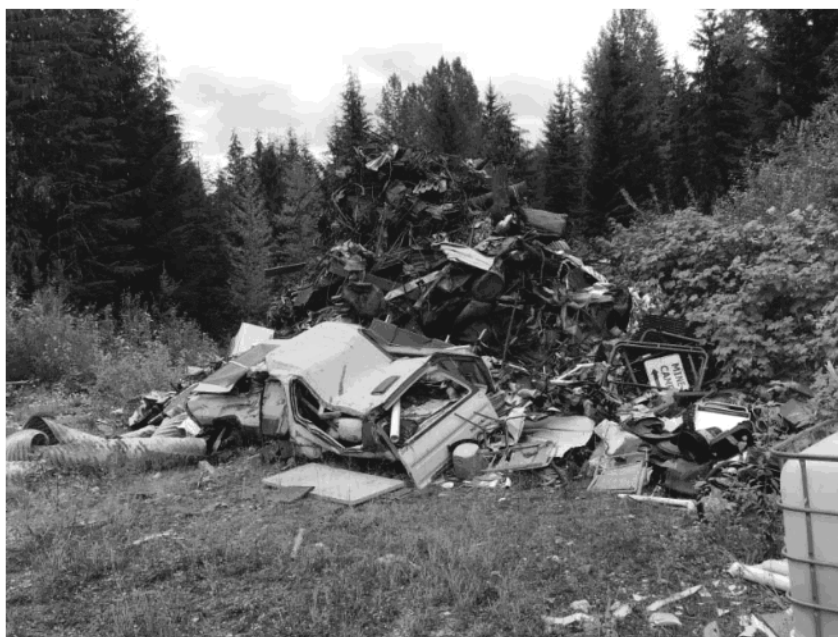
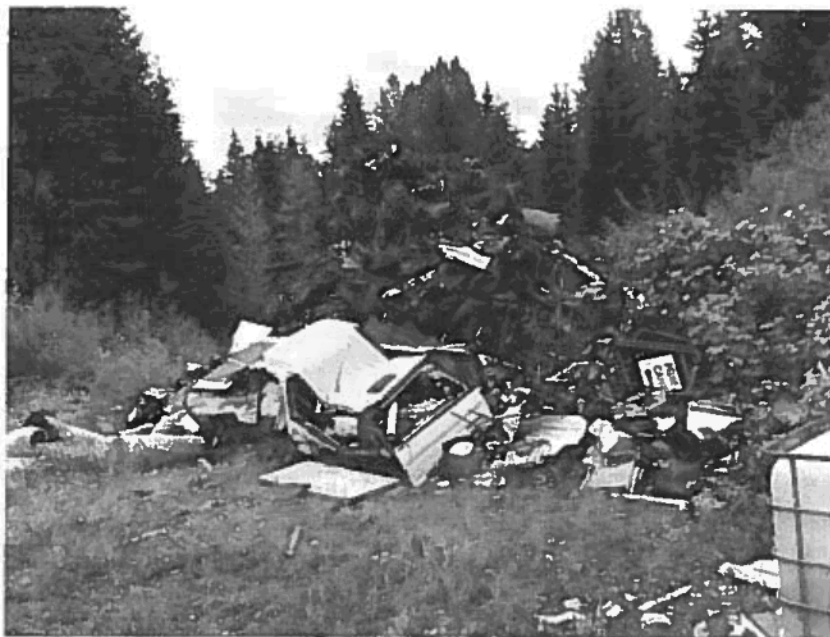
Numerous waste storage containers and scrap materials were observed in an unmarked lay down area during the August 2018 site inspection (Photo 4 and Photo 5). Many of the reagent storage containers appeared to be damaged and holding unknown materials/fluids (Photo 4). Similar observations were documented in the 2015 Reclamation Inspection Report #54096.

Photo 5. Scrap metal pile.

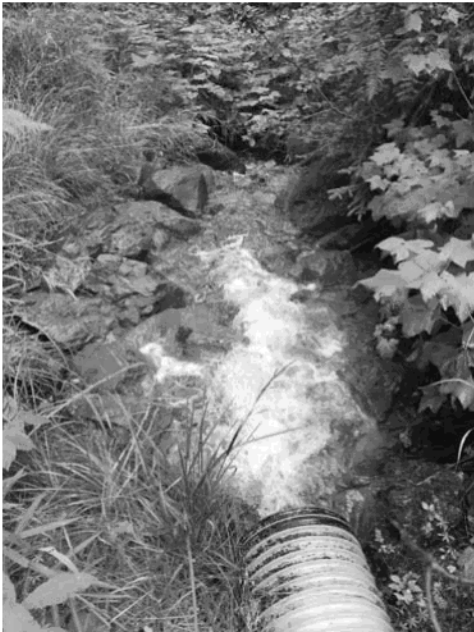
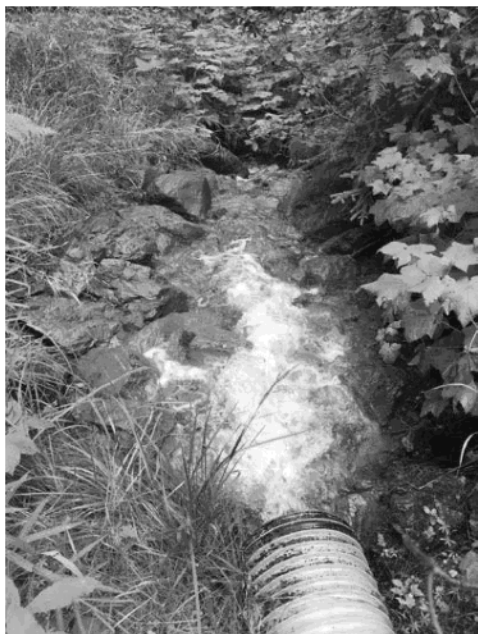
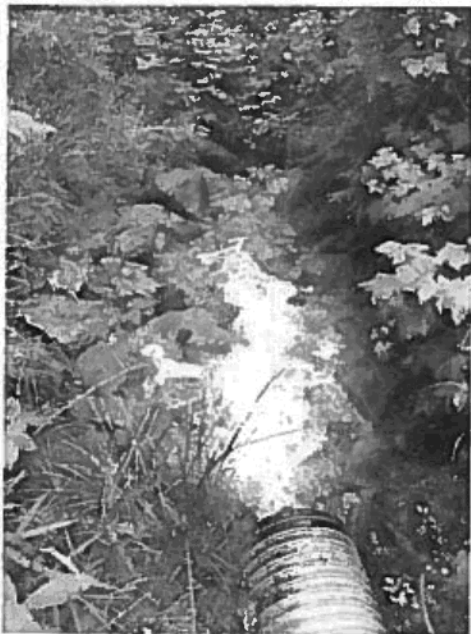
A series of approximately nine secondary settling ponds and seven drainage channels store and transport water flow originating from the portal settling pond. At the time of the inspection, active water flow was observed from the portal outlet pipe and iron staining was observed on the surface of channel materials (Photo 5, Photo 6, Photo 7 and Photo 8). In addition, water quality monitoring data is presented in the 2017 ARR; however, the results for secondary settling pond discharge was not included.

Photo 6. Secondary settling pond drainage channel.

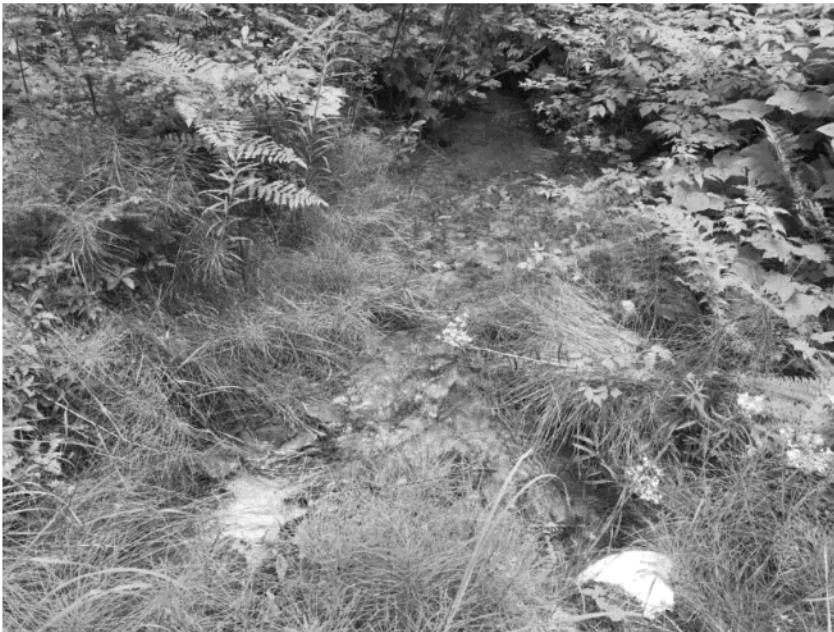
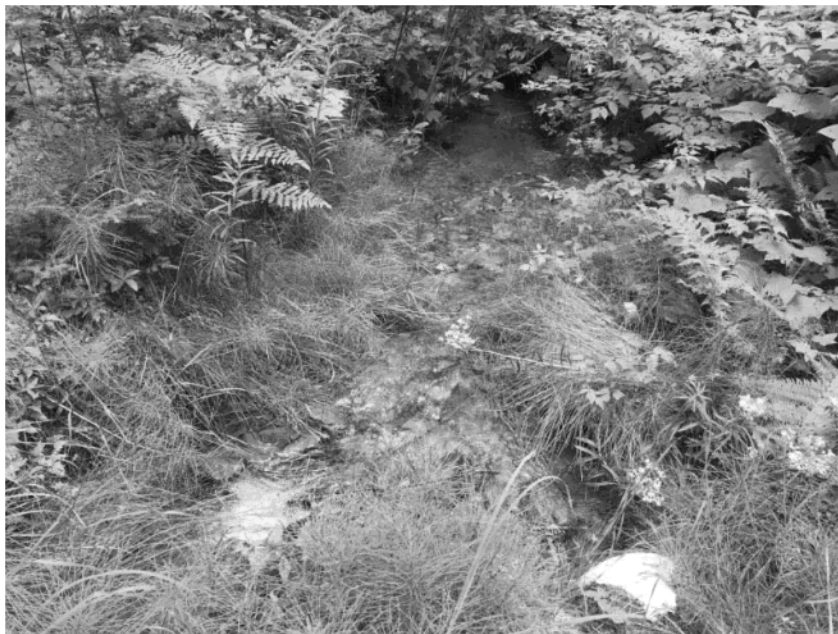
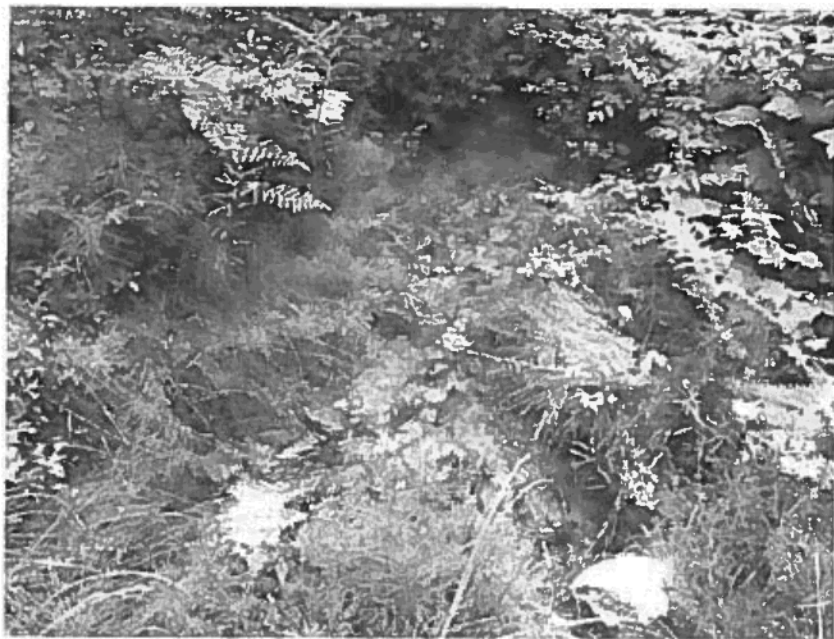
Photo 7. Secondary settling pond drainage channel.

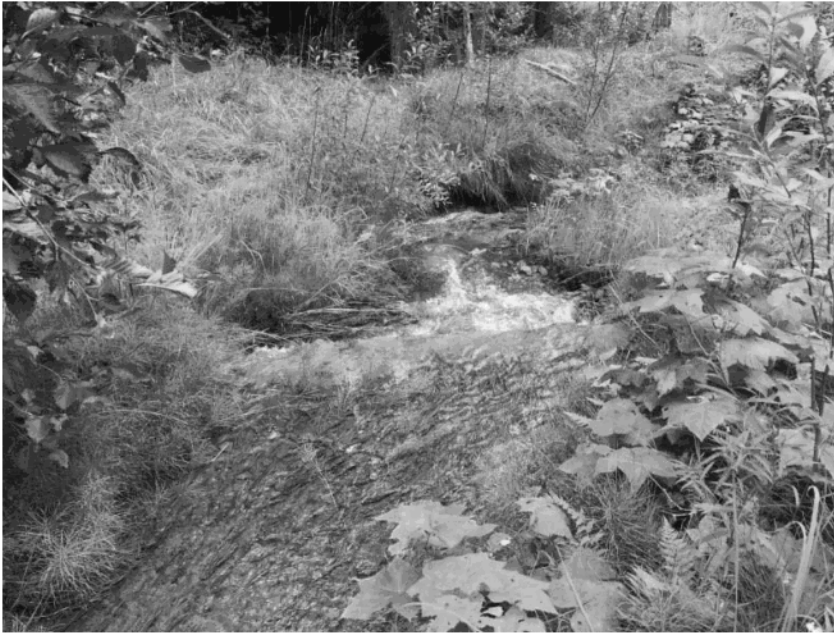
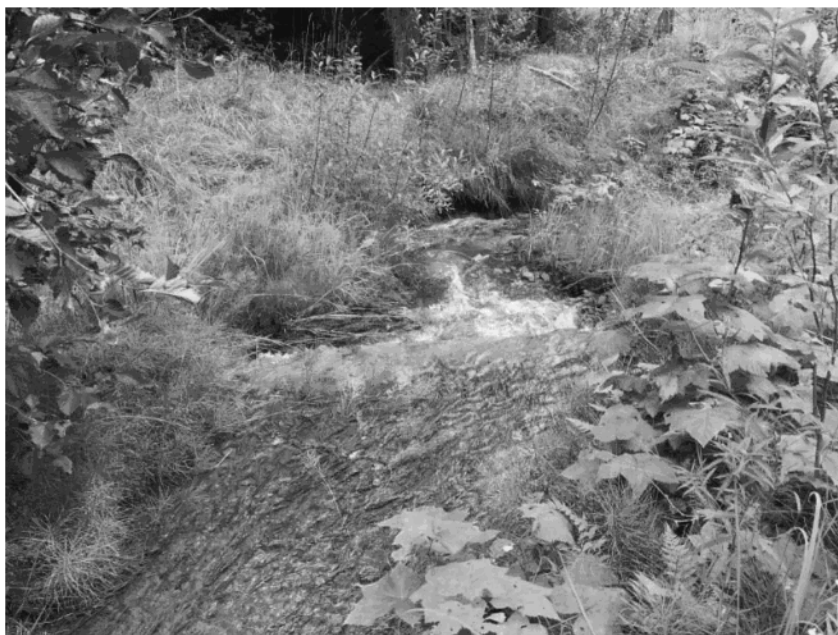
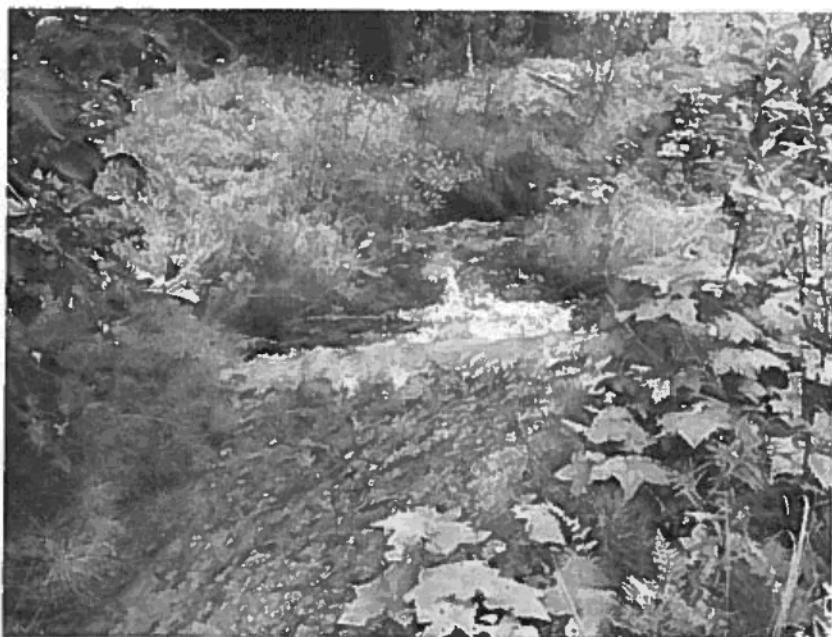
Photo 8. Secondary settling pond drainage channel.

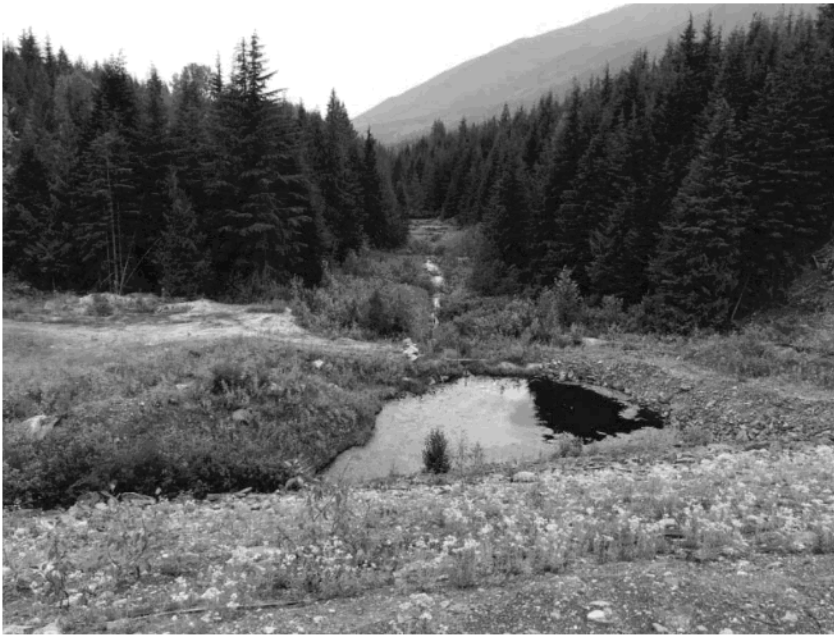
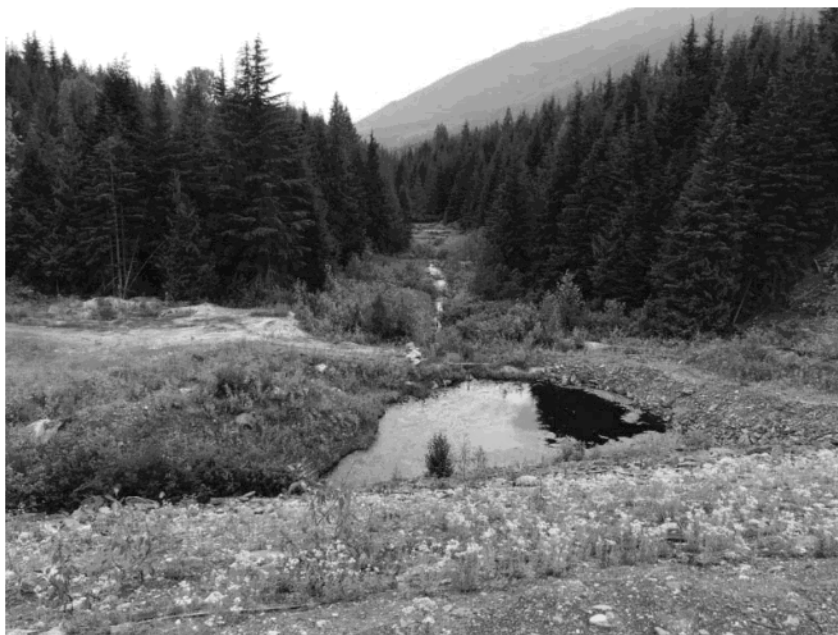
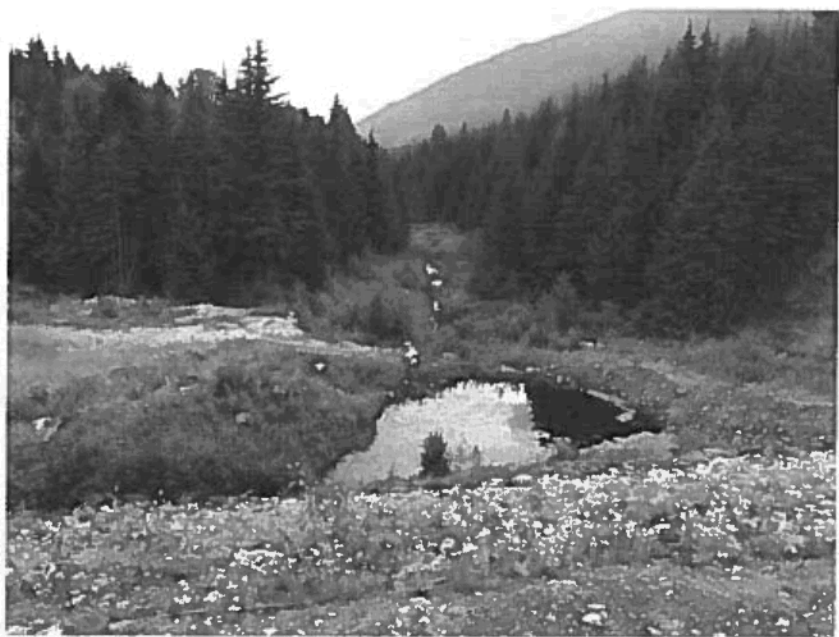
Photo 8. Southeast seepage pond and Shrub Creek.

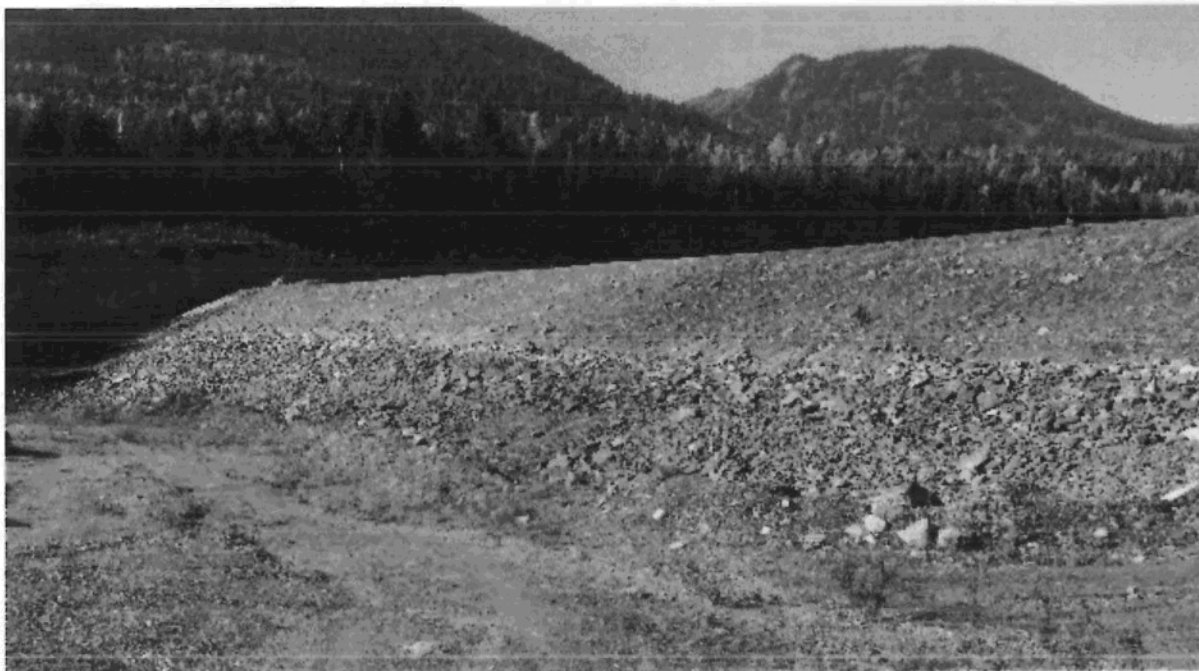
Picture 1: Picture taken looking across the face of the SE Dam structure.

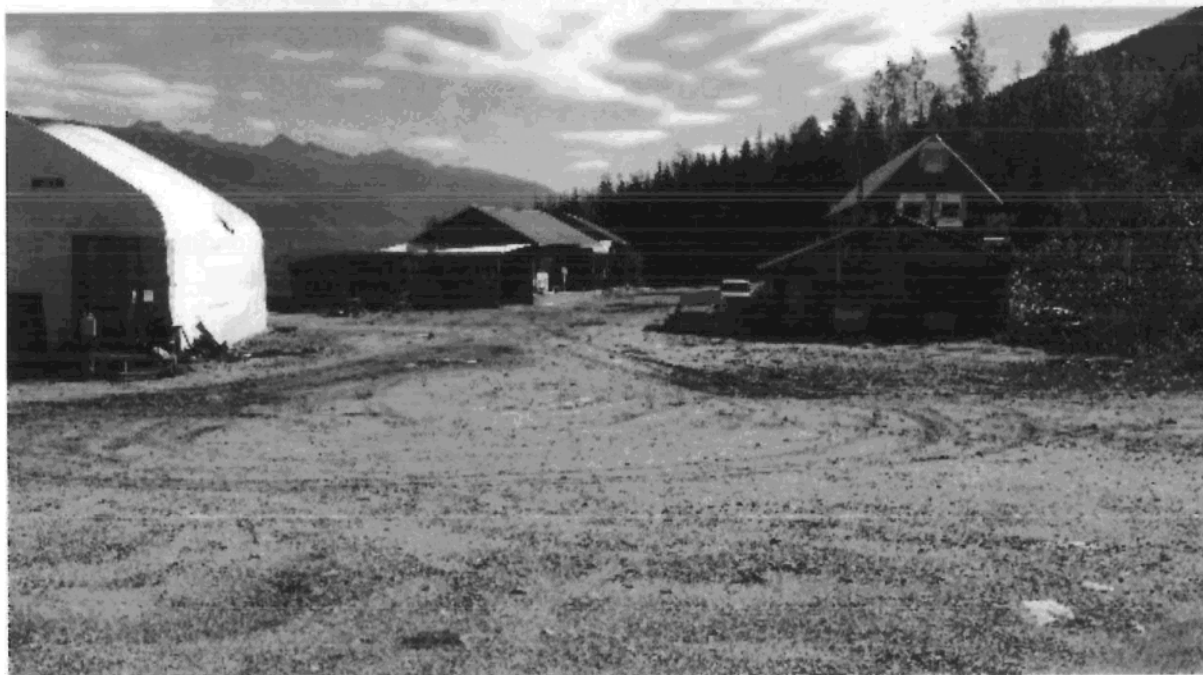
The mill and ancillary structures (picture 11) were visited during the September site inspection. The mill was undergoing some maintenance due to impacts from snow. The interior of the mill was not inspected. Numerous out buildings and structures were observed, specifically the fuel storage area (picture 12), material storage (picture 13), camp and the mine maintenance areas.

Picture 11: Mine office, fuel storage and ancillary buildings.

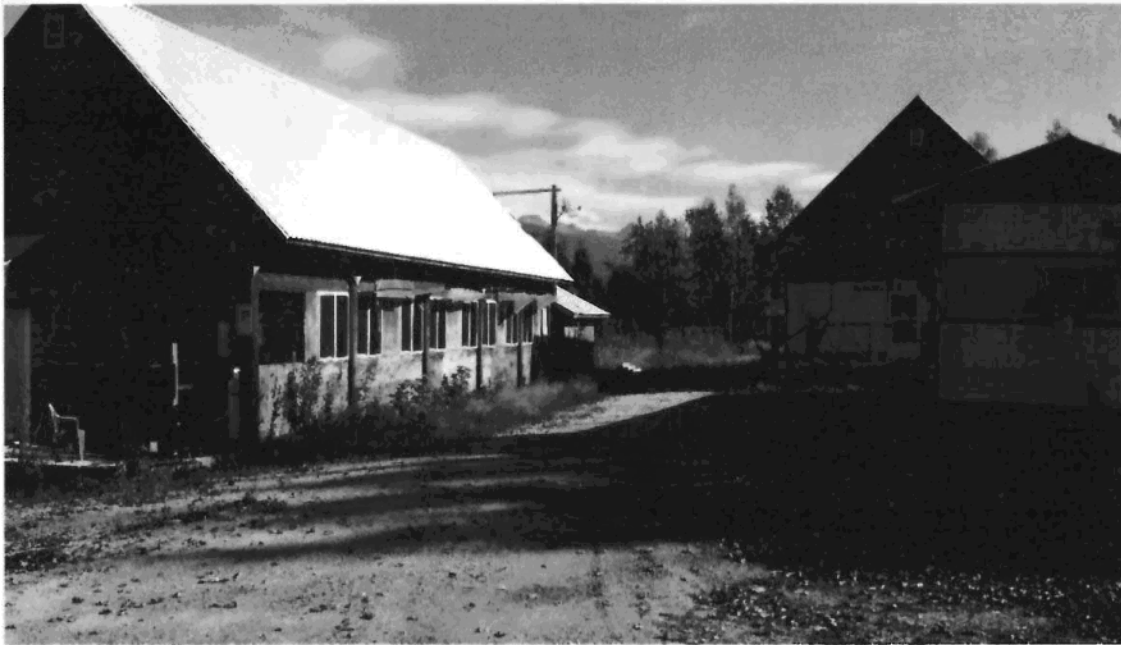
The camp and assay (picture 17) areas were observed and appear to be maintained in good order. Ore quality and grade analysis was largely the function of the assay facility based on personal communication with the onsite representative.

Picture 17: Camp structures.

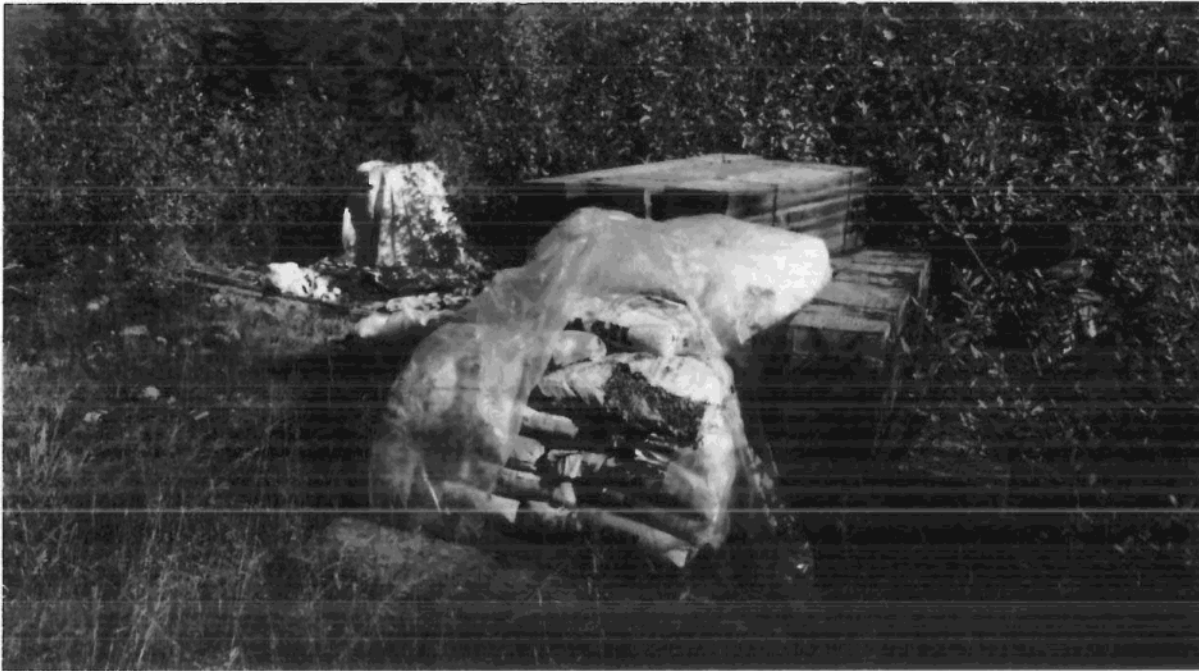
The core storage area was observed and a number of concerns were identified to the company representative. Specifically, open fuel tanks, Xtra Clay product (picture 18), oil soaked geotextiles (picture 20) and a large tank (picture 19) with what appeared to contain a hydrocarbon was observed. The large tote containing the hydrocarbon was not secure, and visual evidence indicated that the material in the tote was released to the ground (picture 19). Staining around this vessel was observed.

Picture 18: Xtra Clay product storage at core area.

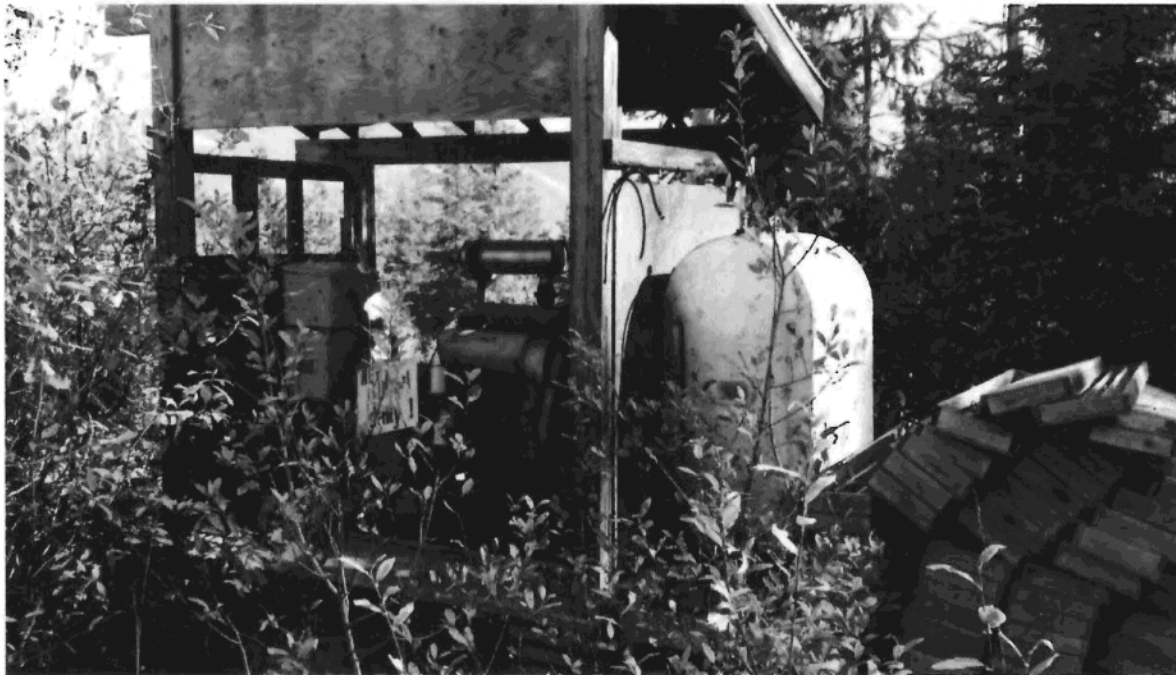
Picture 21: Generator with fuel storage at core storage area.

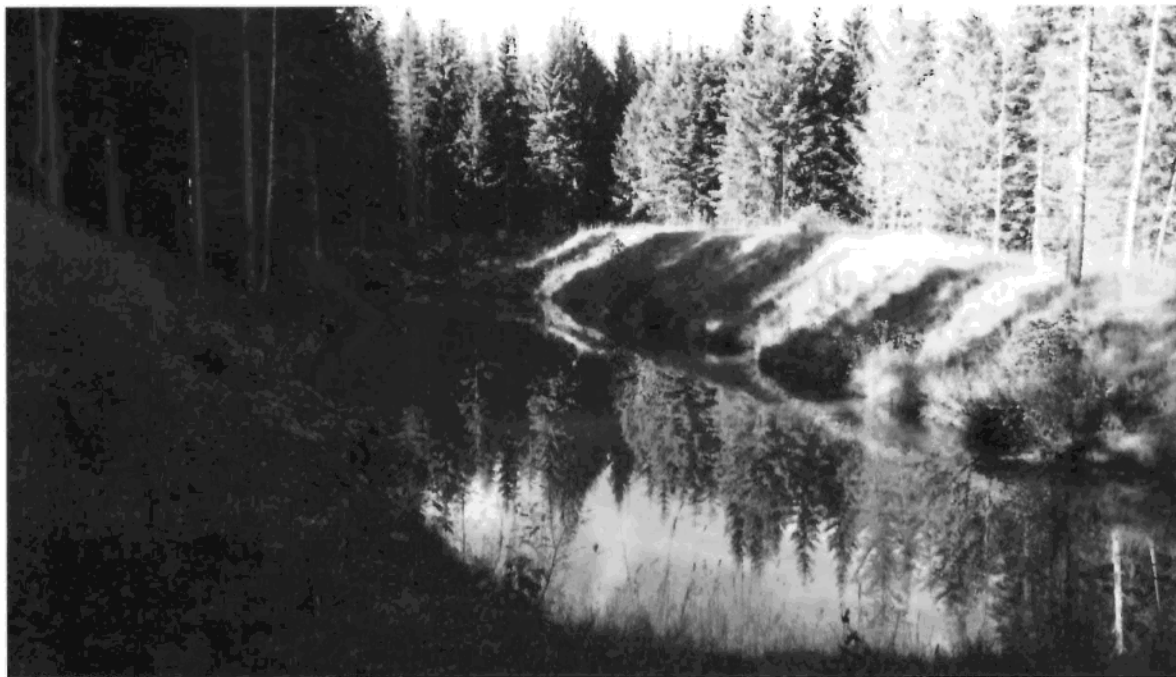
All settling ponds (picture 23) and channels (picture 24) were observed.

Picture 23: Settling pond.
