2015 MATSQUI DYKE INSPECTION

Prepared By: James Hill

October 2015

CITY OF ABBOTSFORD

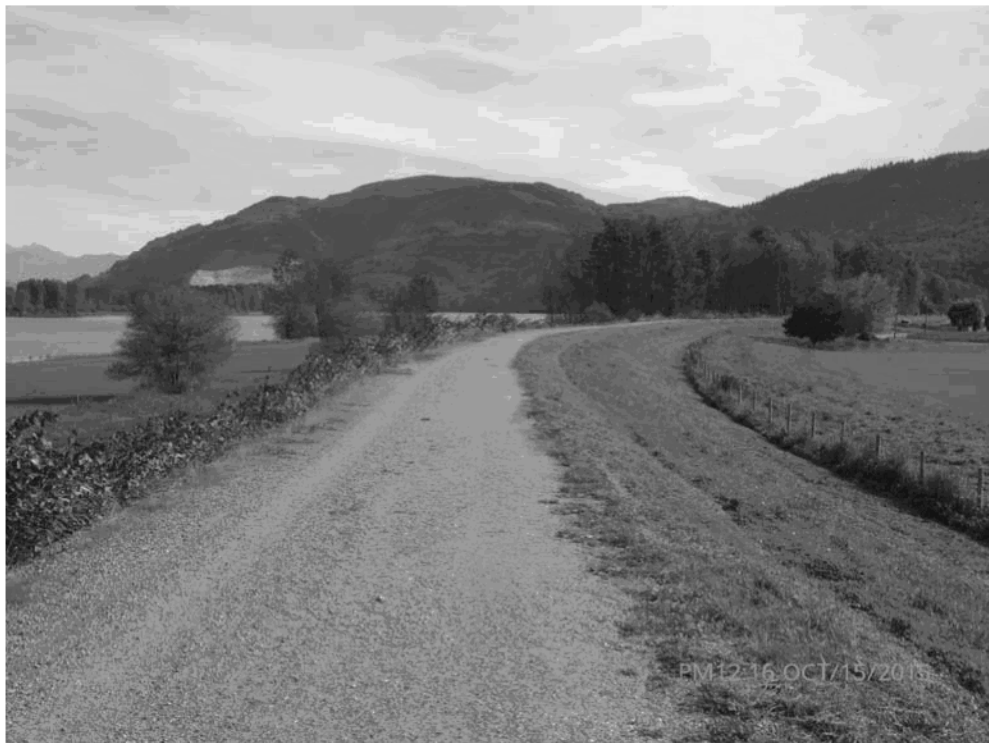
Figure 18: Dyke - Station 95+00 – One of the Erosion Arcs

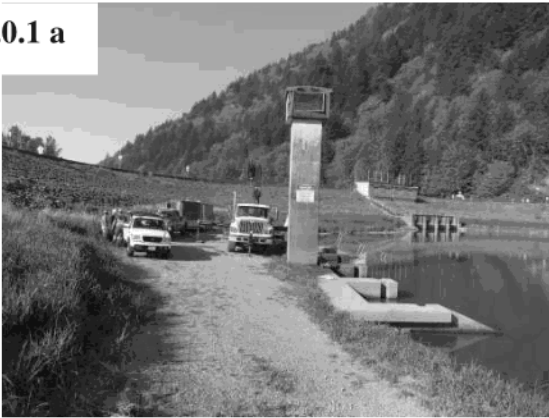
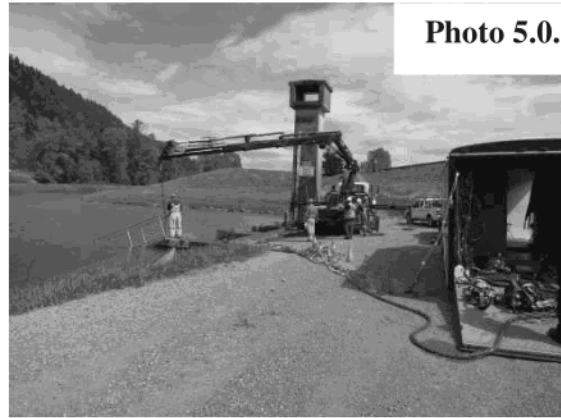
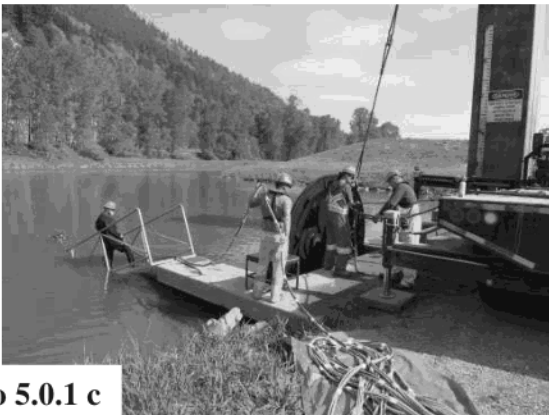
Inspected items were found in satisfactory working condition (see photos 5.0.1a, b, c & d).

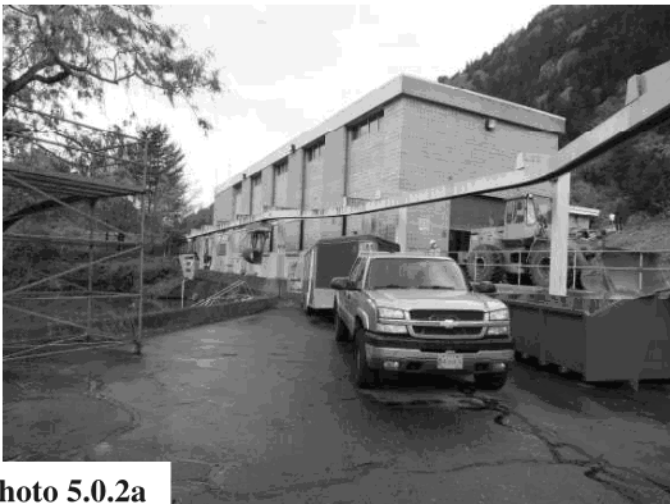
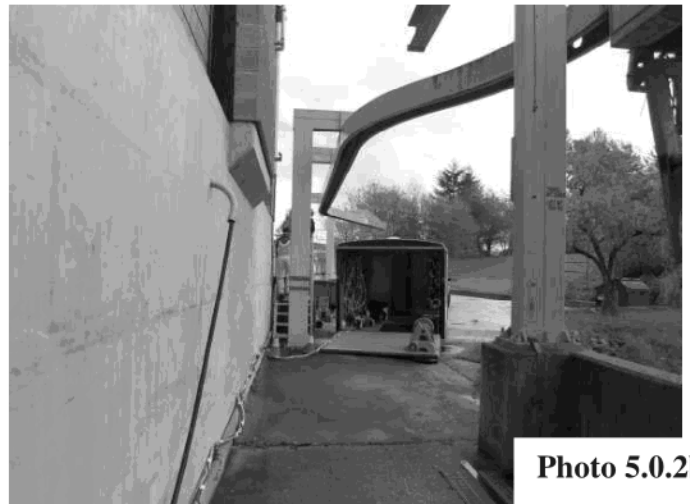
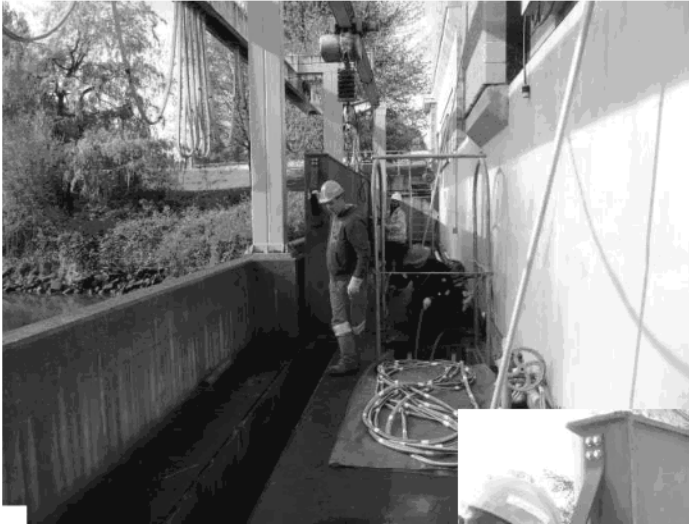
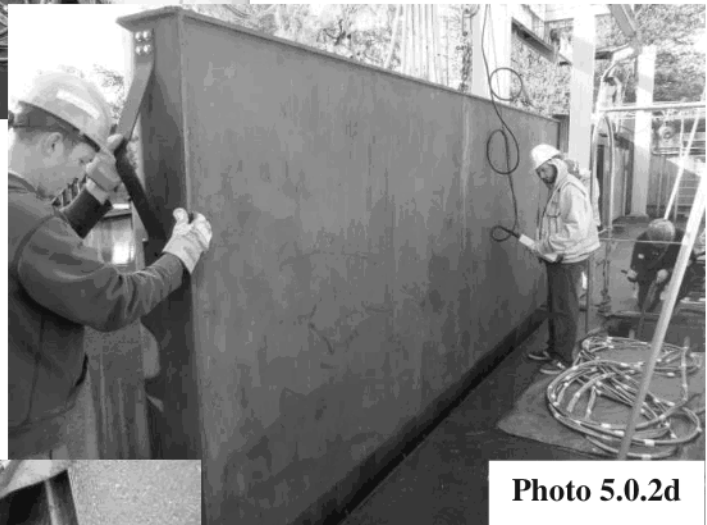
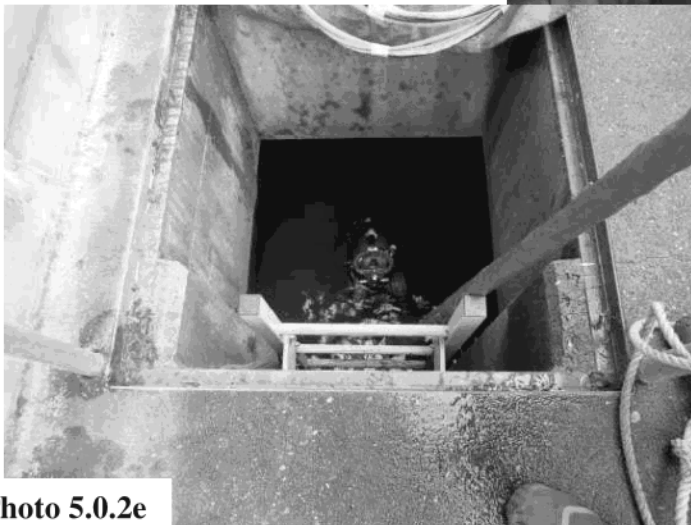
- Divers inspected submerged concrete structure and trash racks. All inspected items were reported in satisfactory condition.
- Slots and guides at the bay #2 were inspected and found free of obstruction and visible mechanical damages.
- Three sections of the stop lock were inserted at the front of the pump compartment. Diver inspected seal tightness between pontoons and at the guides (see photos 5.0.2a, b, c, d & e).

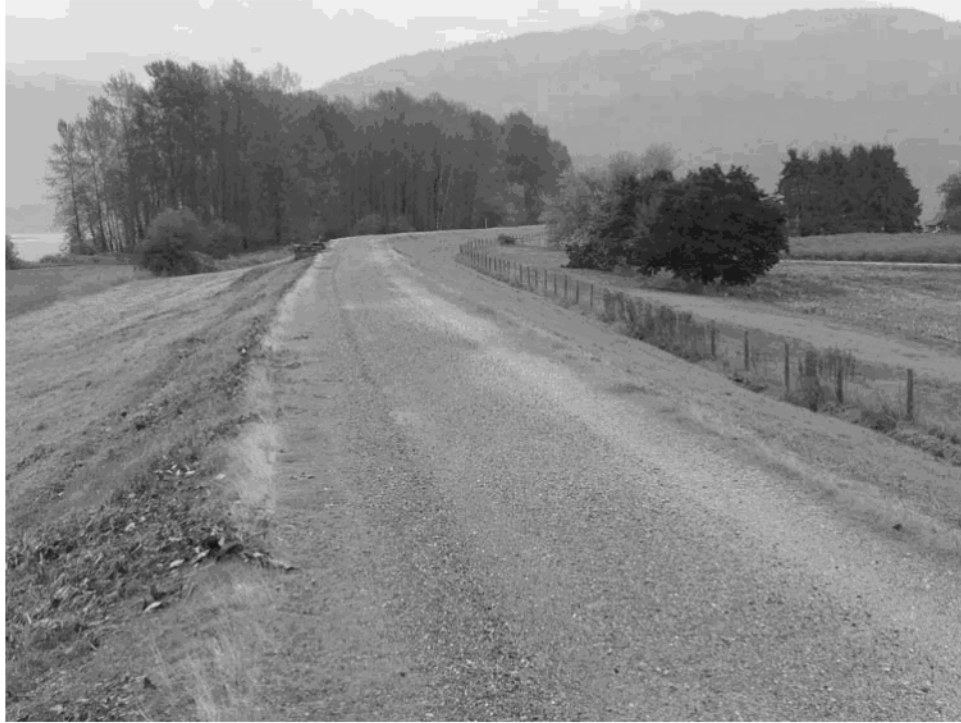
Figure 18: Dyke - Station 95+00 – One of the Erosion Arcs

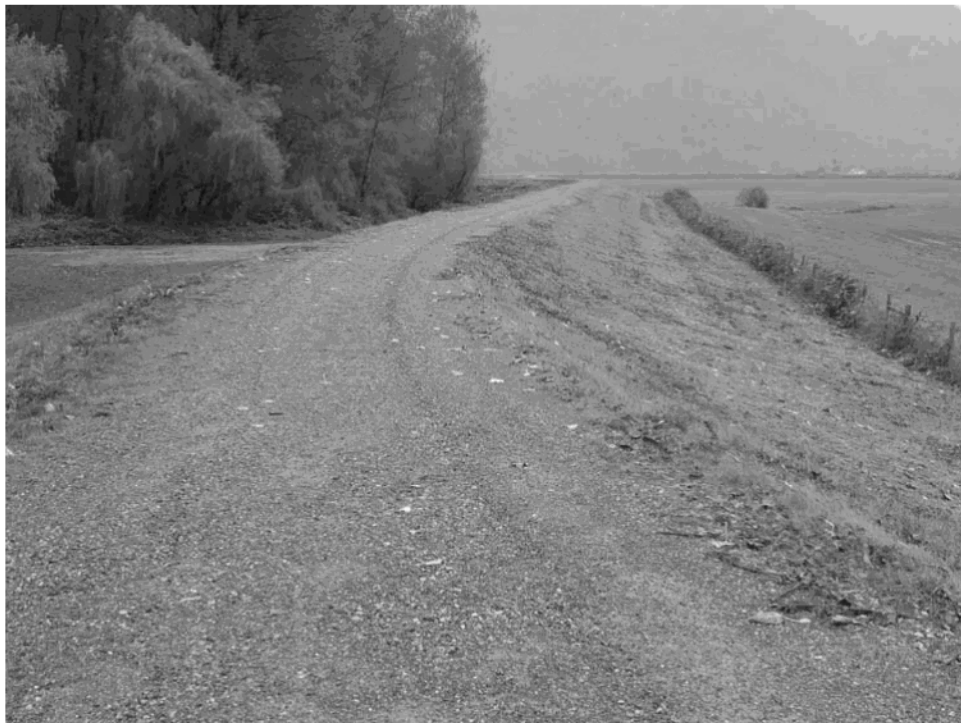
Figure 21: Dyke - Station 110+00 – One of the Erosion Arcs

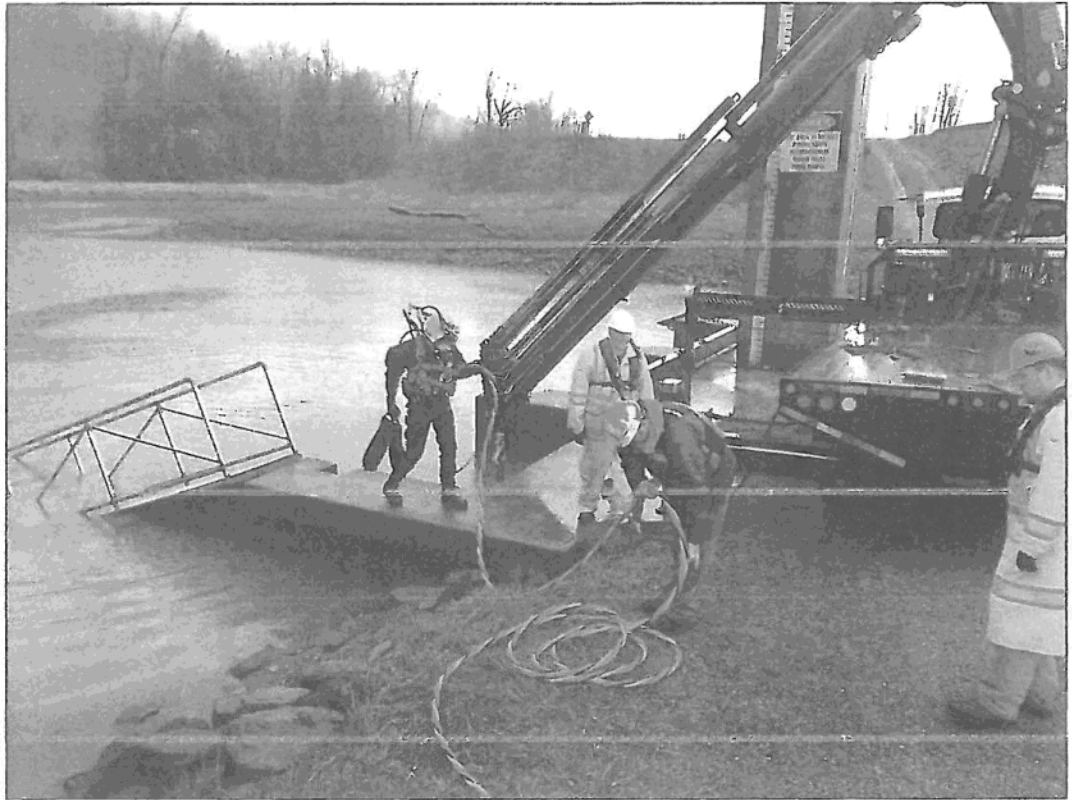
Ref. 2

City crew opening Flap Gate in preparation for hoisting.

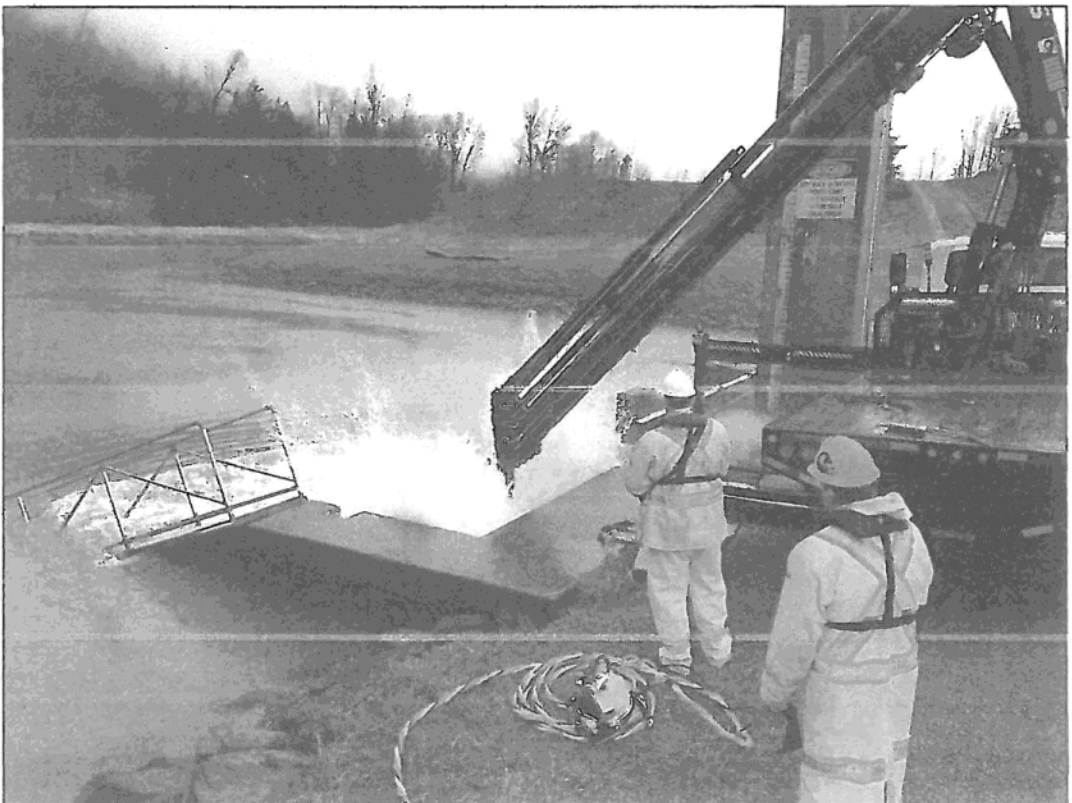
Ref.3

Number 1 Flap Gate being hoisted to its secure position in preparation for inspection.

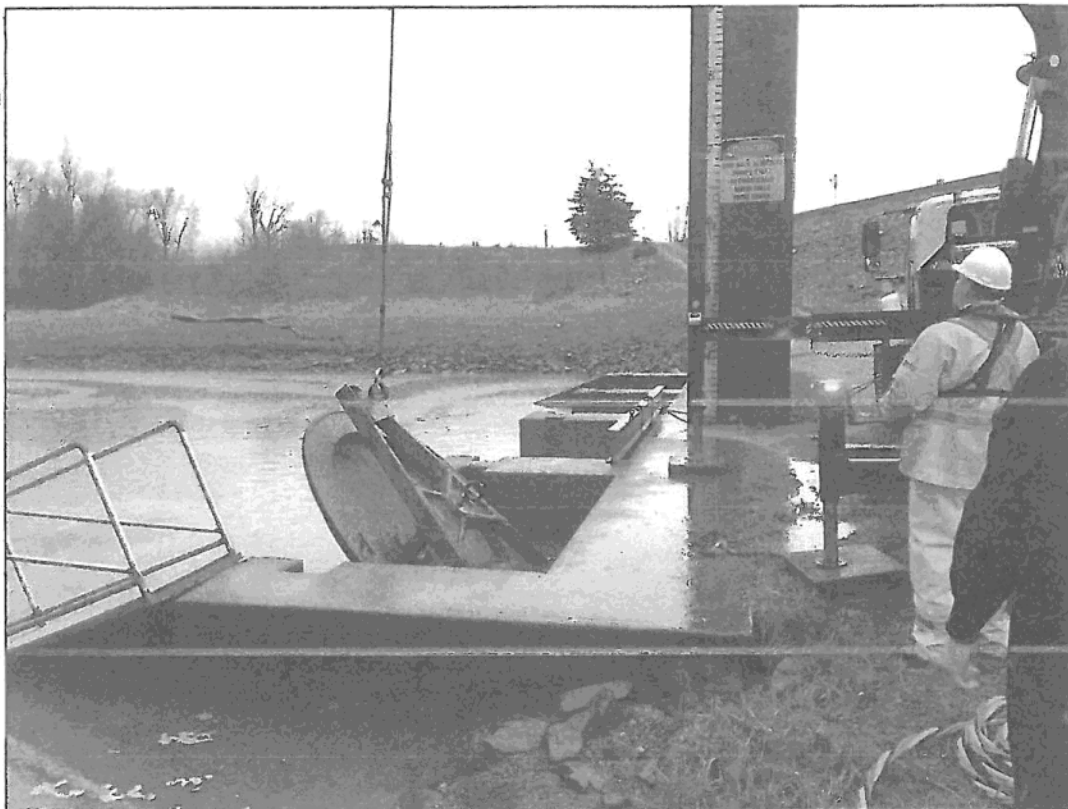
Ref.4

Securing Flap Gate to truck and bulkhead.

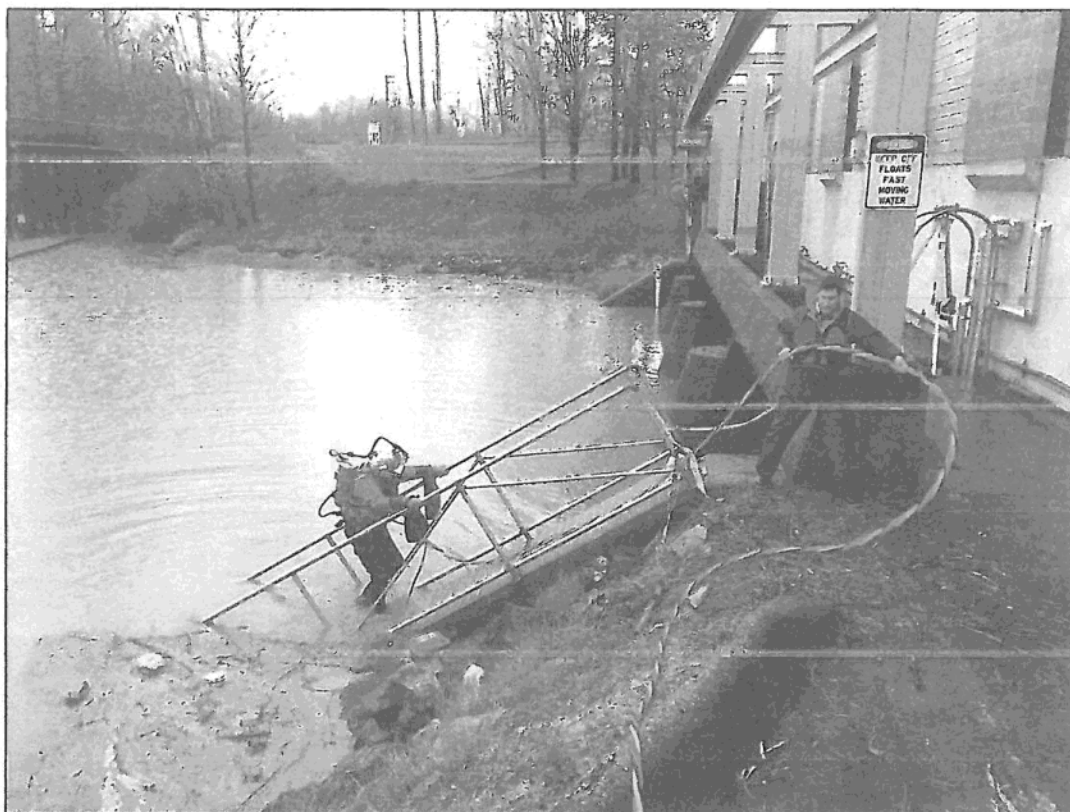
Ref.5

Diver entering water in preparation for Trash Rack inspections.

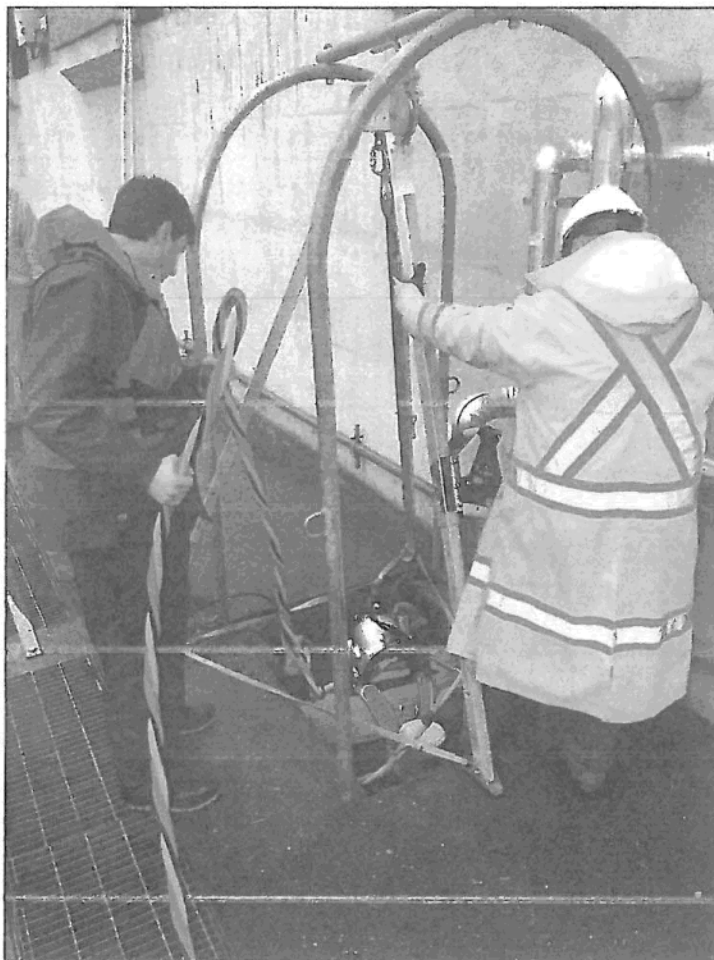
Ref.7
Diver entering #4 pump bay for
stop log inspection.
