June 22, 2018

ISSUED FOR USE
FILE: 704-ENG.VGEO03227-03
Via Email: Ryan.Gustafson@gov.bc.ca

Subject: Rumming Road Erosion Event – Summary of Remediation

RUMMING ROAD FAILURE REMEDIATION
LANTZVILLE, BC

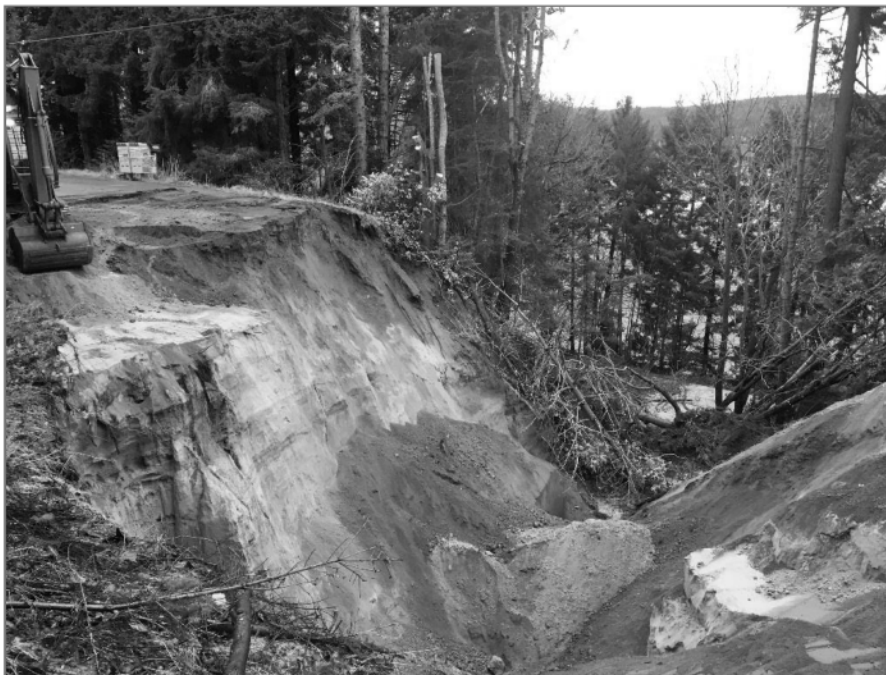
Photo 1: Excavator benching the gravel overburden on the west side of failure.

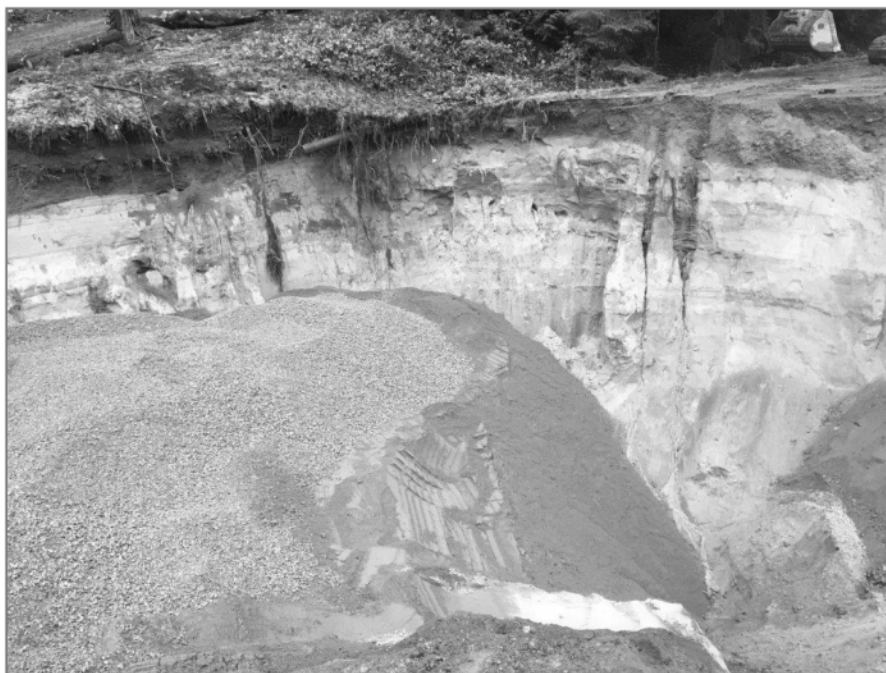
Photo 2: Filter sand being placed up sides of sand sidewalls on southern sidewall of failure.

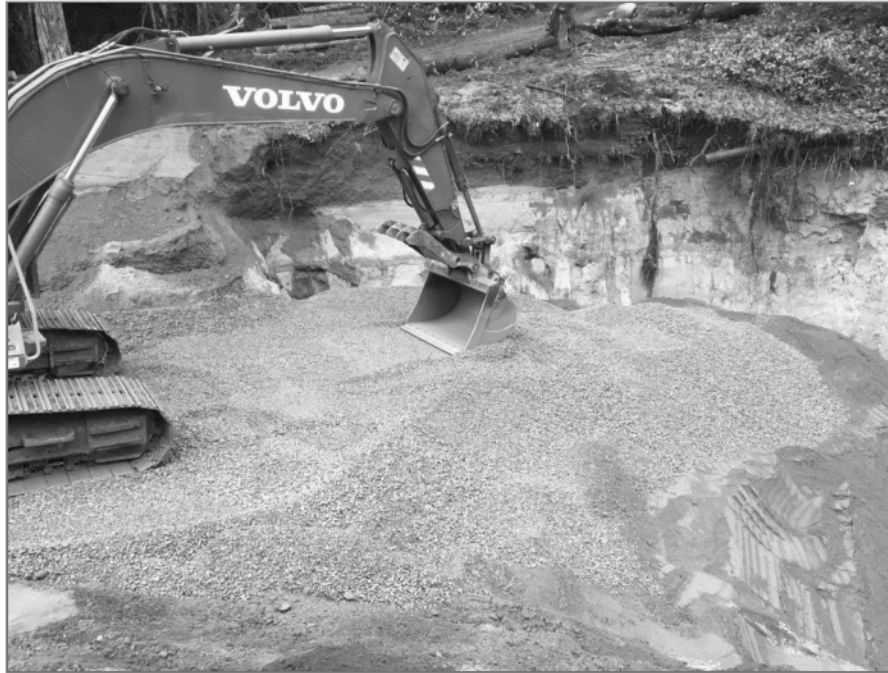
Photo 3: Crush travel surface being placed and tamped above sand filter.

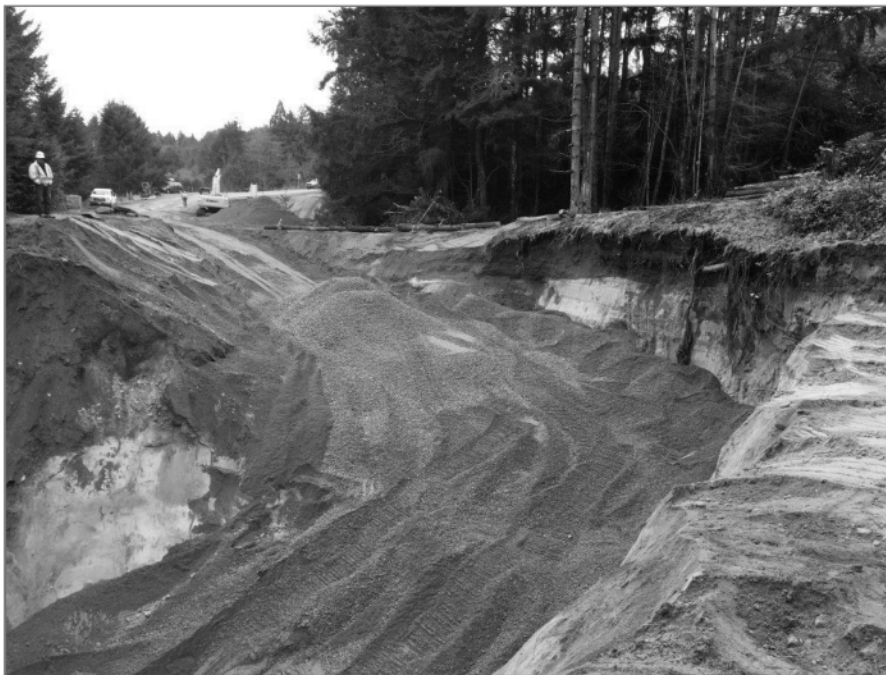
Photo 1: Progress of the ramp and access to the toe of the failure.

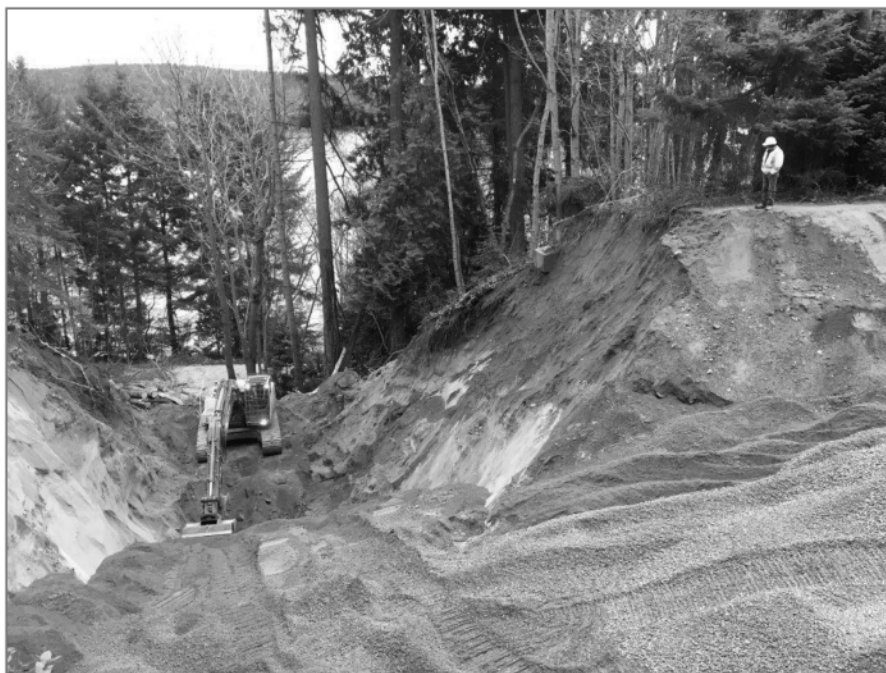
Photo 2: Excavator just over halfway down the slope, continuing to excavate loose material and asphalt debris.

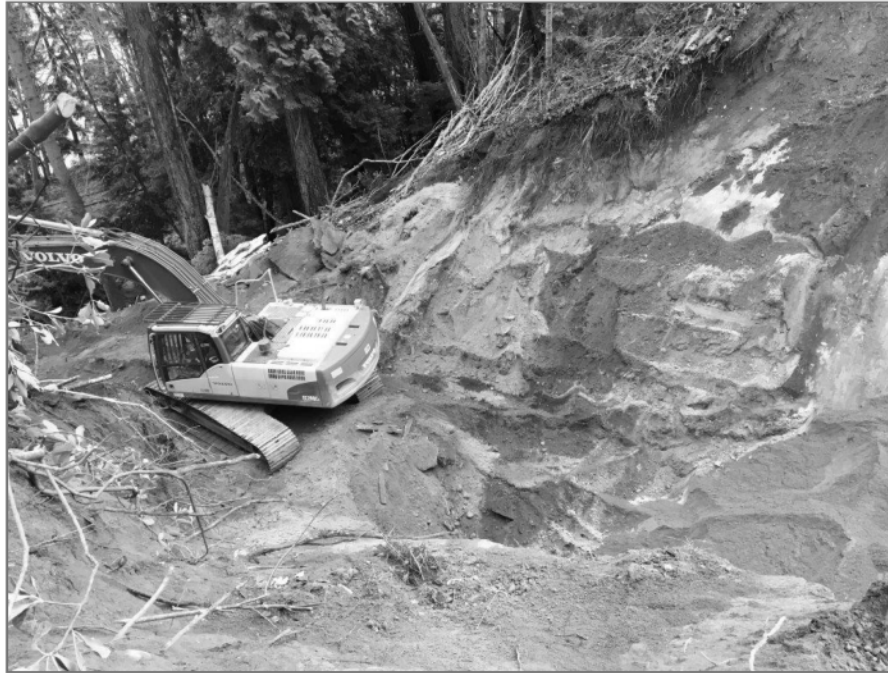
Photo 4: Excavation of loose material and asphalt to expose undisturbed subgrade reviewed, covered with sand filter. Progressed to over midway down slope.

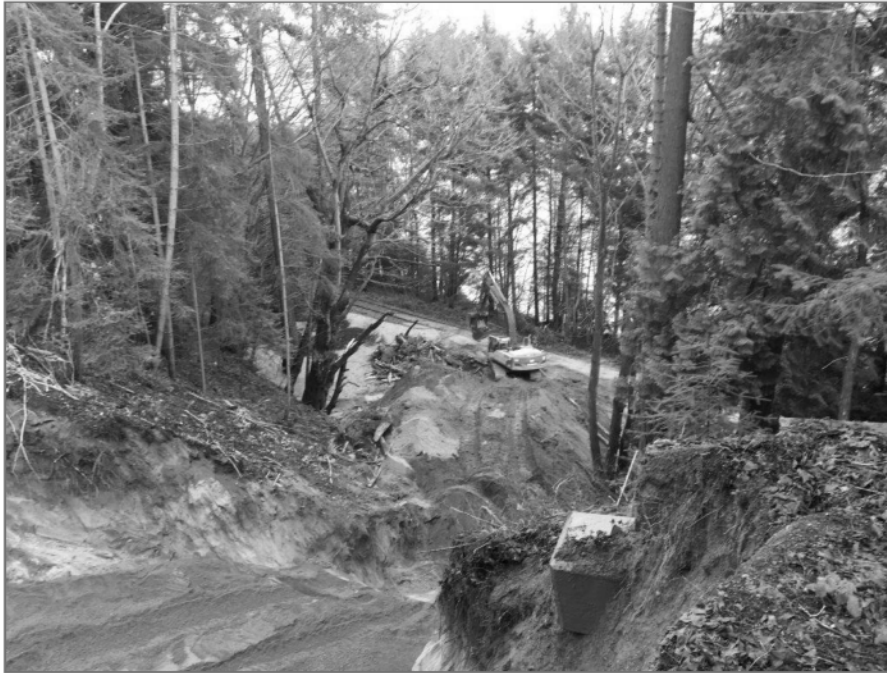
Photo 1: Excavator at toe continuing to stockpile loose material and sort wood debris, asphalt and sand.

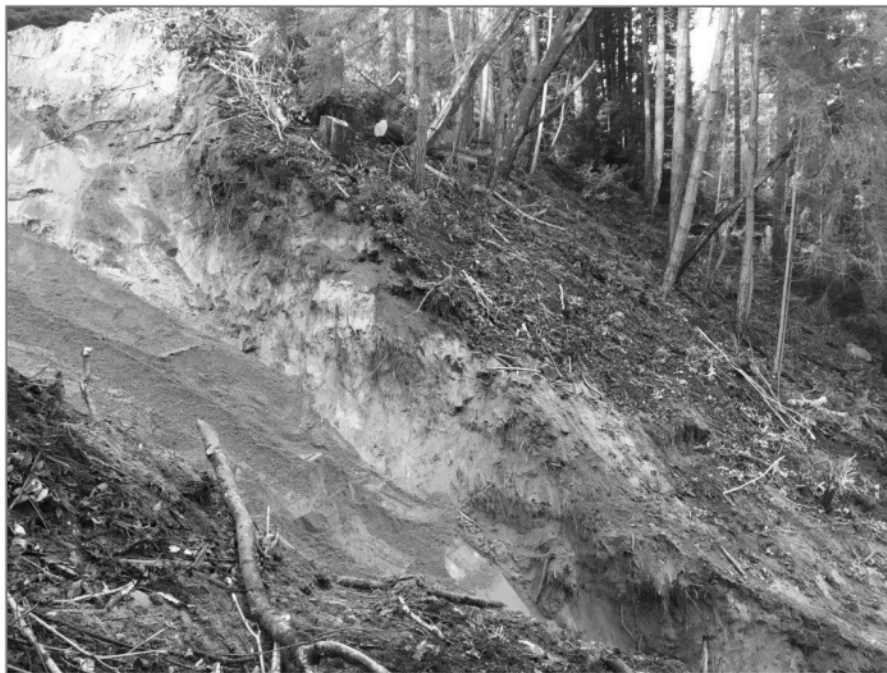
Photo 2: Looking west, mid-slope of the failure area.

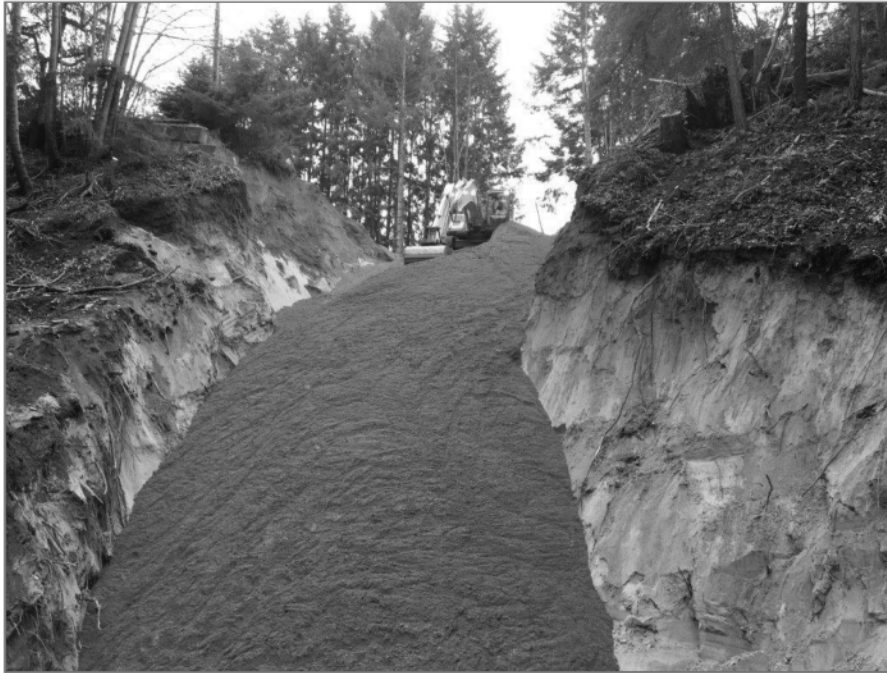
Photo 5: Sand being moved down the failure to cover the cleaned up toe excavations and help shore up the recent sloughing.

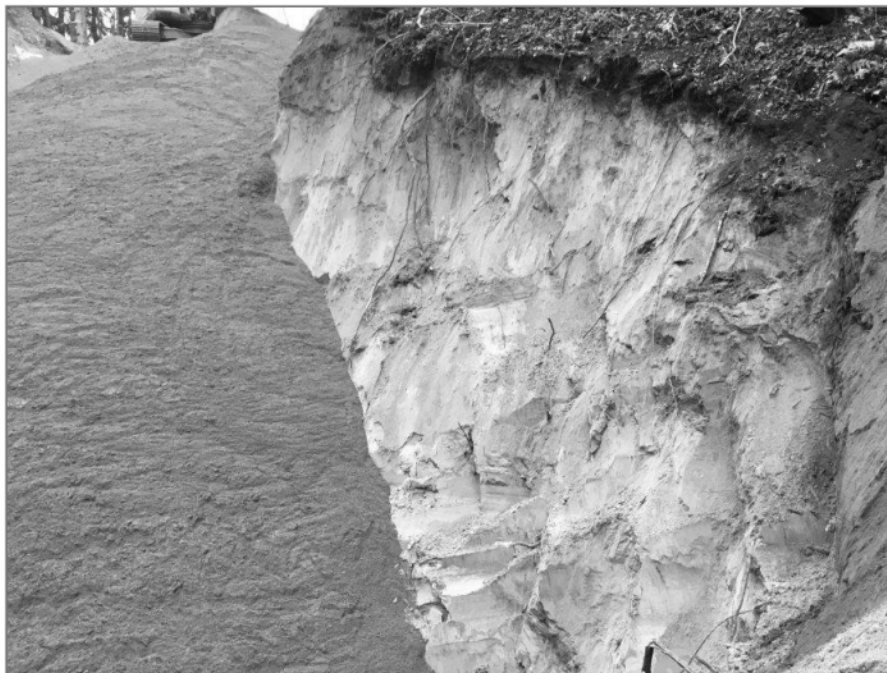
Photo 6: Cleaned up face of sloughed area.

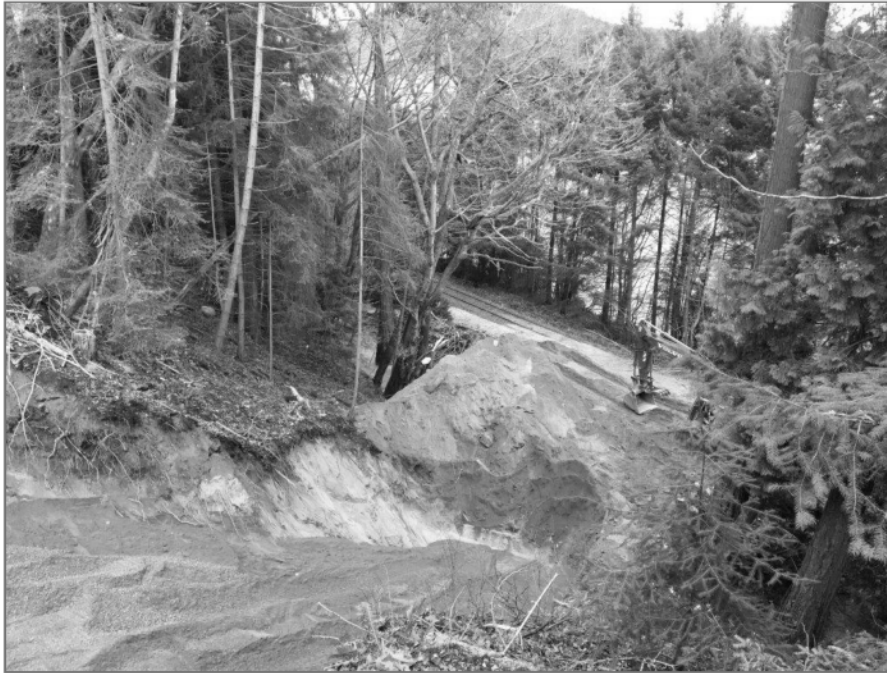
Photo 1: Excavator at toe continuing to stockpile loose material and clean out toe.

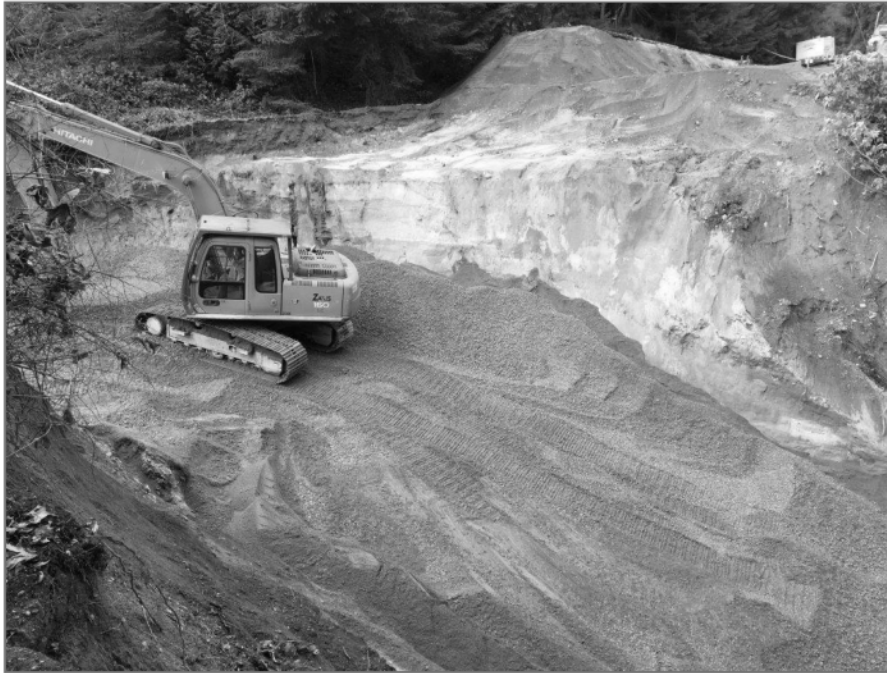
Photo 3: Contractor continuing to build up sand filter and crush material to help support existing sidewalls.

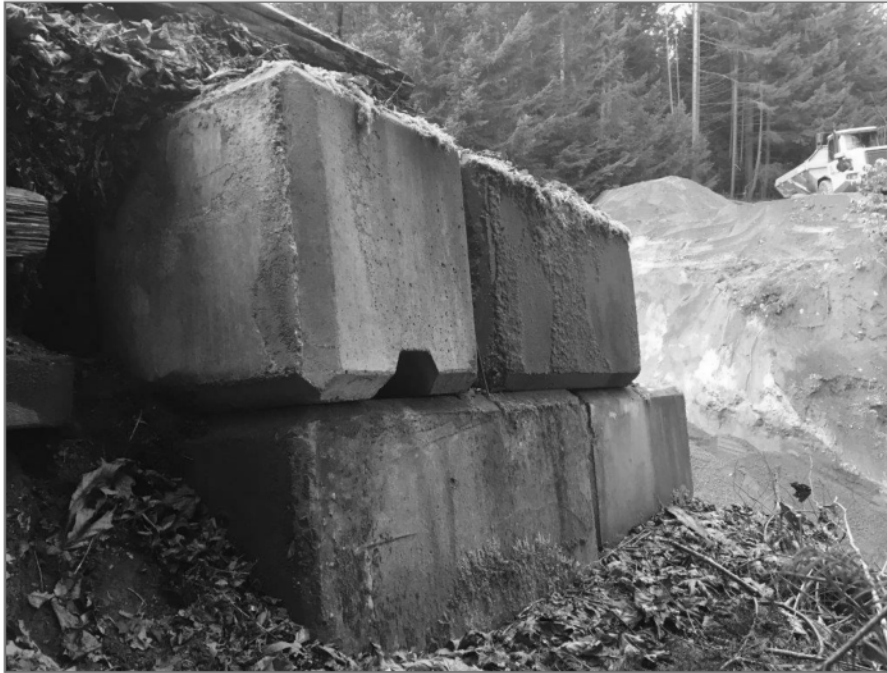
Photo 3: Lock block retaining wall on eastern property.

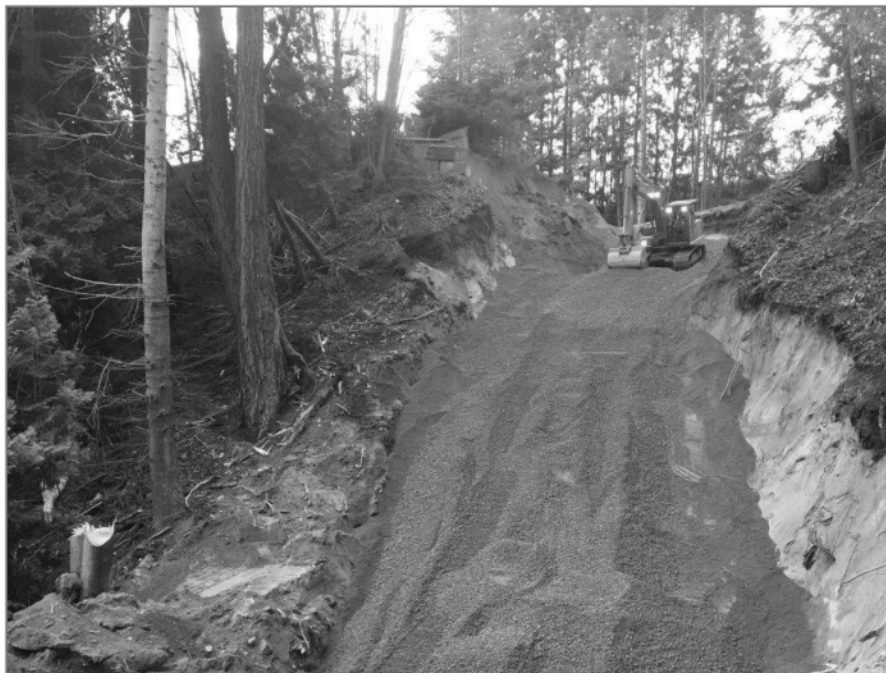
Photo 6: Progress of the access road down to the toe of failure.

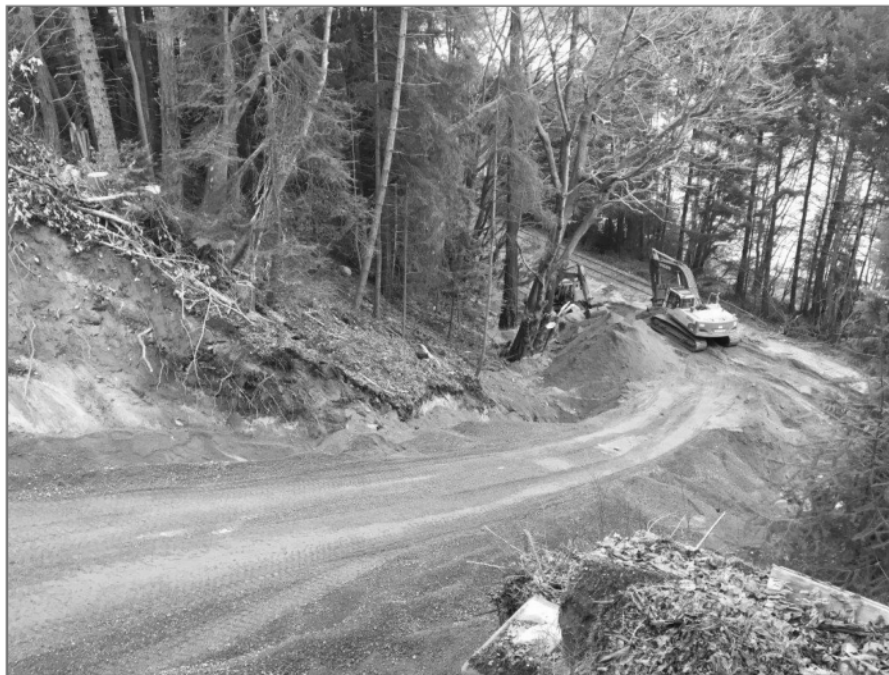
Photo 1: Continued progress on the removal of the waste material from the bottom of the failure.

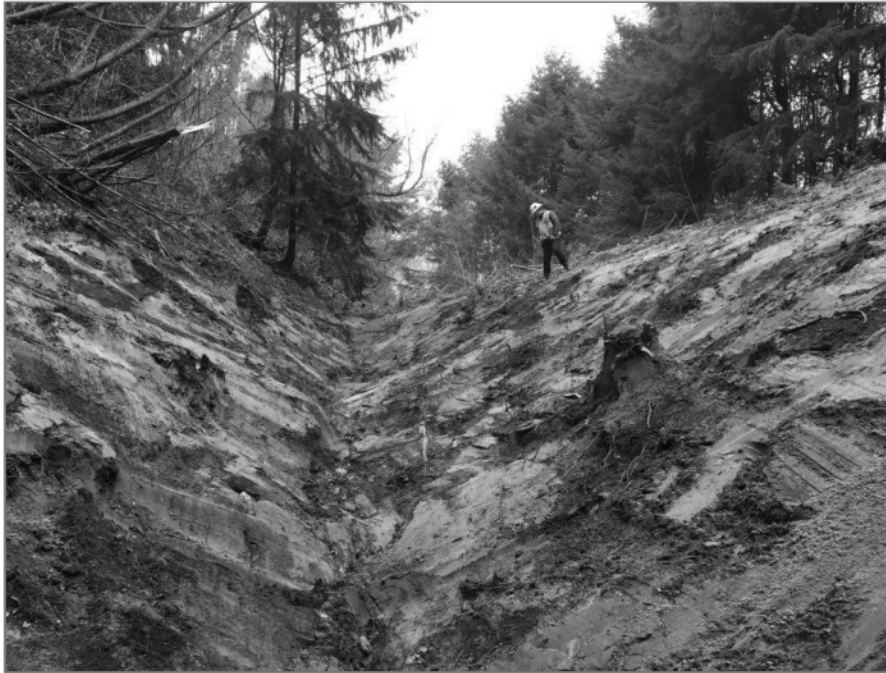
Photo 3: View from inside the ditch. Looking west.

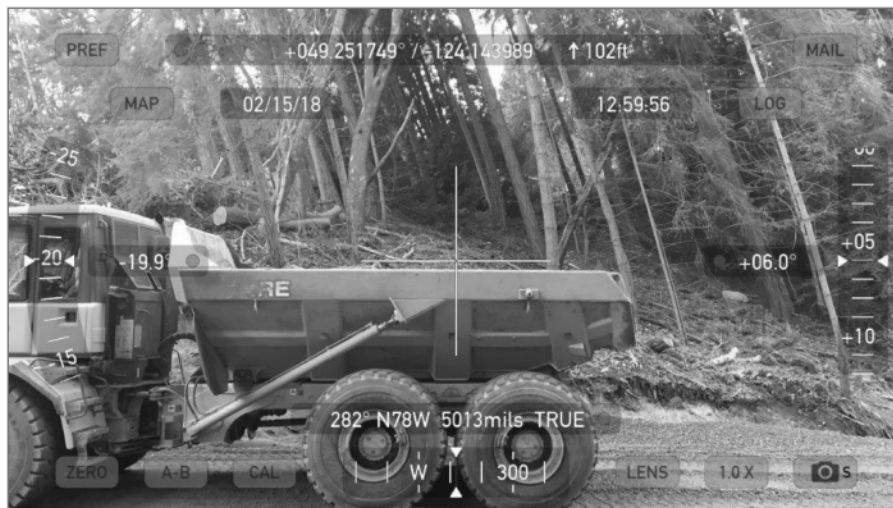
Photo 5: Slope inclinometer image indicating the access ramp is approximately 20 degrees.

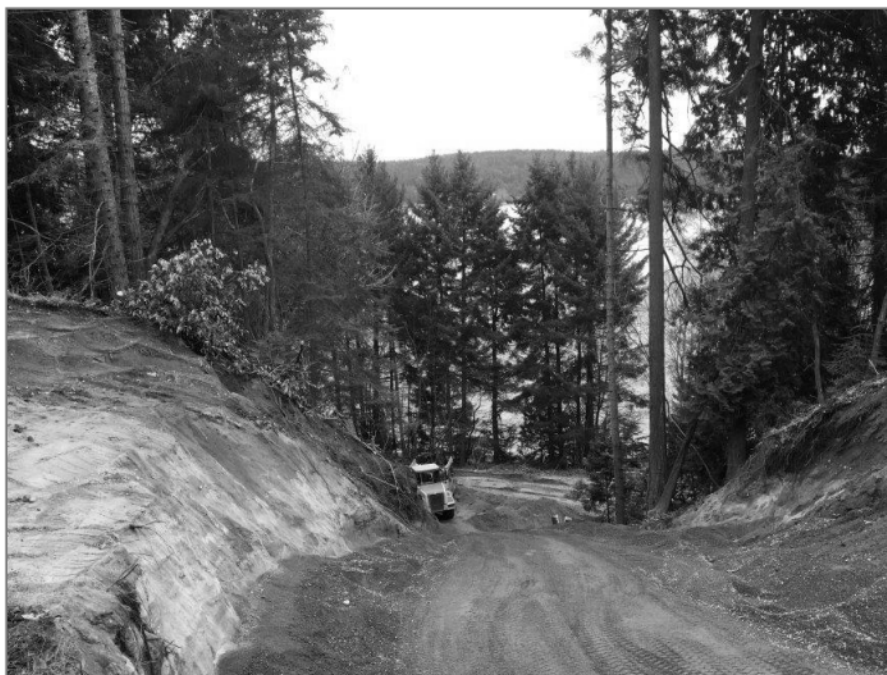
Photo 6: View looking down the slope failure.

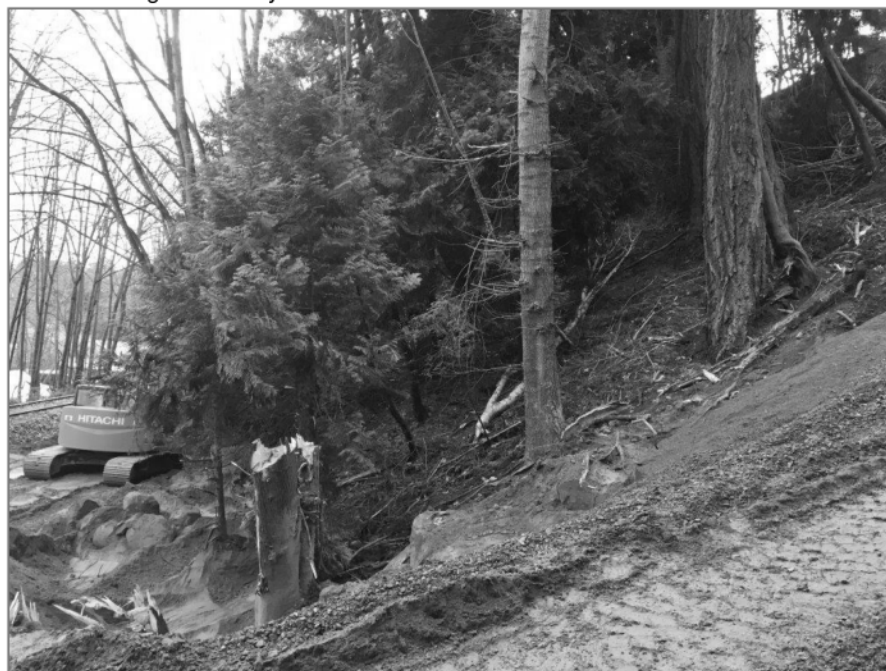
Photo 2: Looking east at the same area to be developed for slope reconstruction stability.

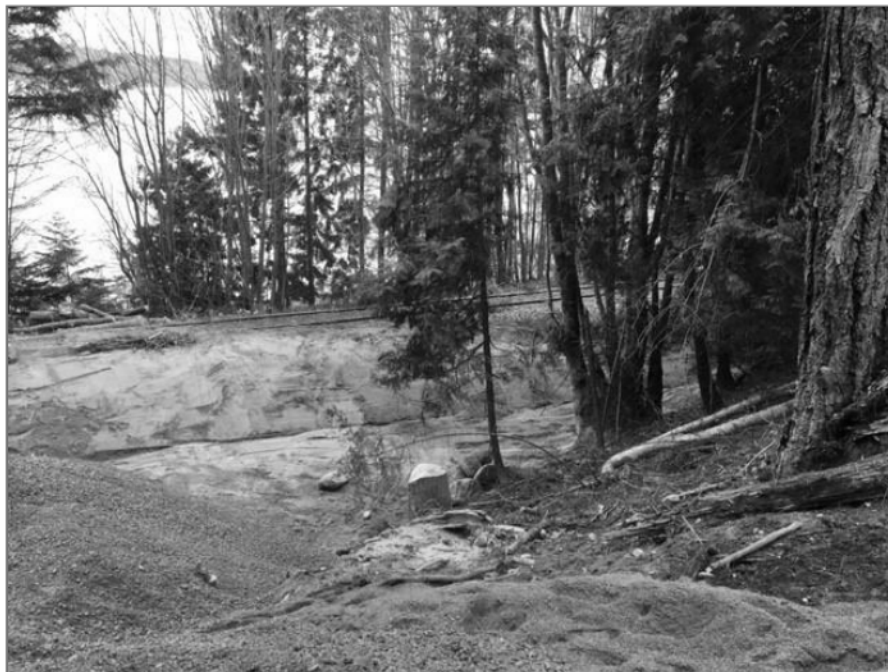
Photo 1: Looking down slope of the area that will require additional excavation to shore up upper areas of the slope. Stump to be removed and tree shown on right may need to be removed, however reconstruction will try work around.

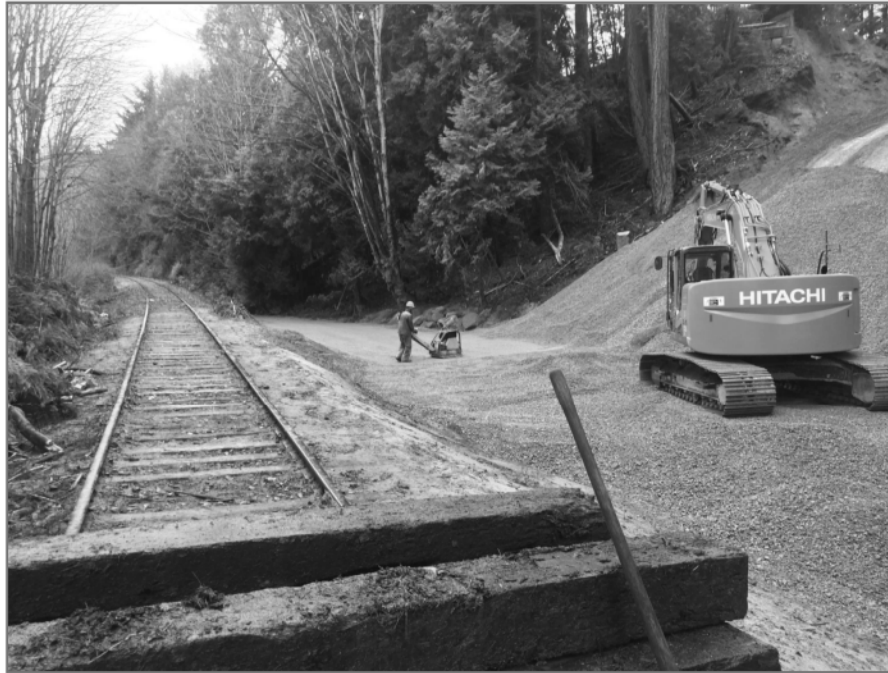
Photo 1: Looking east along the base of the slope at crush being placed and compacted.

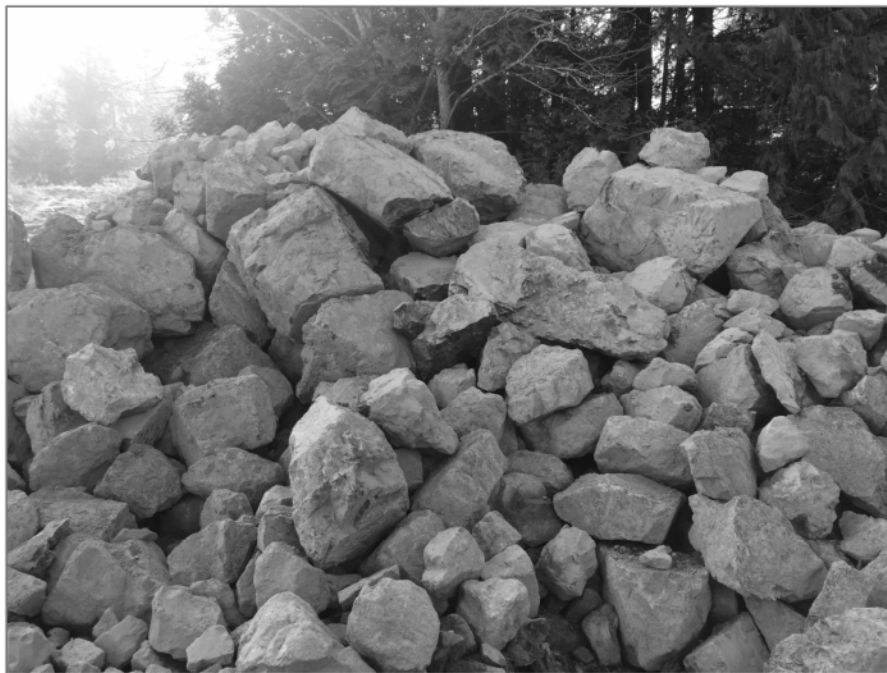
Photo 2: Photo of angular riprap inspected and approved prior to use.

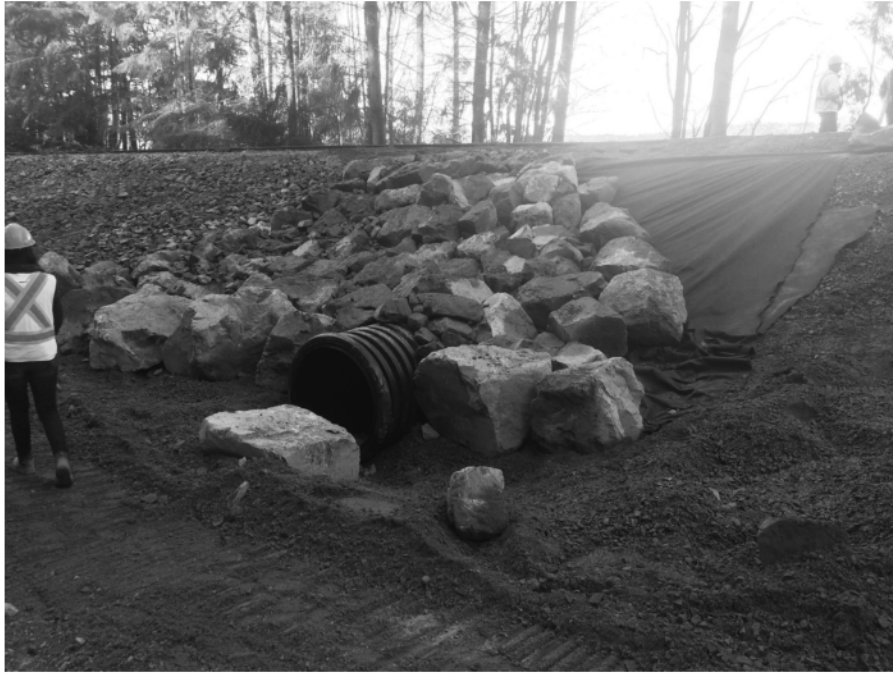
Photo 3: Inlet side of seaward outfall.

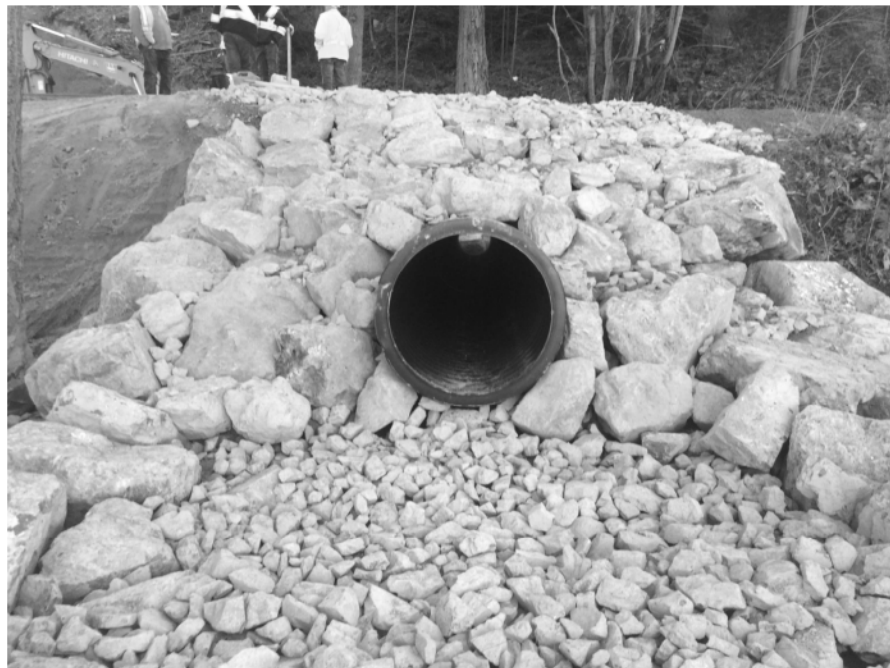
Photo 4: Outlet side of seaward outfall.

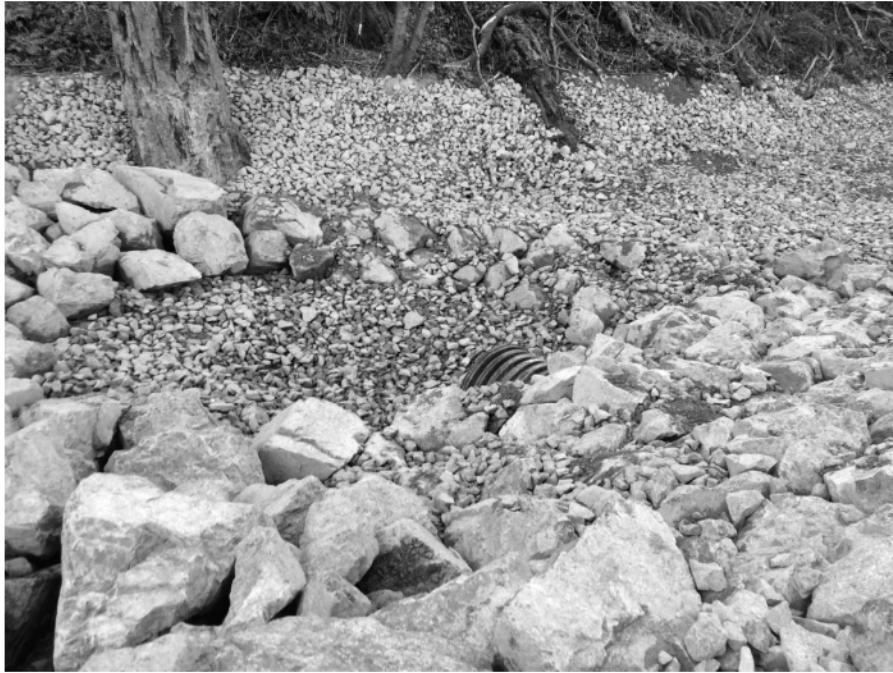
Photo 5: Complete collection pool at seaward outfall.

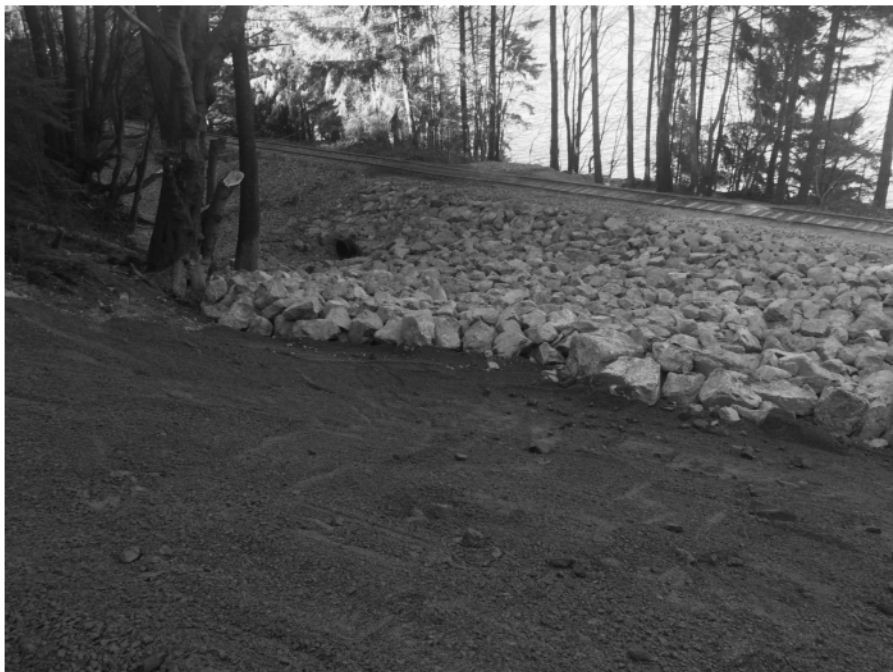
Photo 6: Completed riprap along base. Next step is importing and placing blast rock fill as the construction moves up the slope.

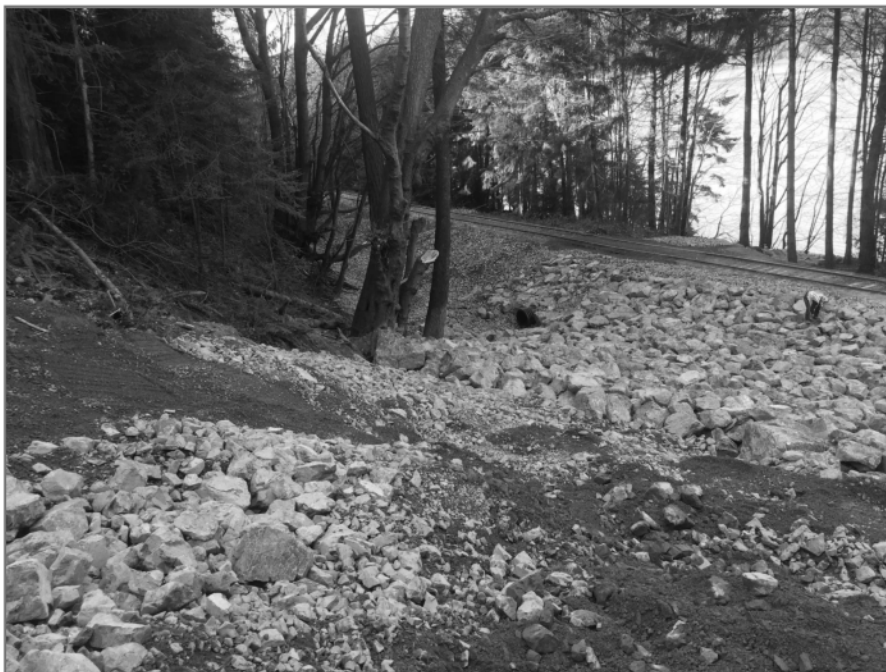
Photo 1: March 19, 2018. Looking down slope at the 18" blast rock placed

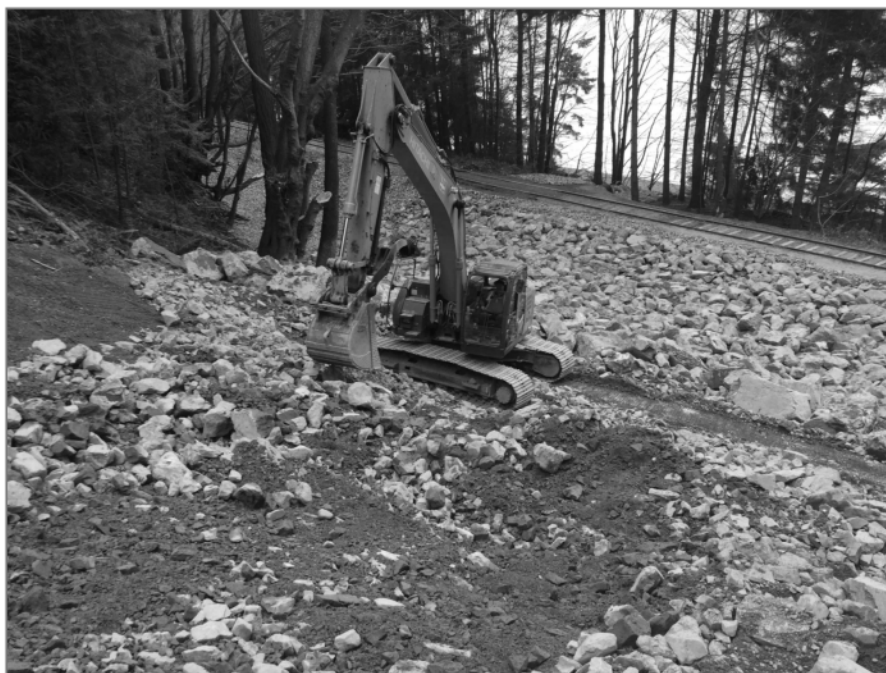
Photo 2: March 20, Excavator track packing the 18" blast rock material.

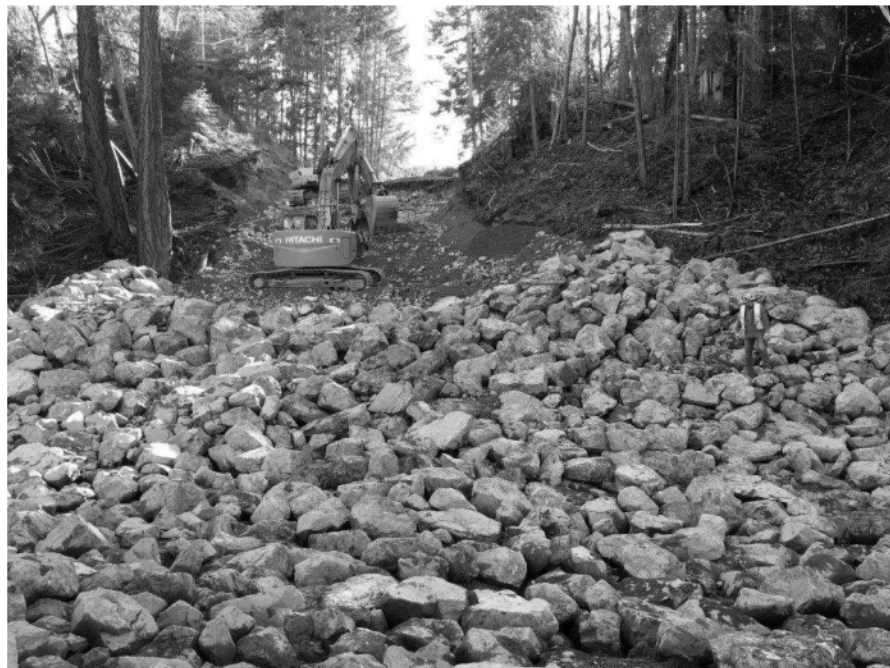
Photo 4: March 22, 2018. Looking upslope at riprap placement progress.

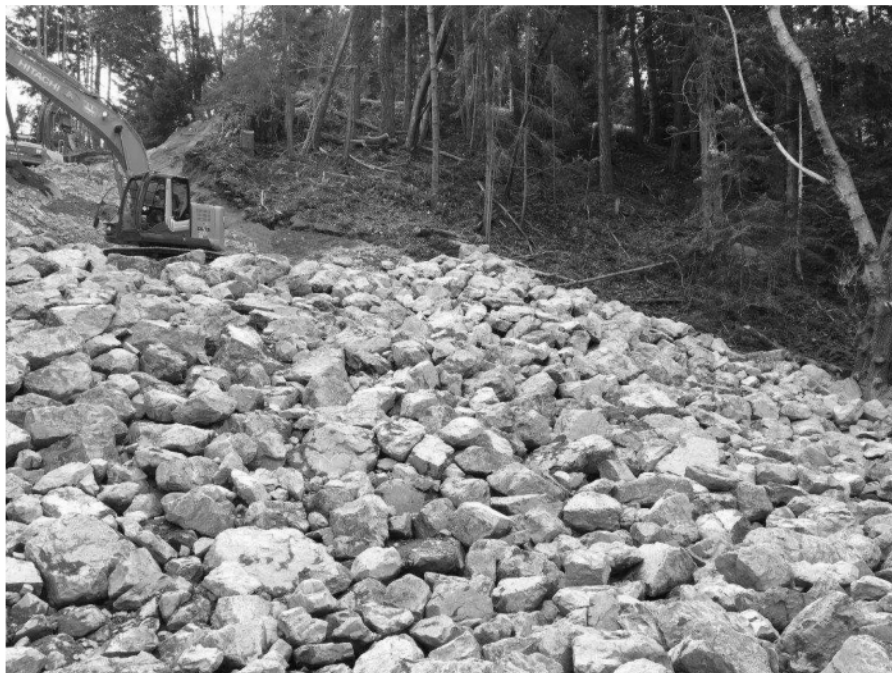
Photo 5: March 23, 2018. View looking at the west side.

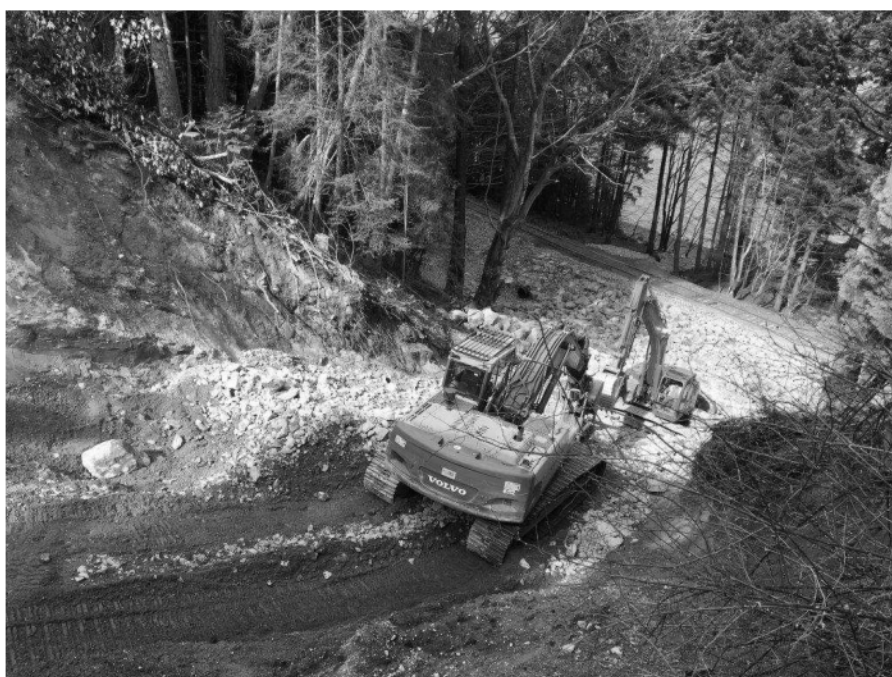
Photo 6: March 23, 2018. View looking downslope of the failure reconstruction progress. 18" Blast rock being mixed and track packed before graded to have swale surface.

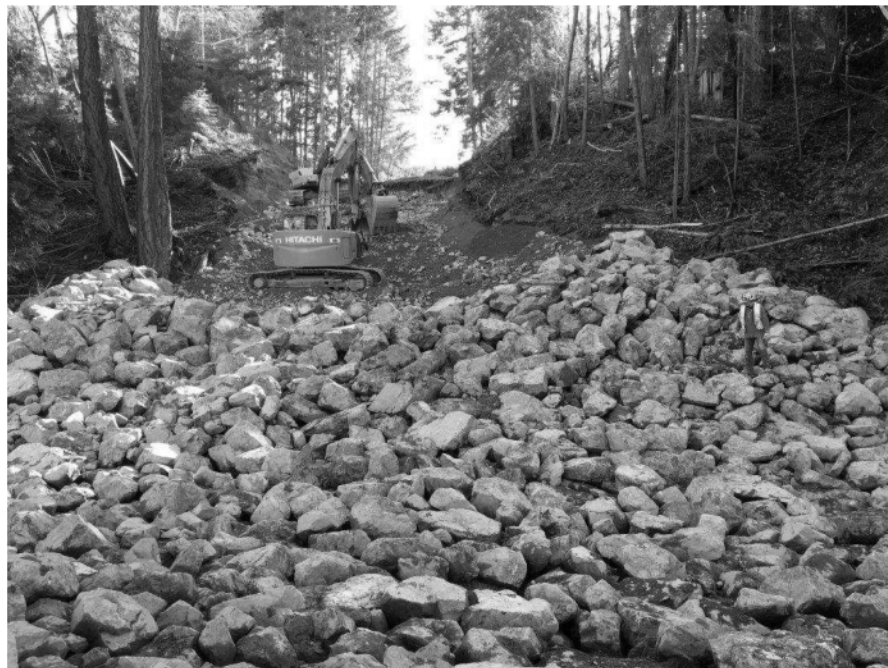
Photo 4: March 22, 2018. Looking upslope at riprap placement progress.

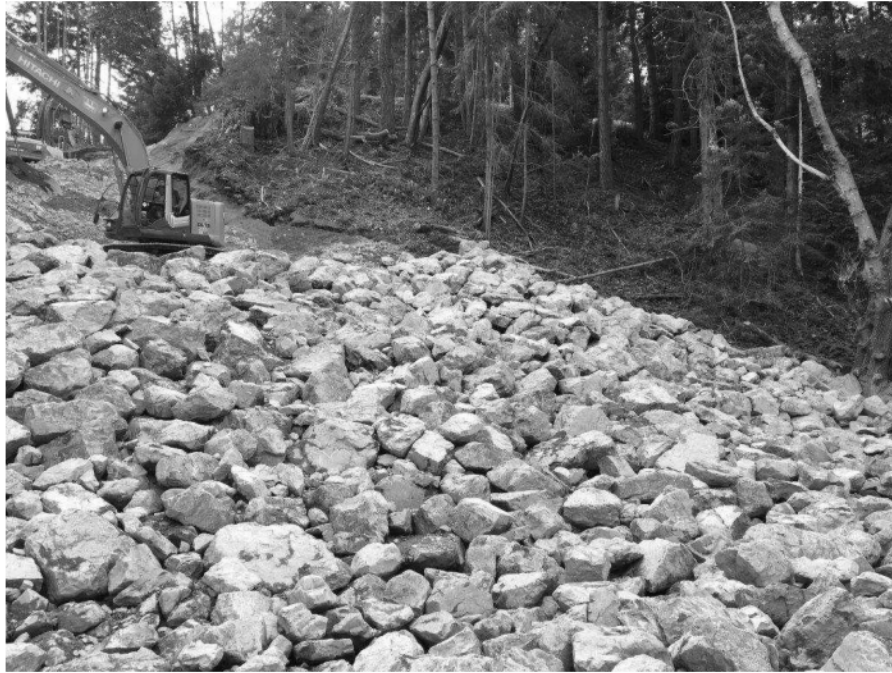
Photo 5: March 23, 2018. View looking at the west side.

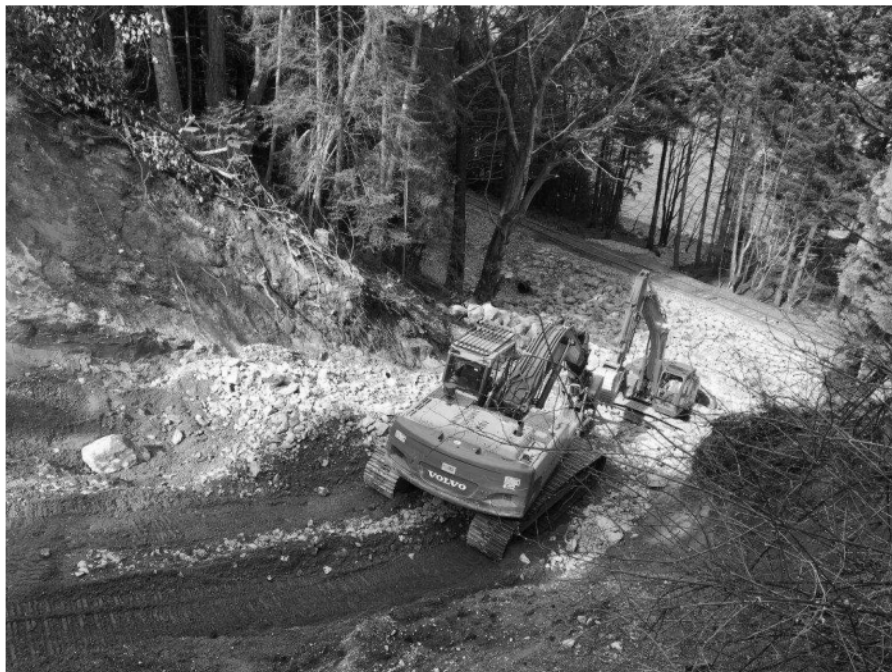
Photo 6: March 23, 2018. View looking downslope of the failure reconstruction progress. 18" Blast rock being mixed and track packed before graded to have swale surface.

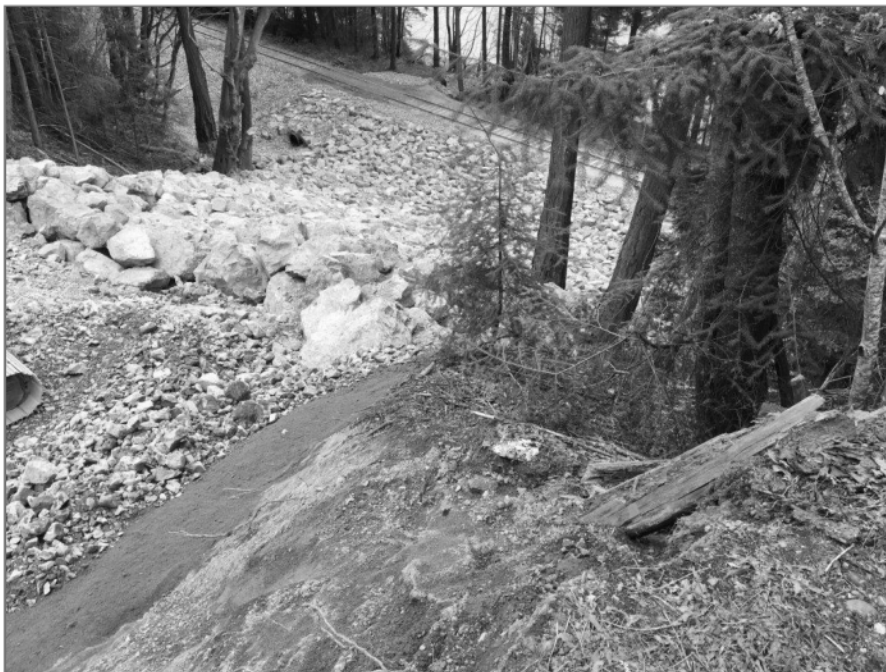
Photo 1: April 3, 2018. Looking down slope riprap construction and the recently removed lock block wall area.

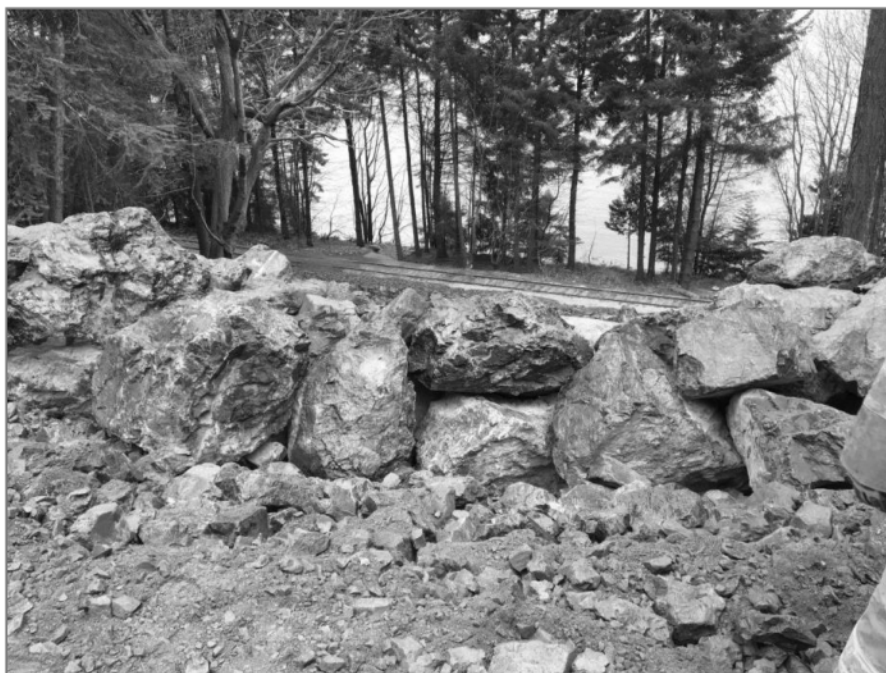
Photo 2: April 4, 2018, Swale being developed in the riprap subsequent granular layers.

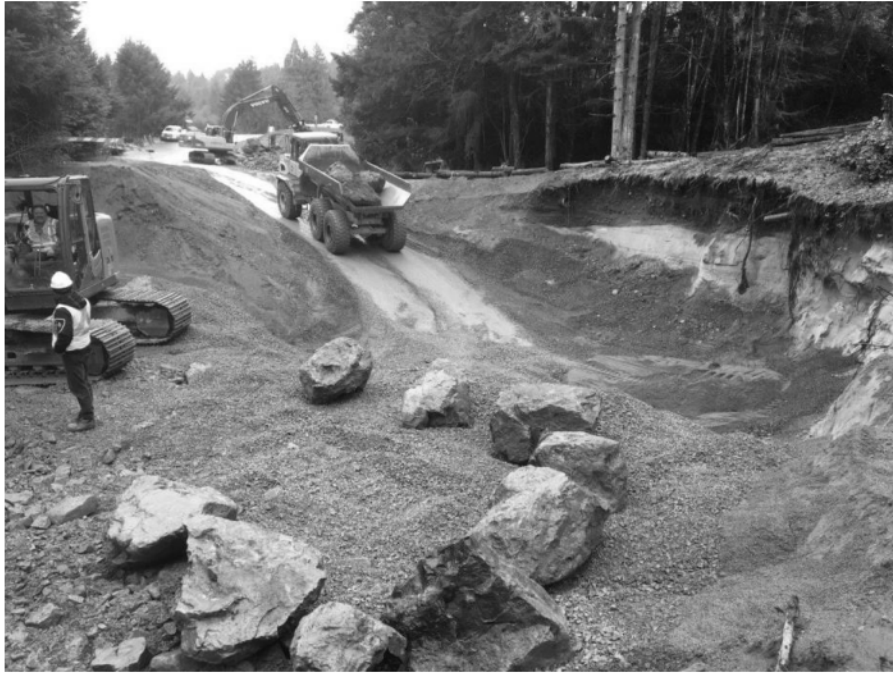
Photo 3: April 5, 2018. 1.5" crush hauled in to build up grades within the road prism.
