June 22, 2018

ISSUED FOR USE
FILE: 704-ENG.VGEO03227-03
Via Email: Ryan.Gustafson@gov.bc.ca

Subject: Rumming Road Erosion Event – Summary of Remediation

RUMMING ROAD FAILURE REMEDIATION
LANTZVILLE, BC

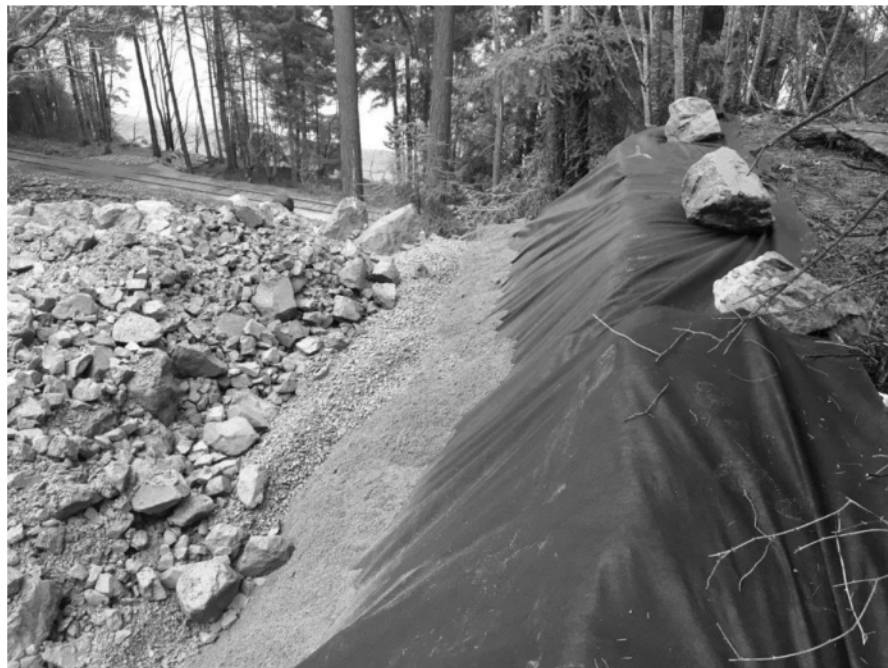
Photo 4: April 5, 2018. Geotextile place along eastern property cut and retaining wall area.

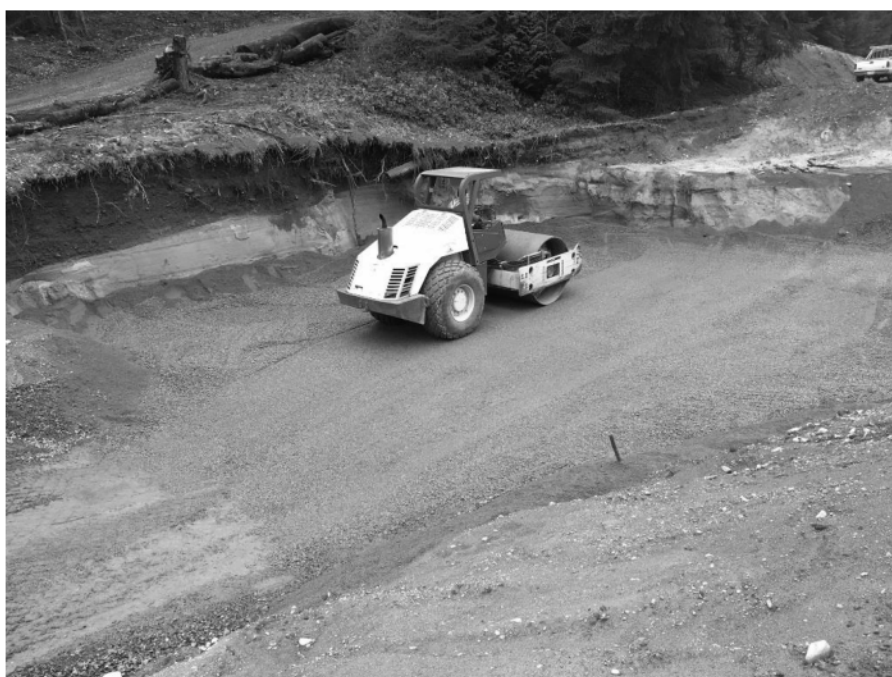
Photo 6: April 6, 2018. Packer at site to complete compaction of the road rebuild area. Lifts being placed at approximately 0.3 m.

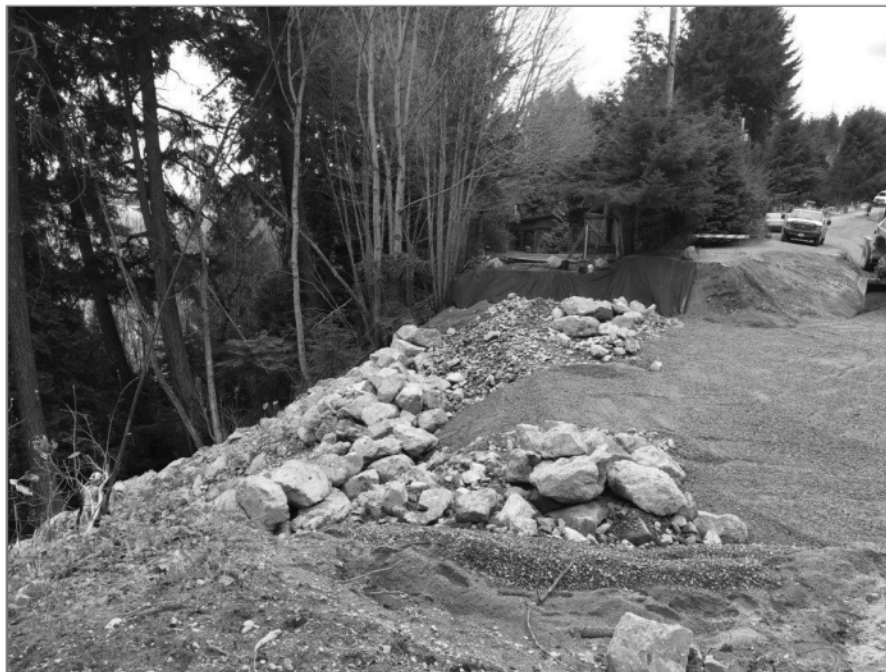
Photo 1: April 9, 2018. East at the slope reconstruction progress.

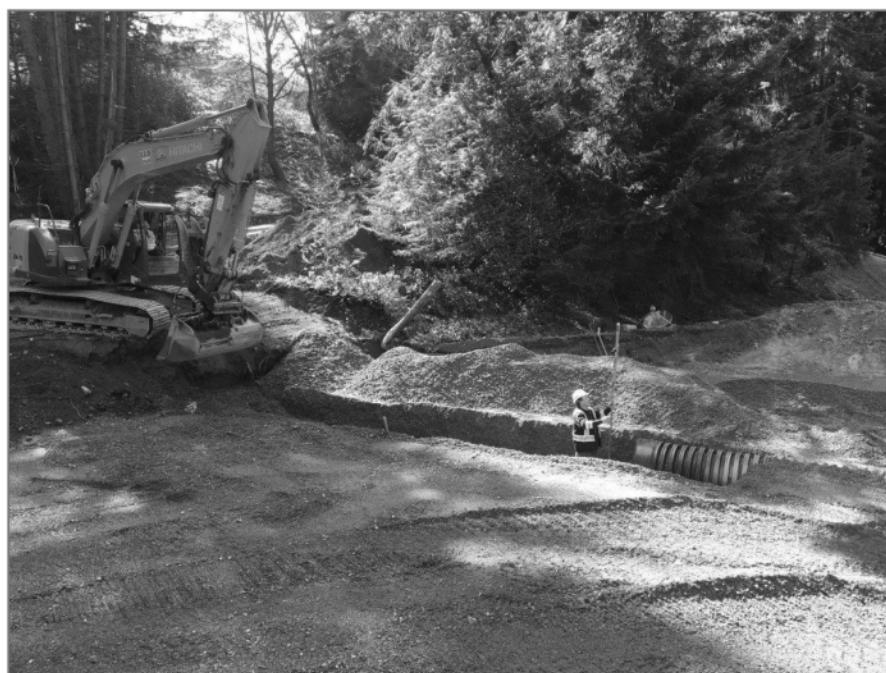
Photo 2: April 10, 2018. Culvert being placed in the Rumming Road reconstruction.

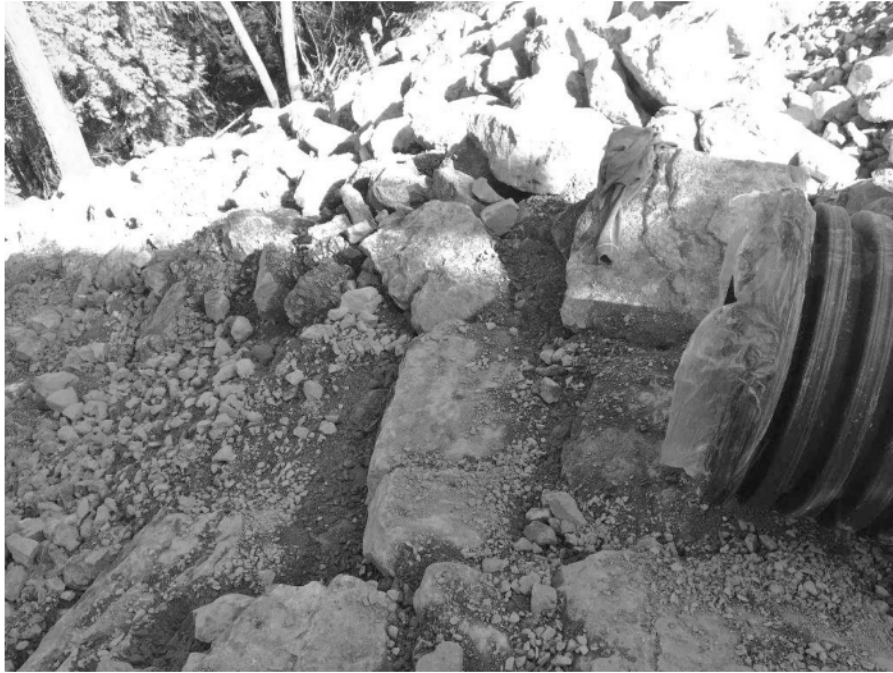
Photo 3: April 9, 2018. Culvert outfall area. Flat tabular particles placed to receive initial water discharge and dissipate water energy.

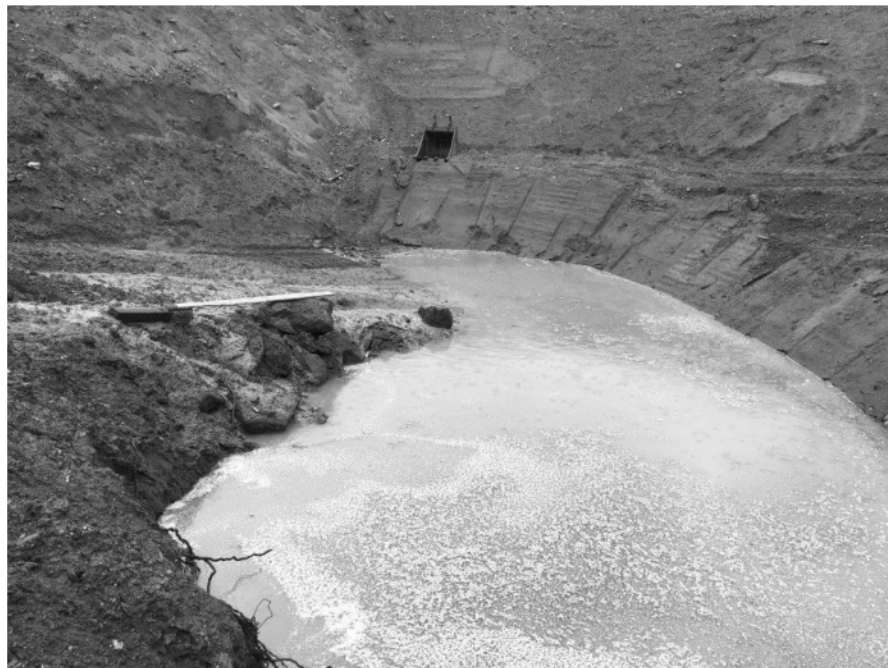
Photo 4: April 10, 2018. Sump area collecting stormwater from catchment areas. Contractor to monitor and reduce level as appropriate.

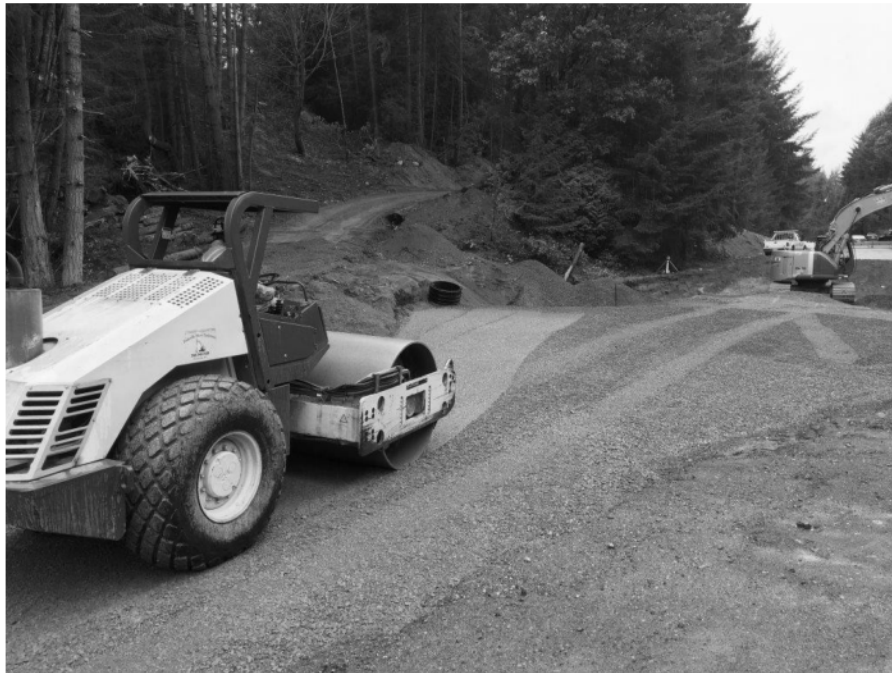
Photo 5: April 11, 2018. Placement and compaction of the pavement structure – Rumming Road.

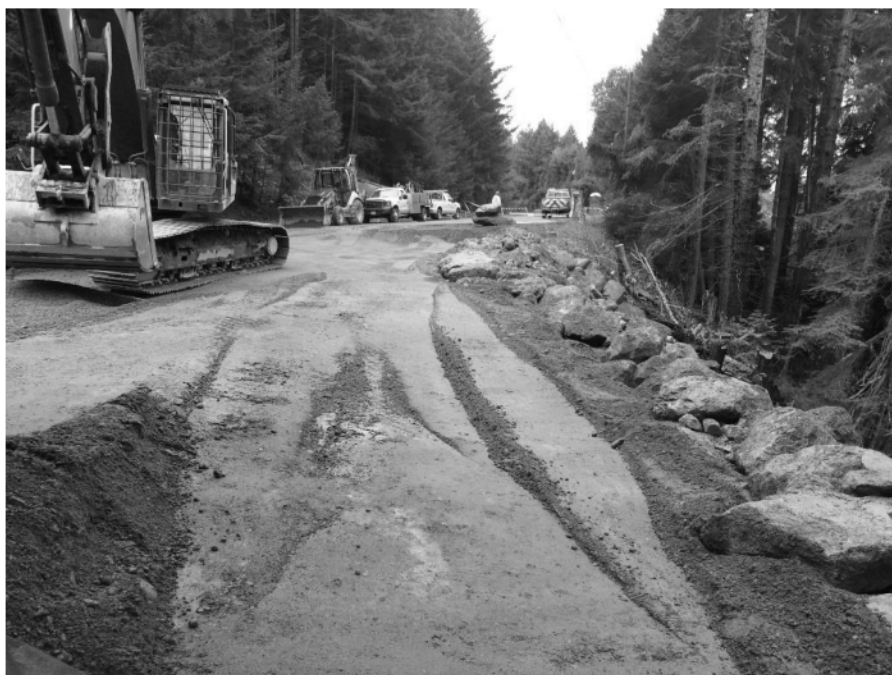
Photo 6: April 13, 2018. View looking west at the final slope reconstruction grade. Existing granular fill being spread out to level out area and transition the new construction with existing grades.
